Deepwater Horizon Accident Investigation Report

September 8, 2010

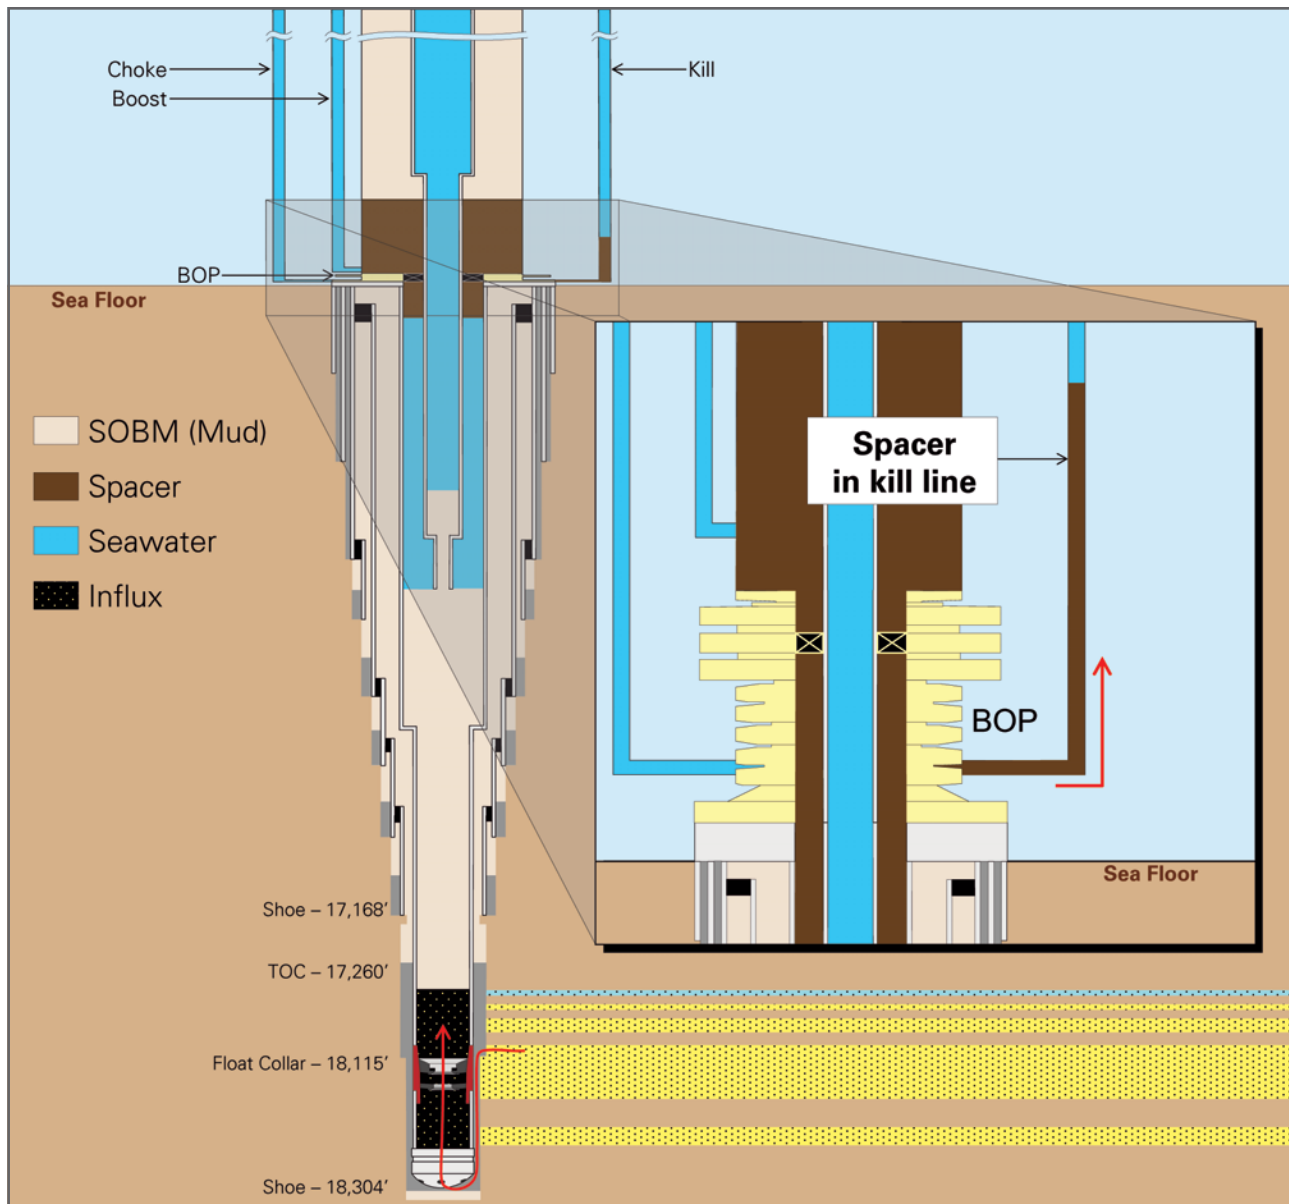
Figure 3. Possible Movement of Spacer into the Kill Line.

The BP Macondo well team provided broad operational guidelines for the negative-pressure test. The rig crew and well site leader were expected to know how to perform the test. The rig crew began the negative-pressure test by monitoring the drill pipe flow. According to witness accounts, this was the rig crew's preferred practice. However, the *Application for Permit to Modify (APM)* to MMS for the Macondo well temporary abandonment stipulated that the negative-pressure test should be conducted by monitoring the kill line. The well site leader noticed the discrepancy and after a discussion with the rig crew, preparations for continuing the negative-pressure test were made by bleeding the kill line. According to witness accounts, between 3 bbls and 15 bbls of seawater flowed from the kill line, which was then shut in.

From 18:00 hours to 18:35 hours, the drill pipe pressure increased from approximately 50 psi to 1,400 psi. To resume the negative-pressure test, the kill line was filled and then opened, 0.2 bbls flowed, and no further flow was observed from the kill line during a 30-minute period of monitoring. The drill pipe pressure was constant at 1,400 psi.

This pressure of 1,400 psi on the drill pipe was misinterpreted by the rig crew and the well site leaders. According to witness accounts, the toolpusher proposed that the pressure on the drill pipe was caused by a phenomenon referred to as 'annular compression' or 'bladder effect.' The toolpusher and driller stated that they had previously observed this phenomenon. After discussing this concept, the rig crew and the well site leaders accepted the explanation. The investigation team could find no evidence that this pressure effect exists.

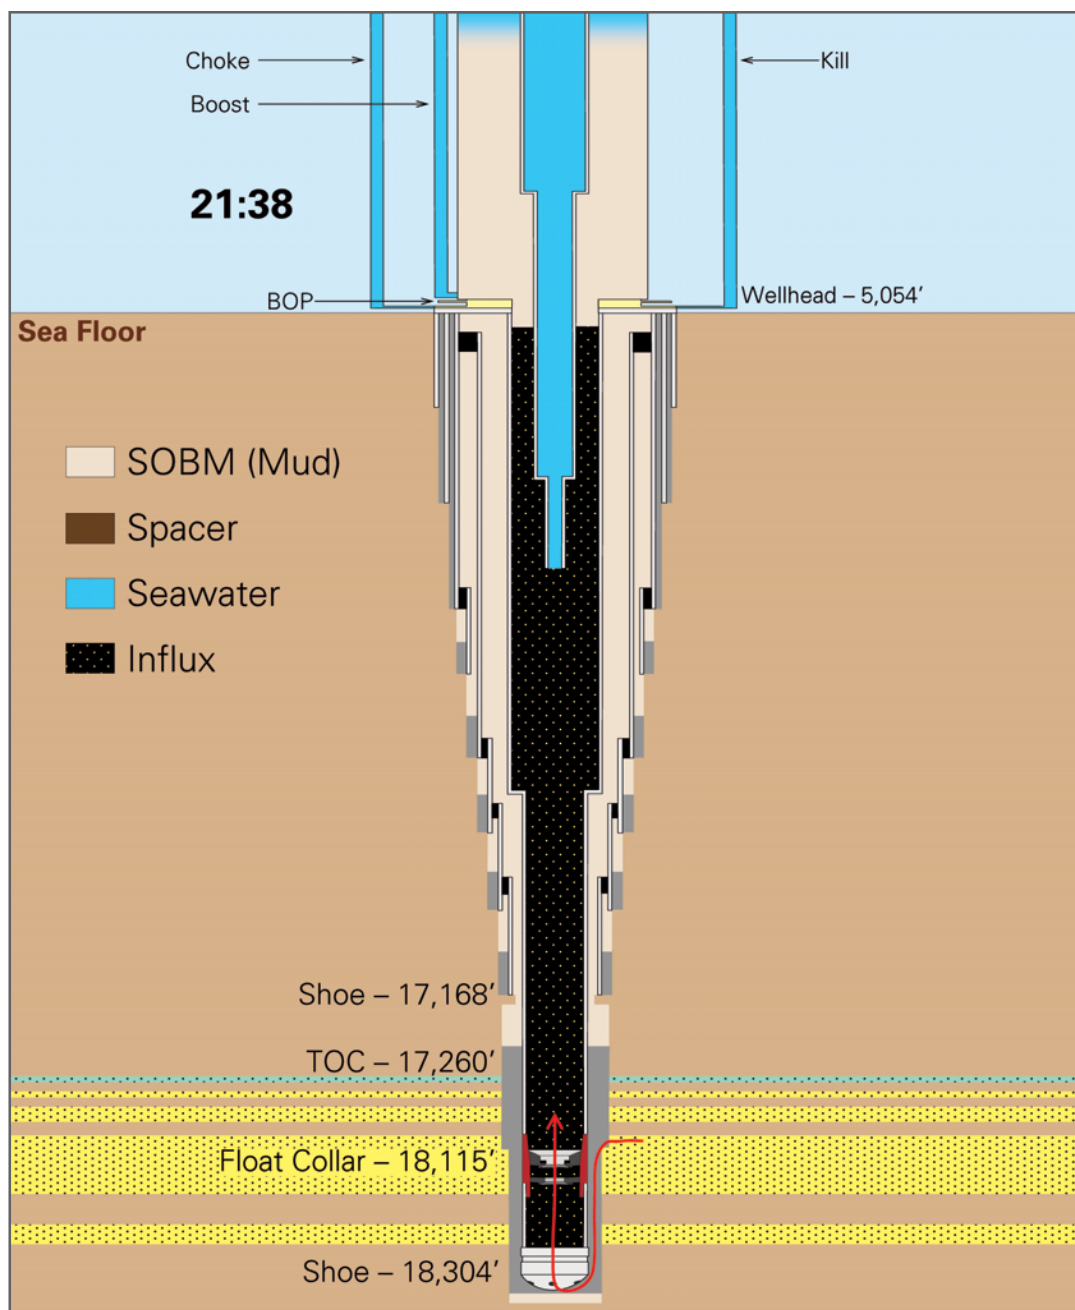
Figure 4. Hydrocarbons Entering the Riser.

Analysis indicates that the first indications of flow from the well could be seen in the real-time data after 20:58 hours. The rig crew and mudloggers either did not observe or did not recognize indications of flow until after hydrocarbons entered the riser at approximately 21:38 hours. The first well control response likely occurred at 21:41 hours.

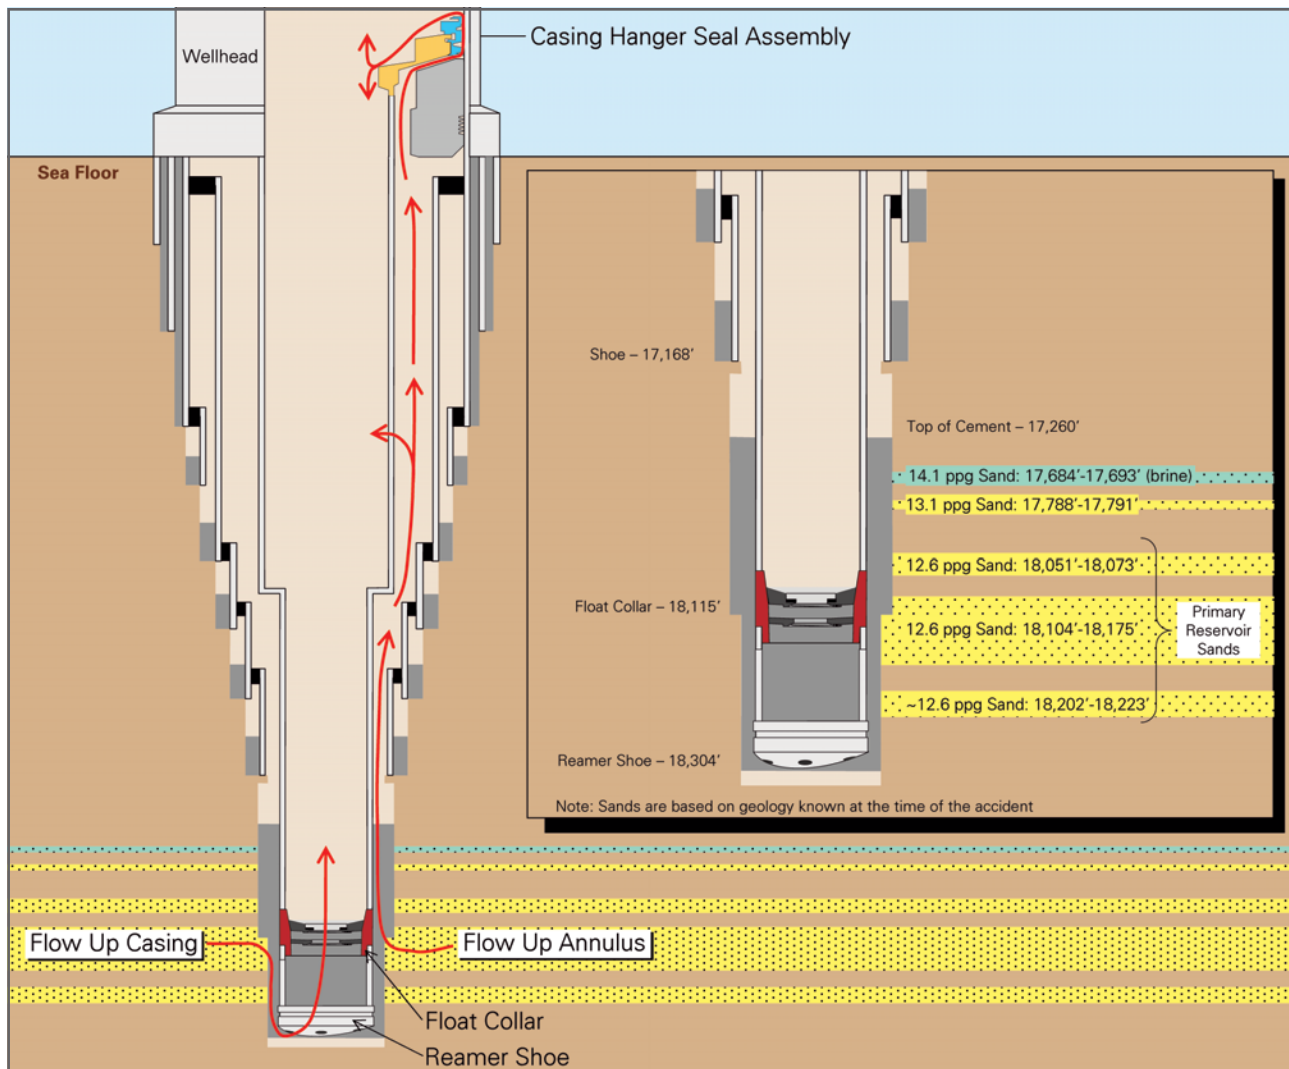
Figure 1. Hydrocarbon Zones and Potential Flow Paths.

The annulus cement barrier failed to prevent hydrocarbons from entering the annulus after cement placement. The investigation team assessed possible failure modes and paths that led to hydrocarbon migration from the formation into the wellbore. (Refer to Figure 1.)

A combination of factors could have contributed to the loss of well integrity, if hydrocarbons entered the wellbore before, during or after cement placement.

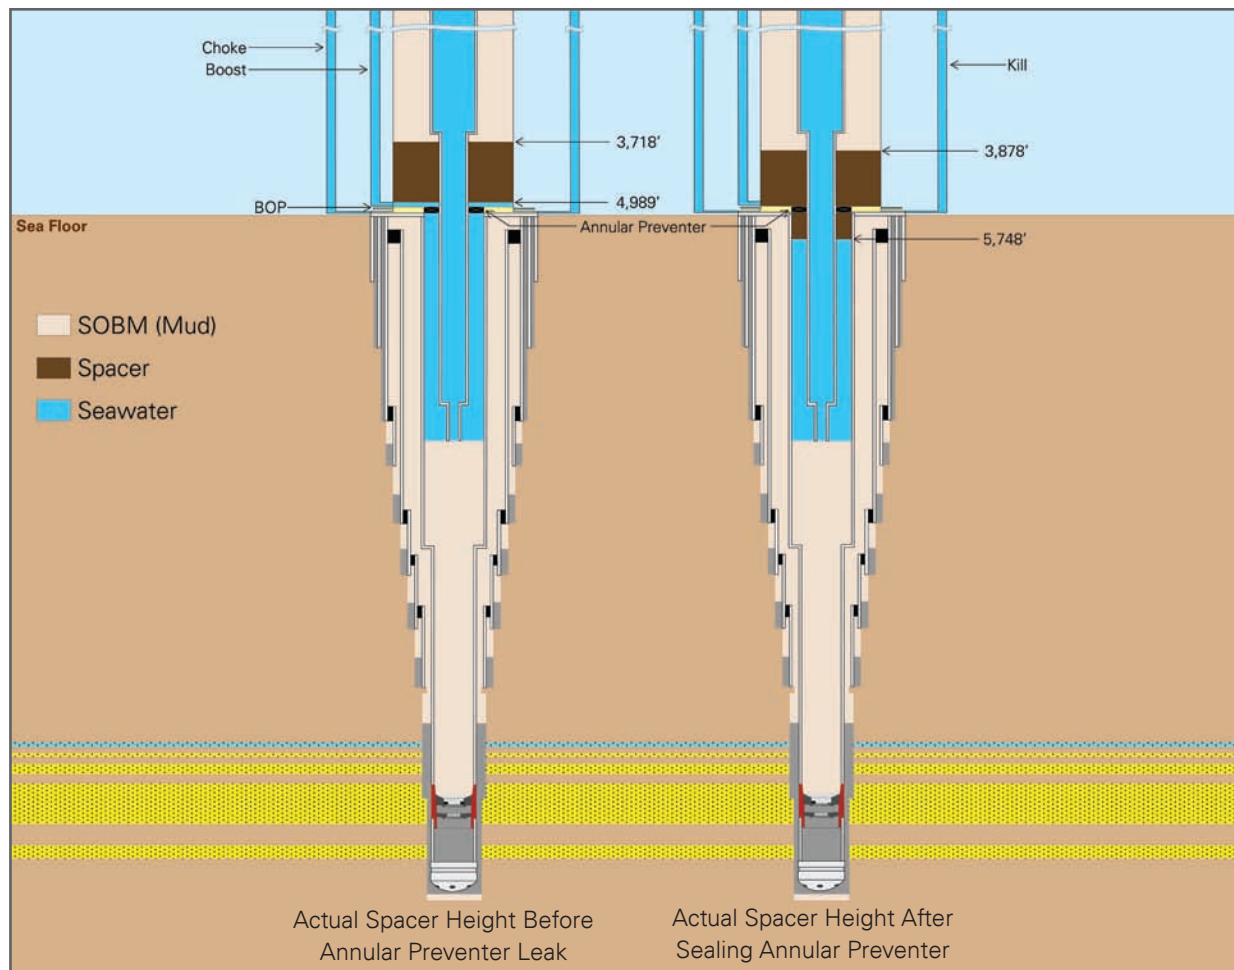
Figure 2. Spacer Placement.

- During the initial attempted negative-pressure test on the drill pipe, the annular preventer was closed, but it failed to seal on the drill pipe, resulting in approximately 50 bbls of spacer leaking past the annular preventer into the BOP during the bleed-off of drill pipe pressure. The investigation team believes that the spacer or spacer/seawater interface was across the BOP during the negative-pressure test procedure. (Refer to *2.3 Opened the Drill Pipe to Bleed Pressure* of this analysis.) The bottom of the spacer, therefore, was not above the upper annular preventer as intended. *Figure 2* shows the actual spacer placement before and after sealing the annular preventer.

- The presence of the spacer across the kill line inlet could have complicated the interpretation of the negative-pressure test. (Refer to *2.5 Continued the Negative-pressure Test on the Kill Line* of this analysis for a discussion of the anomalous pressure readings during the negative-pressure test.)

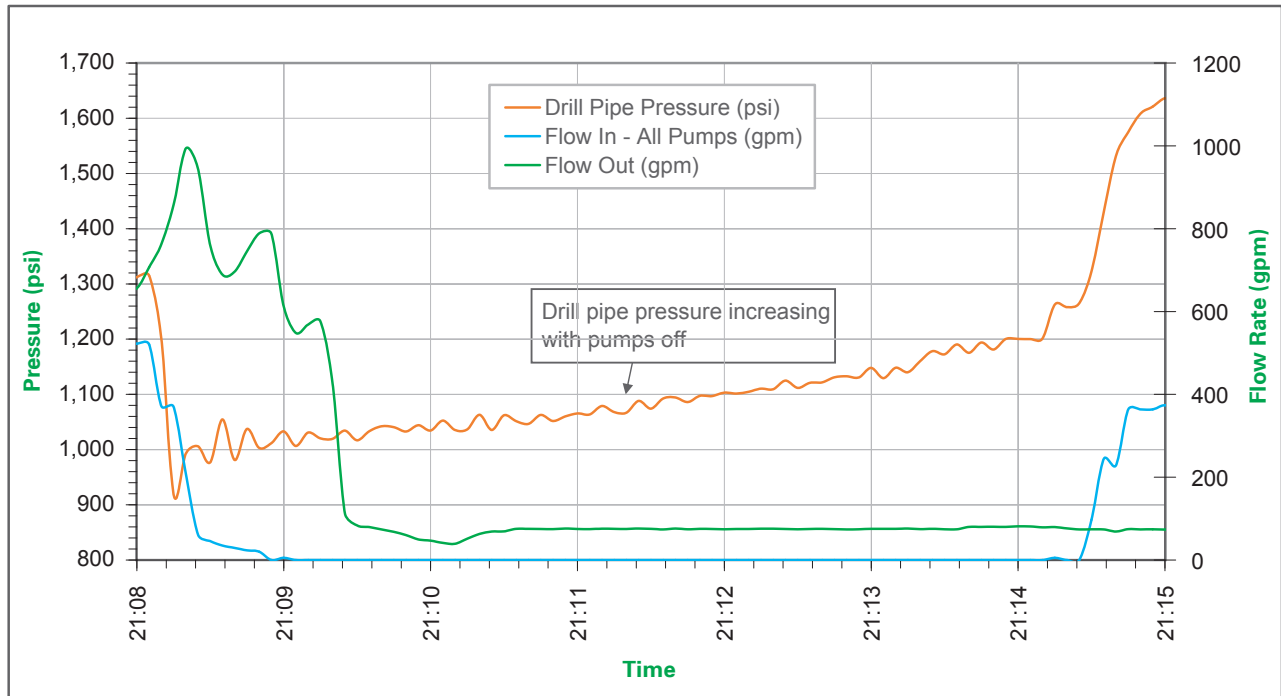
Figure 9. Pressure Increase During the Sheen Test (Real-time Data).

- The drill pipe pressure continued to increase from 1,017 psi at 21:08 hours to 1,263 psi at 21:14 hours. (Refer to Figure 9.) Modeling indicated this pressure increase was caused by 14.17 ppg mud rising above the stinger in the annulus. In addition, modeling suggested that this pressure increase was indicative of flow through the shoe track at a rate of approximately 9 bpm. (Refer to *Appendix G. Analysis Determining the Likely Source of In-flow* for the detailed analysis.)

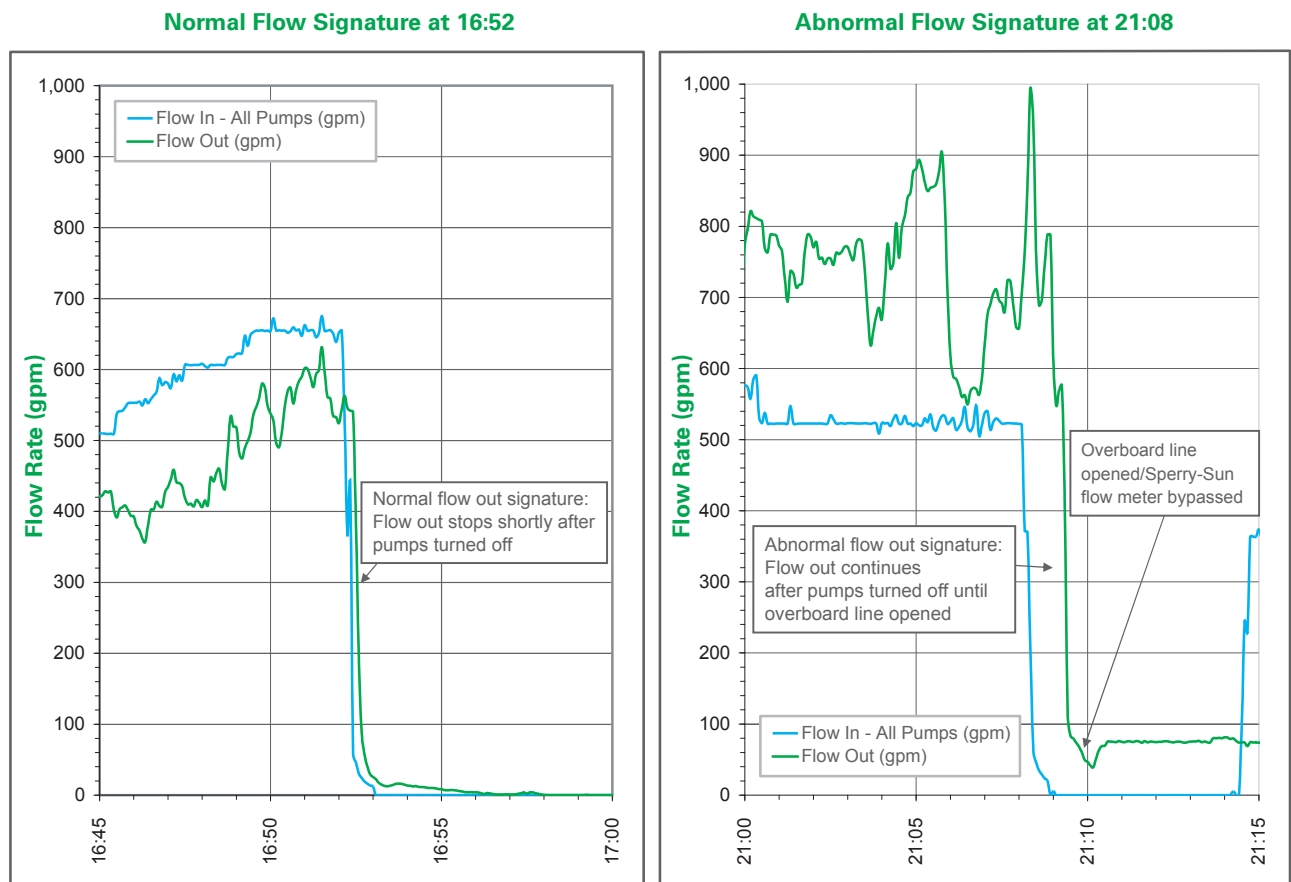
Figure 10. Normal Versus Abnormal Flow Out Signature as Pumps Shut Off (Real-time Data).

- The investigation team compared the flow out signature (i.e., the length of time it took the flow meter sensor to indicate zero flow after shutting the pumps off) to a time when the well was known to be stable. (Refer to Figure 10.) A distinctly different signature was observed at that time, indicating that the well was flowing.

At this point, the rig crew's actions were inconsistent with a team that was aware the well was flowing.

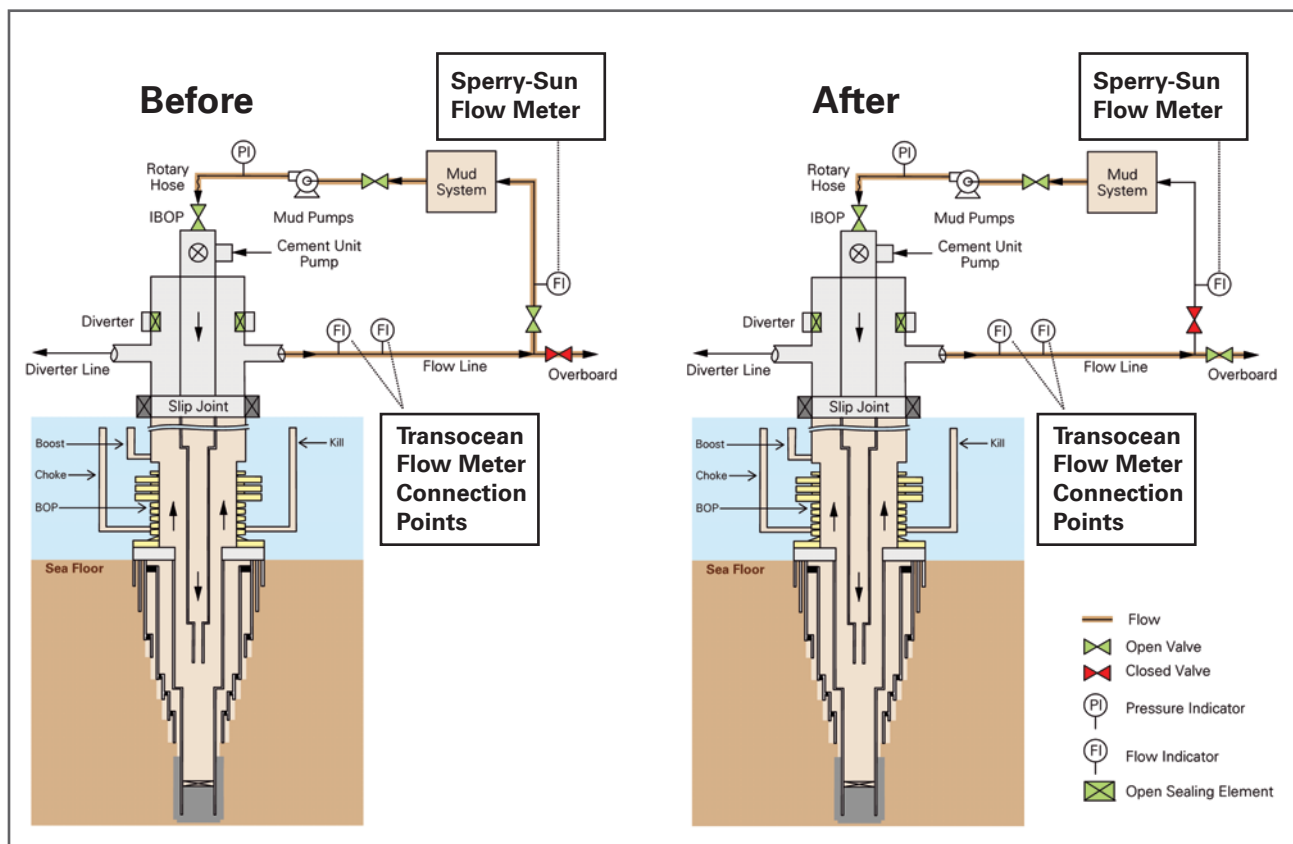
Figure 11. Flow Path Before and After Routing the Spacer Overboard.

The driller should have been able to monitor flow from the well, even after routing the flow overboard. Even though the Sperry-Sun flow meter was not sensing flow after 21:10 hours, information available to the investigation team showed that separate Transocean flow sensors would have been available to the driller. (Refer to Table 1 and Figure 11.)

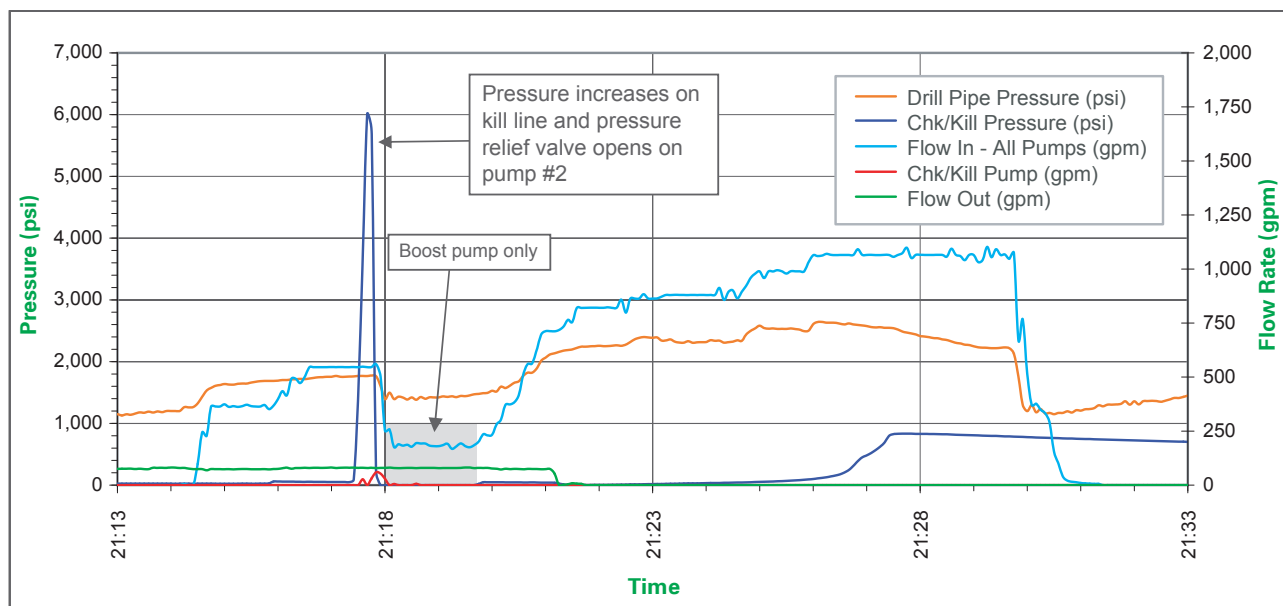
Figure 13. Mud Pump #2 Pressure Increase at 21:17 Hours (Real-time Data).

- An analysis of real-time data combined with MBI testimony suggested that the rig crew was trying to bring mud pump #2 online at 21:17 hours (32 minutes before the explosion). The pump was likely started against a closed valve, lifting the pressure relief valve (PRV). (Refer to Figure 13.)
- Mud pumps #2, #3 and #4 were all shut down, and pump #1 continued to pump into the boost line. Three minutes later, pumps #3 and #4 were put back online, and several personnel were investigating the problem with pump #2. This was another operation that potentially distracted the rig crew from monitoring the well.

- OLGA® well flow modeling indicated that hydrocarbons had been continuously flowing into the well since 20:52 hours and that a 300 bbl gain had been taken by 21:31 hours. During this time period, the rig crew’s actions did not appear to be consistent with a team that was aware that the well was flowing.

- OLGA® well flow modeling also indicated that hydrocarbons entered the riser at approximately 21:38 hours. As described in *4.2 Well Control Response 21:40 Hours to 21:49 Hours* of this analysis, the first well control response did not occur until approximately 21:41 hours.

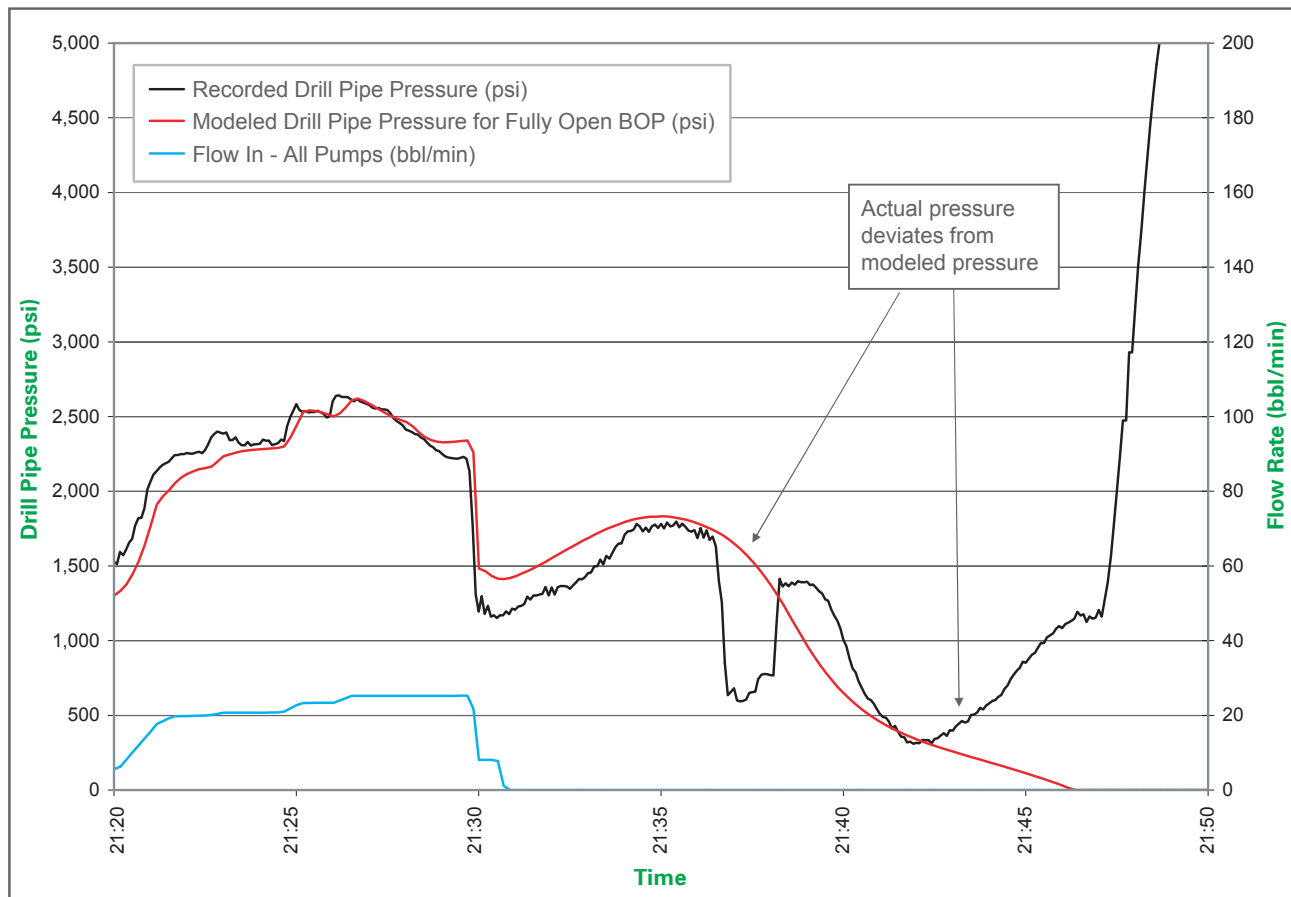
- As mentioned previously, at approximately 21:33 hours (approximately 21:30 hours per MBI testimony), the chief mate observed the toolpusher and the driller discussing 'differential pressure' on the well. This coincided with the real-time data showing the drill pipe pressure increasing at this time.
- The OLGA® well flow modeling predicted the pressure responses from 21:31 hours to 21:42 hours fairly accurately, with the exception of the sudden pressure changes shown in the real-time data from 21:36 hours to 21:38 hours. (Refer to Figure 14 for specific readings.)

Figure 14. OLGA® Well Flow Modeling for Flow Condition with an Open Annular Preventer.

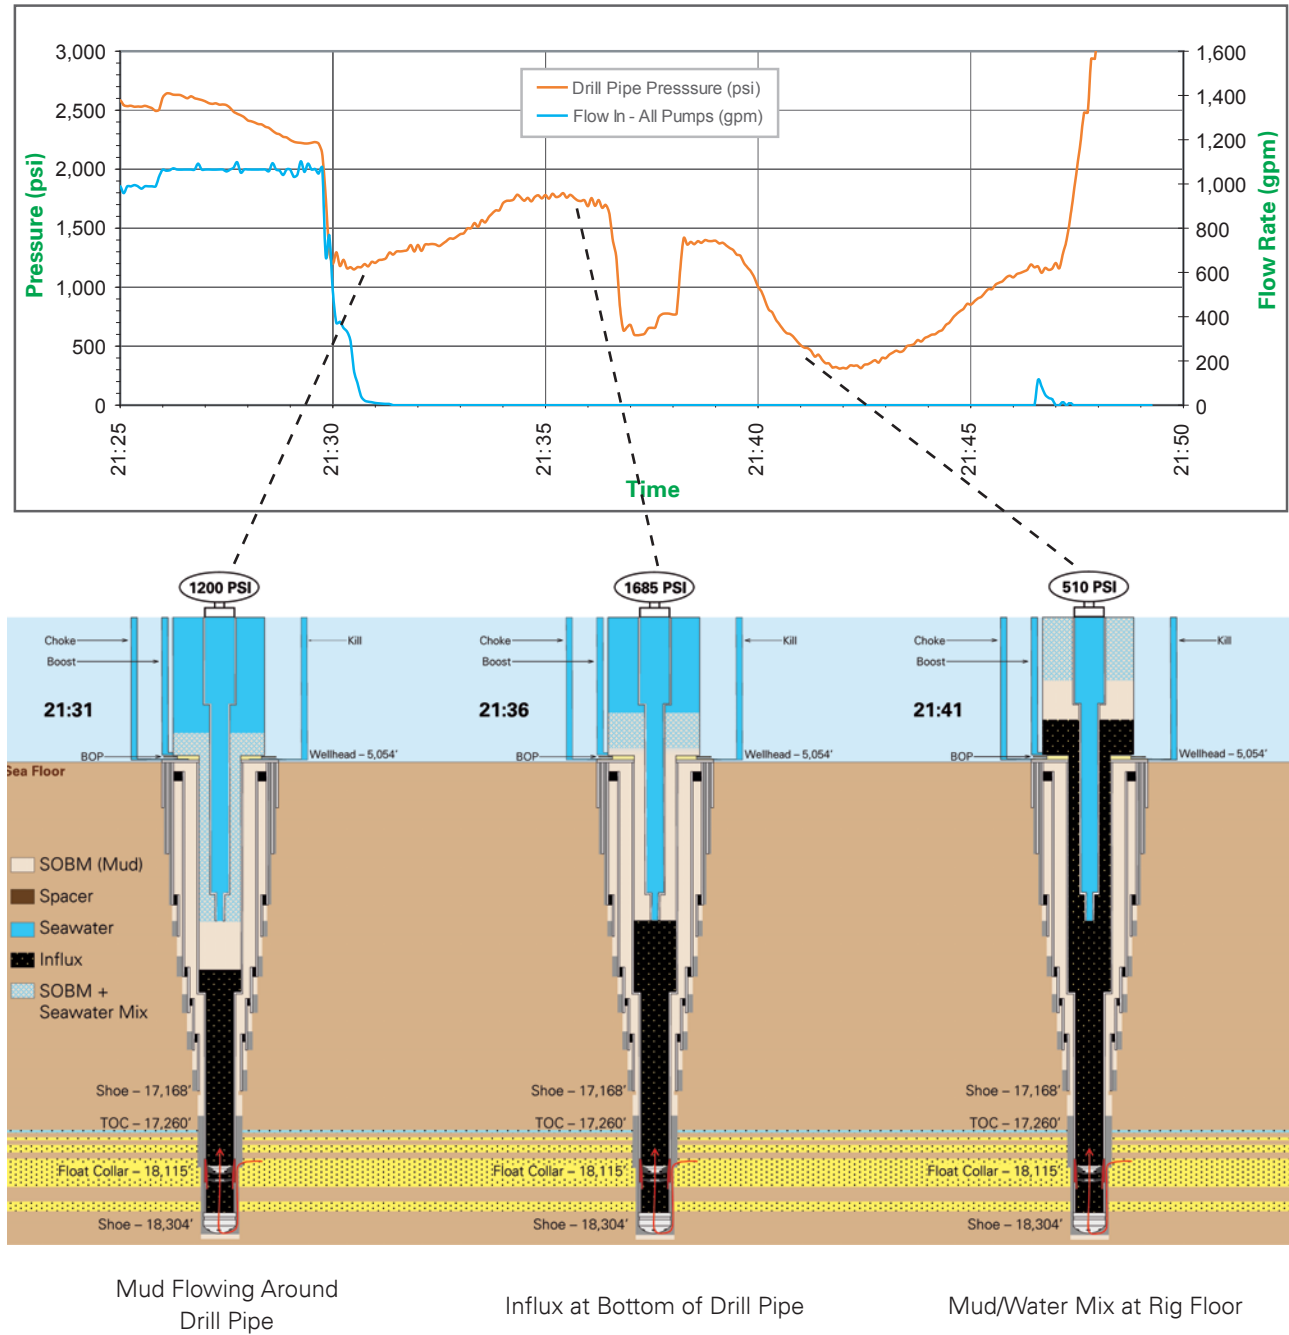
- The rig crew may have conducted this bleed-off when they were investigating the 'differential pressure.' This action would not be consistent with a rig crew responding to a recognized well control condition.
- Other than the sudden pressure changes between 21:36 hours and 21:38 hours (interpreted to be the bleed-off of the drill pipe pressure), the drill pipe pressure increased until 21:35 hours as 14.17 ppg mud rose above the stinger and then declined after that as hydrocarbons rose above the stinger.
- Modeling indicated that this fluctuation was consistent with the change in fluid densities (spacer, seawater, mud and hydrocarbons) moving through the various cross-sectional areas in the well. *Figure 16* illustrates the hydrostatic changes occurring in the well and the corresponding pressure responses.

Figure 16. Modeled Pressure Responses Resulting from Hydrostatic Changes in the Wellbore.

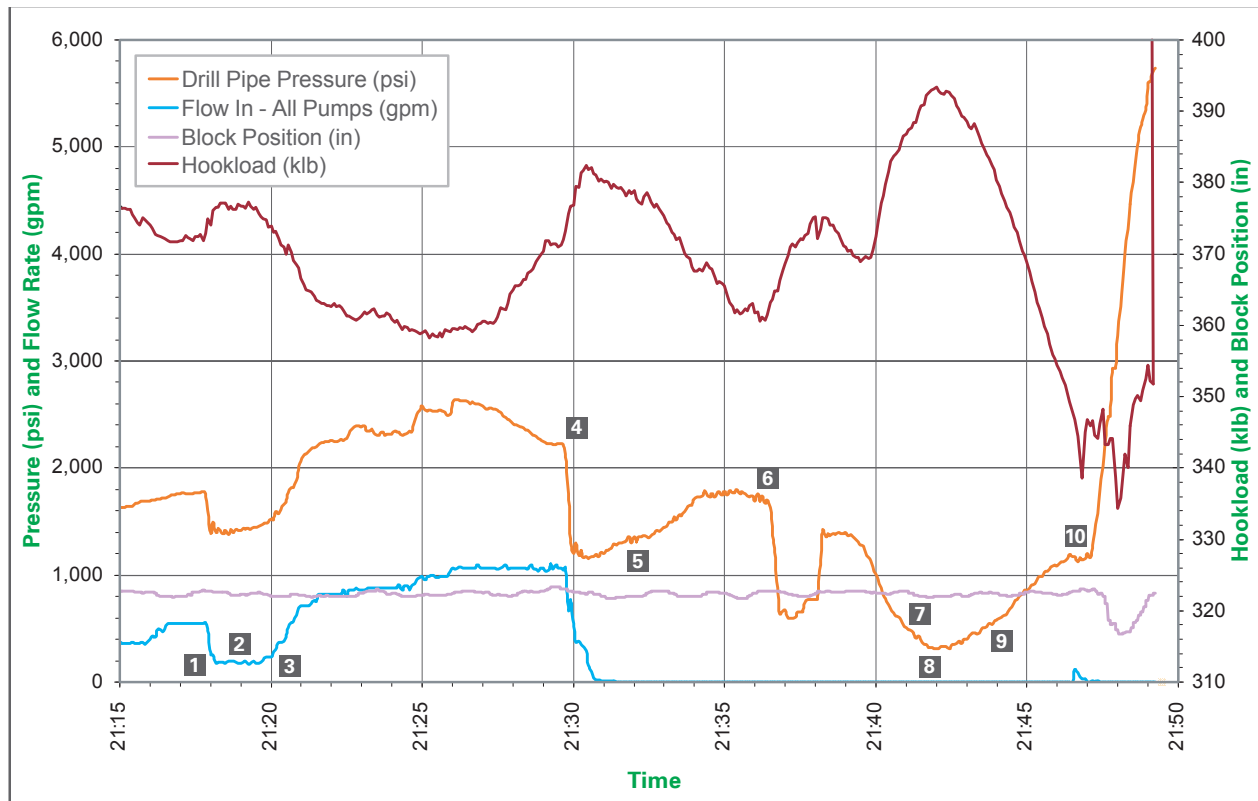
- Analysis shows that to create the pressure increase observed on the drill pipe from 21:42 hours to 21:47 hours, the annular preventer was over 99% closed (but not fully sealed) around the drill pipe. If the annular preventer was fully closed and sealed during this time period, the pressure increase would have been more immediate. (Refer to *Analysis 5D. The Blowout Preventer Did Not Seal the Well* of this section for a detailed explanation.)

- One of two possible actions would have caused the rapid pressure increase to 5,730 psi from 21:47 hours to 21:49 hours:
 - The rig crew possibly first closed an annular preventer and then closed a VBR in accordance with Transocean’s protocol for handling well control events.

- The rig crew possibly first closed an annular preventer and then increased its closing pressure to create a seal.

| <p>1 Pressure relief valve on pump #2 opens; toolpusher called to rig floor.</p> <p>2 All pumps shut down except boost pump.</p> <p>3 Assistant driller called to pump room.</p> <p>4 Pumps shut off.</p> <p>5 Toolpusher and driller discuss 'differential pressure.'</p> <p>6 Opening of 4" surface line to bleed pressure.</p> | <p>7 Mud/water flows onto rig floor and then unloads through the derrick.</p> <p>8 Diverter and annular preventer activated; diverted to mud gas separator.</p> <p>9 Well site leader and senior toolpusher receive calls from rig floor; annular preventer attempting to close.</p> <p>10 BOP sealing.</p> |

Figure 17. Interpretation of Well Control Response (Real-time Data).

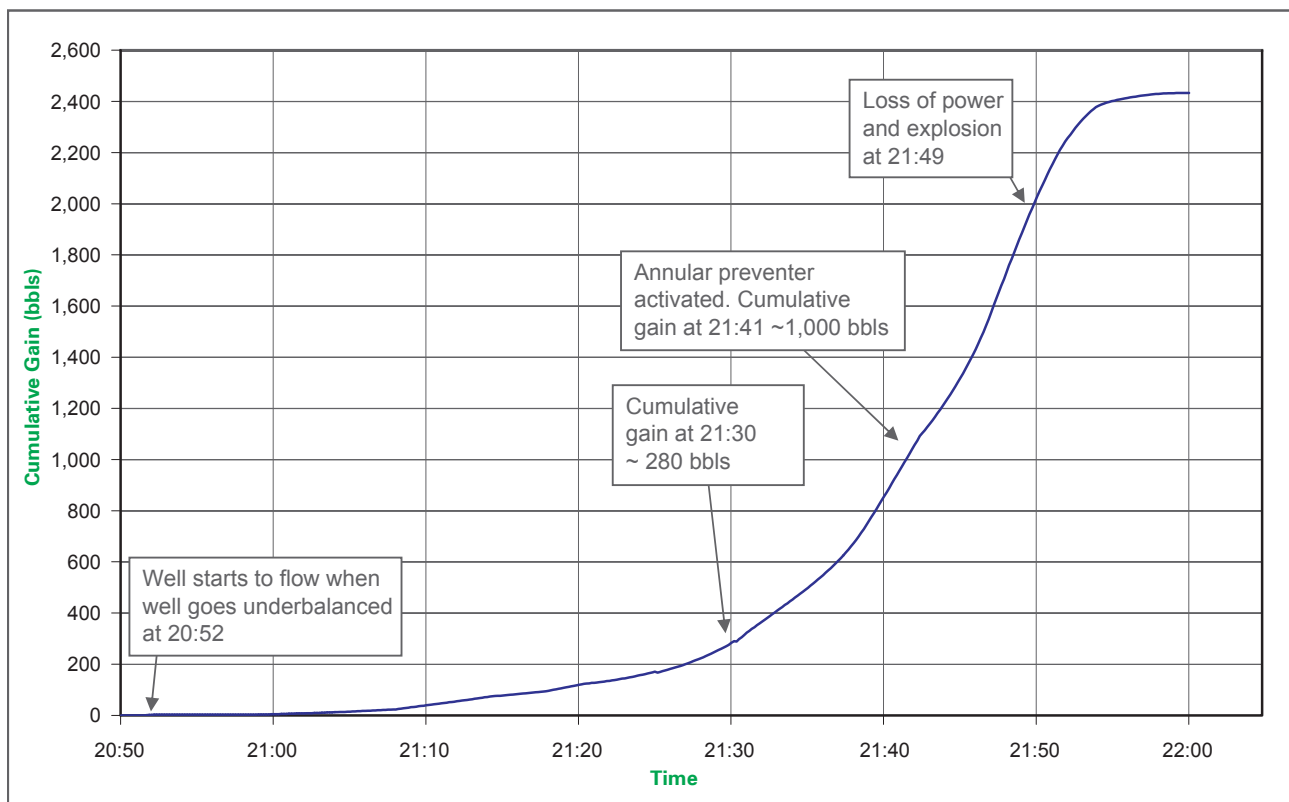
When the annular preventer was activated at approximately 21:41 hours, the model estimated the influx volume to be approximately 1,000 bbls. By the time the explosion occurred at approximately 21:49 hours, the model estimated the gain to be approximately 2,000 bbls. (Refer to Figure 18 for the cumulative gain over time.)

Figure 18. OLGA® Well Flow Modeling Prediction of Cumulative Gain Excluding Pumped Volumes 20:52 Hours–21:49 Hours.

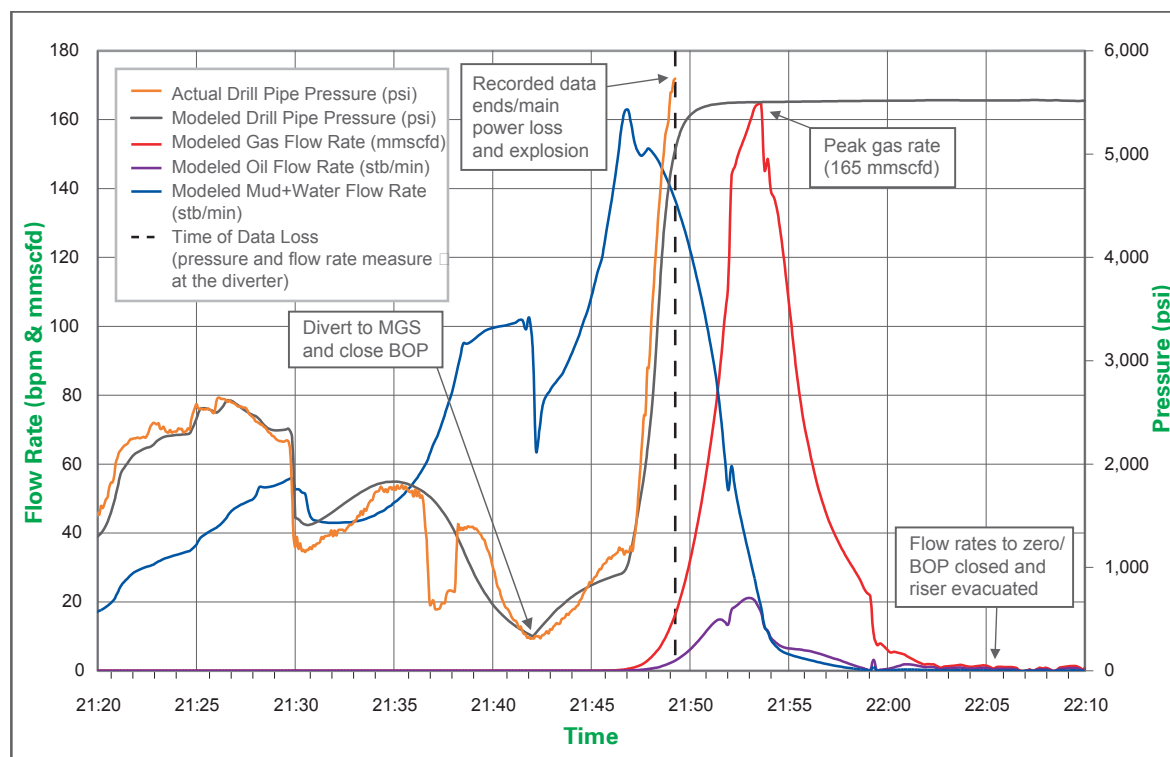
Figure 1 shows the predicted flow rates of mud/water, gas and oil. At approximately 21:46 hours, the gas reached the surface, and over a 5-minute period the flow of gas increased to more than 140 mmscfd. Simultaneously, the flow of mud and water to the surface reduced from 140 bpm to 20 bpm. The modeled timeline of flow to the surface aligns with eyewitness accounts described in *Table 1*.

Figure 1. OLGA® Well Flow Modeling Prediction of Fluid Outflow from the Riser.

Based on the assumption that the BOP remained closed and sealed around the drill pipe, *Figure 1* shows that predicted flow tails off approaching 22:00 hours, though it is evident from the actual event that this did not occur. (Refer to *Appendix W. Report–Dynamic Simulations Deepwater Horizon Incident BP.*) The failure modes that may have allowed the flow to continue are described in *3.5 Sustaining the Flow Following the Closure of the BOP* of this analysis.

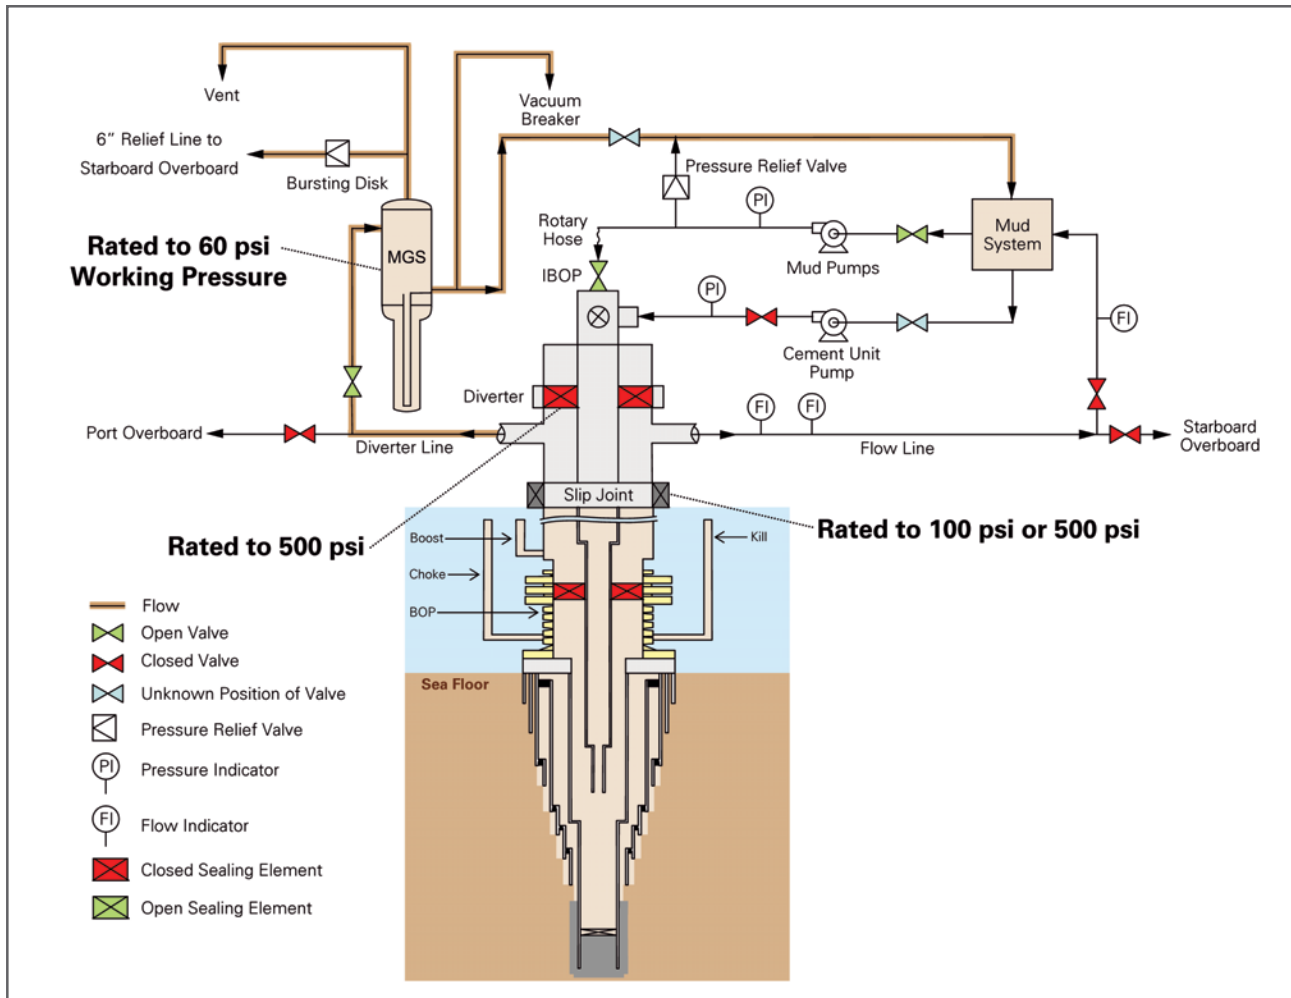
Figure 2. Simplified Process Flow Diagram of Selected *Deepwater Horizon* Surface Equipment.

Based on these modeled pressures, it appears that some of the surface equipment could have begun to fail and release hydrocarbons. (Refer to Figure 2.) The two most vulnerable pieces of equipment were the MGS vessel, which was rated for 60 psi; and, if selected in low-pressure mode, the riser slip joint seal, which was rated for 100 psi.

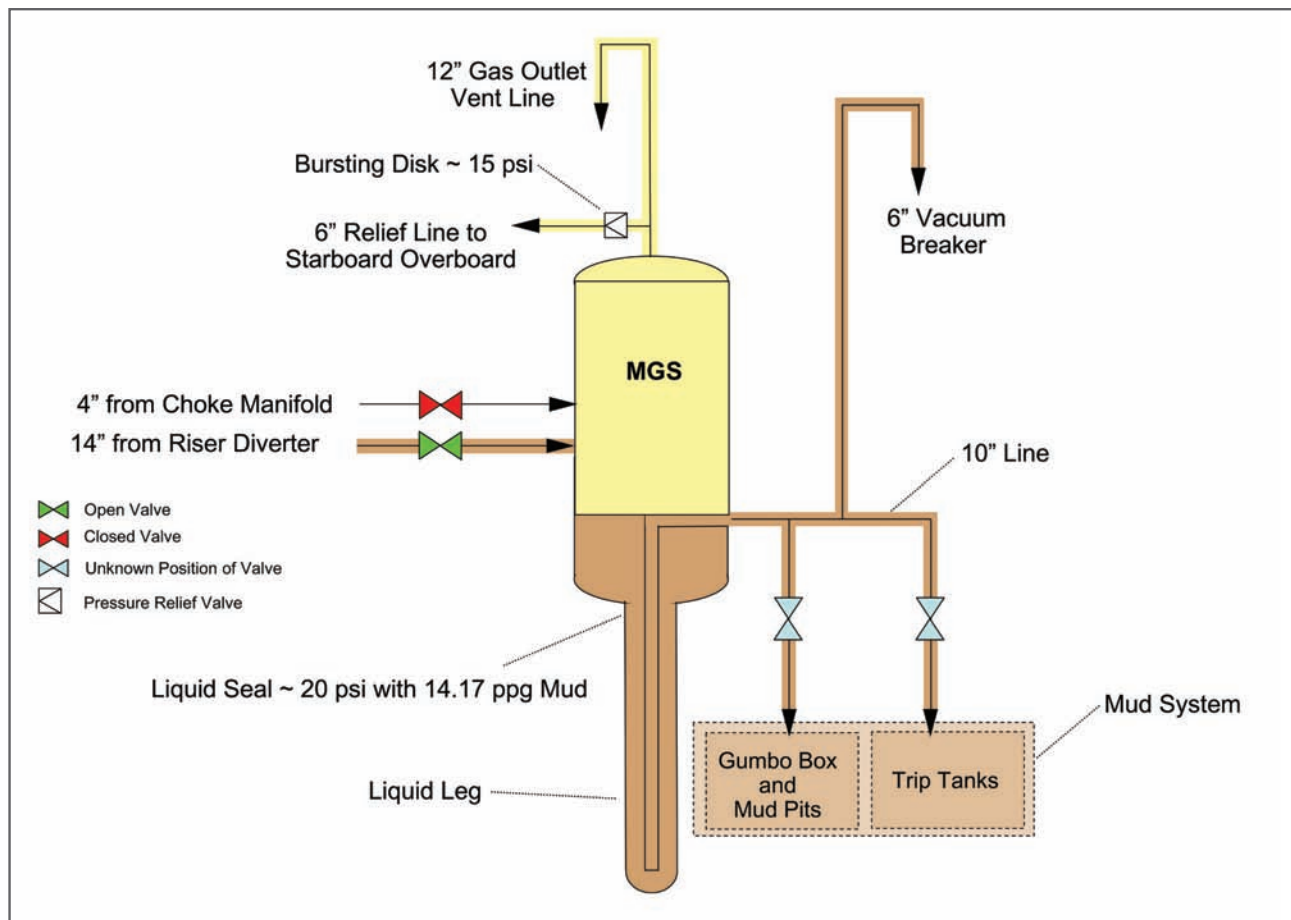
Figure 3. Simplified Drawing of the MGS.

Because the 12 in. MGS outlet vent and the 6 in. vacuum breaker vent were goosenecked, they would have diverted flow back down toward the rig.

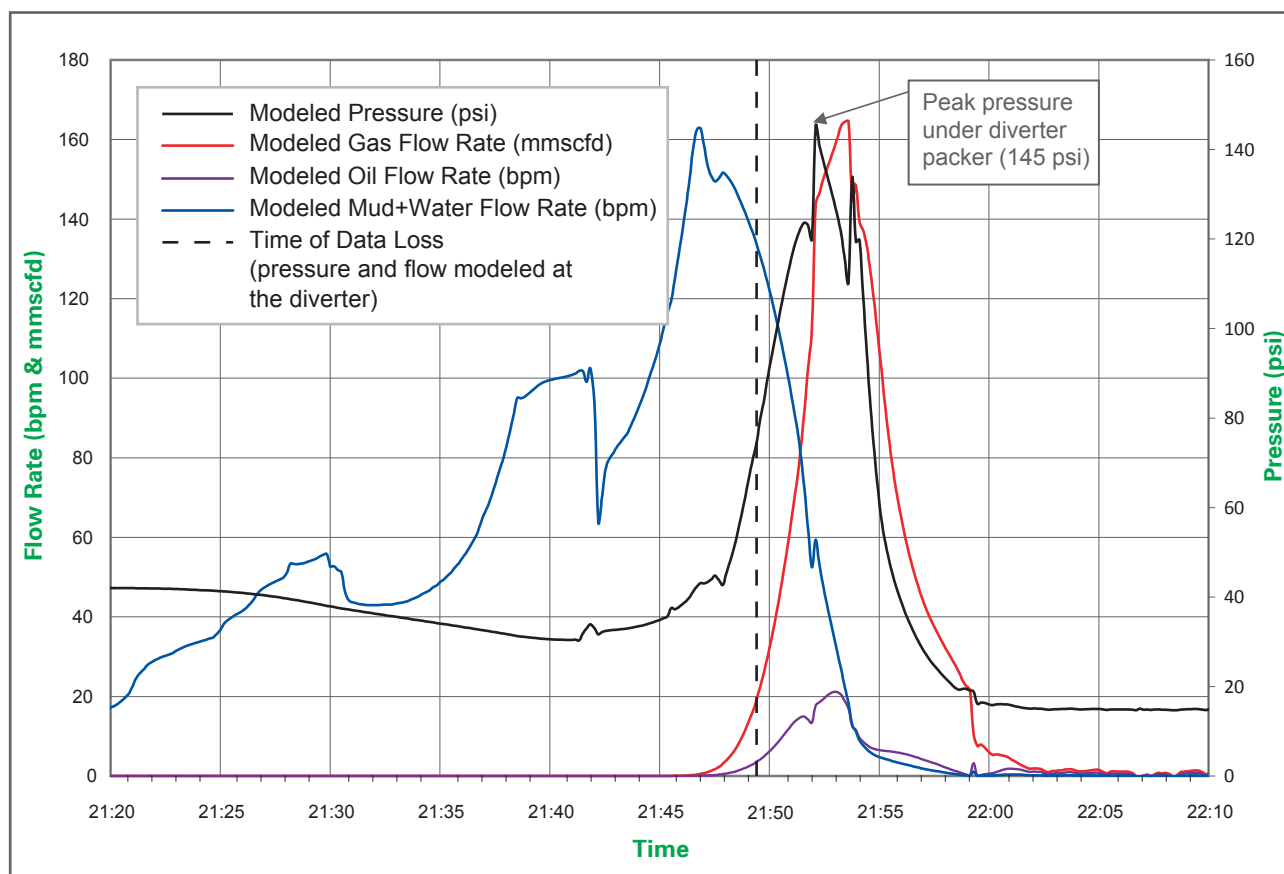
A simplified model of surface equipment was used to determine the backpressure at the diverter packer. As shown in *Figure 4*, this pressure could have reached 145 psi.

At these pressures it was possible that some components of the MGS vessel such as flange connections began to fail, but it was unlikely that the vessel itself ruptured.

Figure 4. OLGA® Well Flow Modeling Prediction of Backpressure and Flow at the Diverter Packer.
