Deepwater Horizon Accident Investigation Report

September 8, 2010

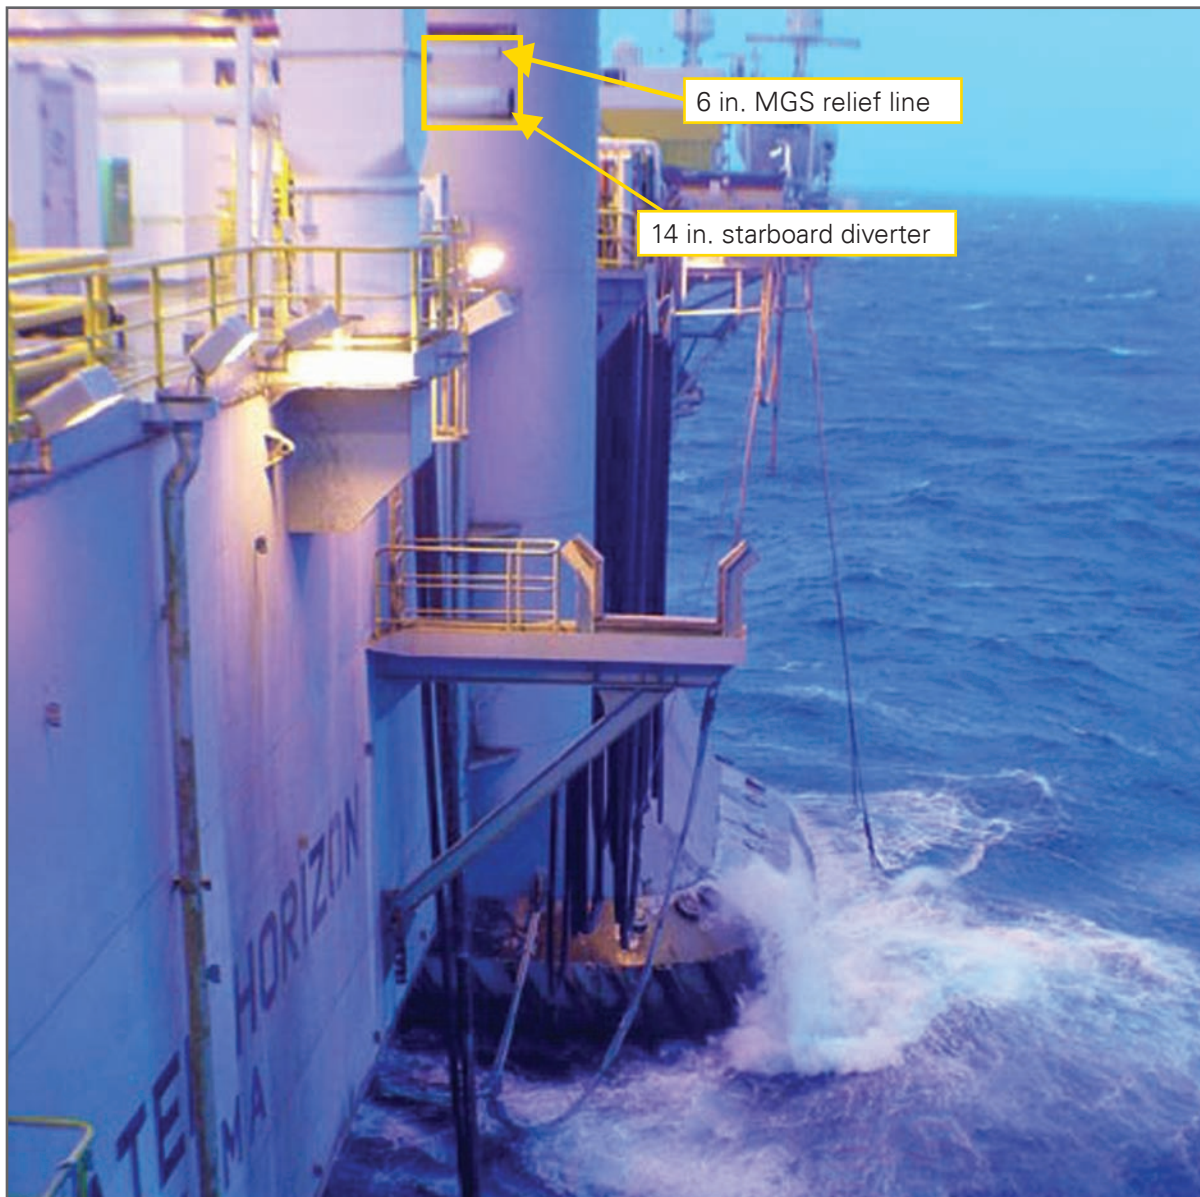
The photograph in *Figure 6* shows that the 6 in. MGS relief line was routed along the same path as the main 14 in. starboard diverter and terminated at the same location on the starboard side of the rig.

Figure 6. Photograph of Starboard Overboard Lines.

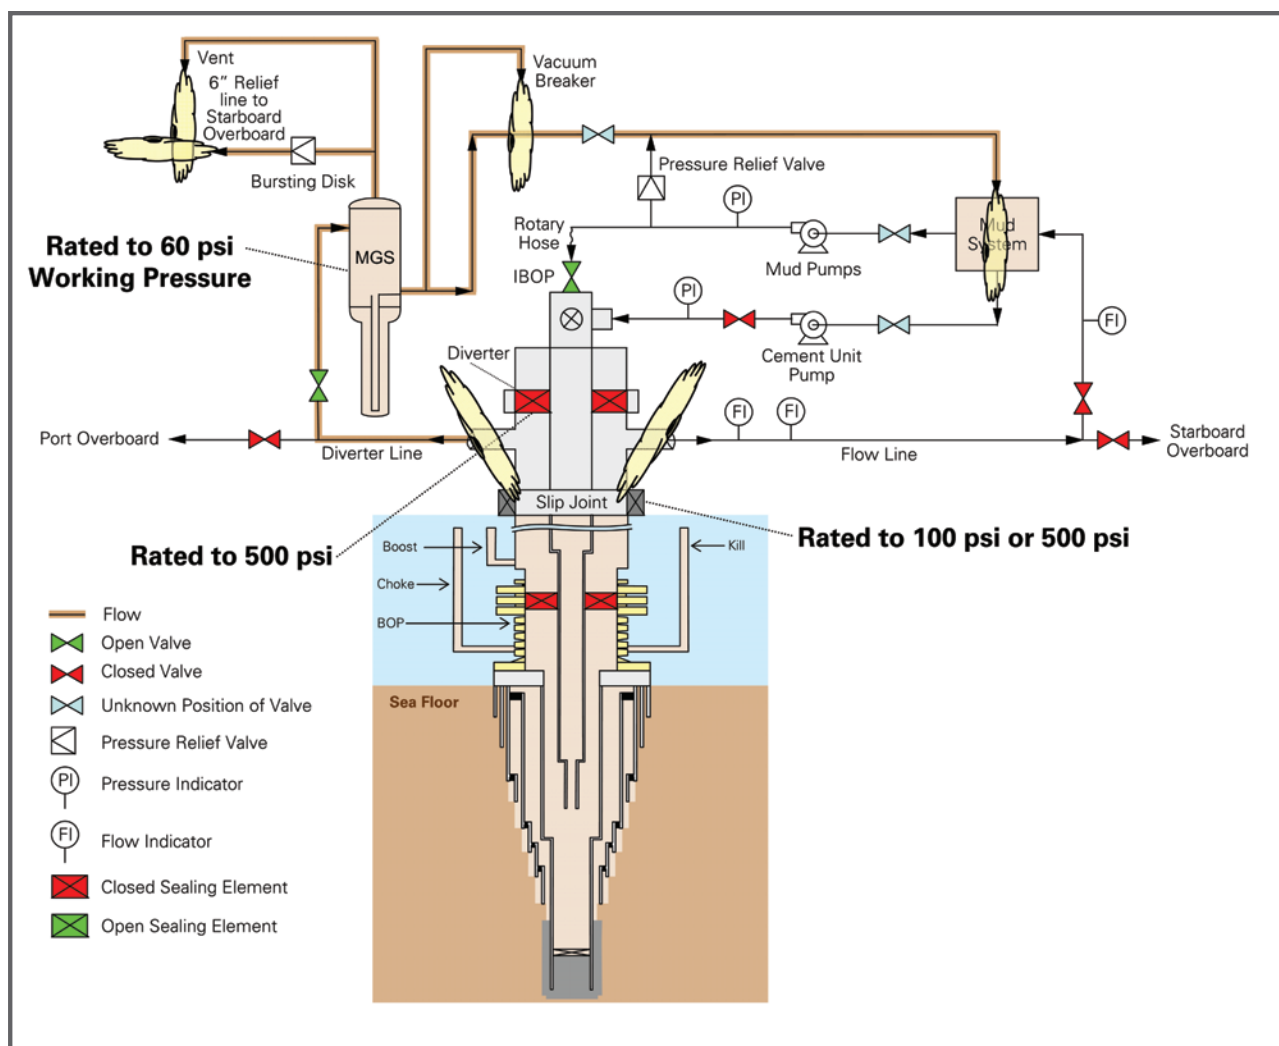
The case presented in this analysis assumes that the 12 in. MGS vent and the 10 in. MGS liquid outlet to the gumbo box, the riser slip joint seal, the MGS 6 in. bursting disk and the 6 in. MGS vacuum breaker vent were all open flow paths. *Figure 8* is a simplified illustration of these open flow paths.

Figure 8. Schematic of Postulated Hydrocarbon Release Locations.

The design of the MGS system allowed the rig crew to divert riser fluids to the MGS vessel when the well was in a blowout condition. The decision to divert the well through the MGS rather than the starboard diverter increased the potential for the gas to reach an ignition source. (Refer to Figure 8.)

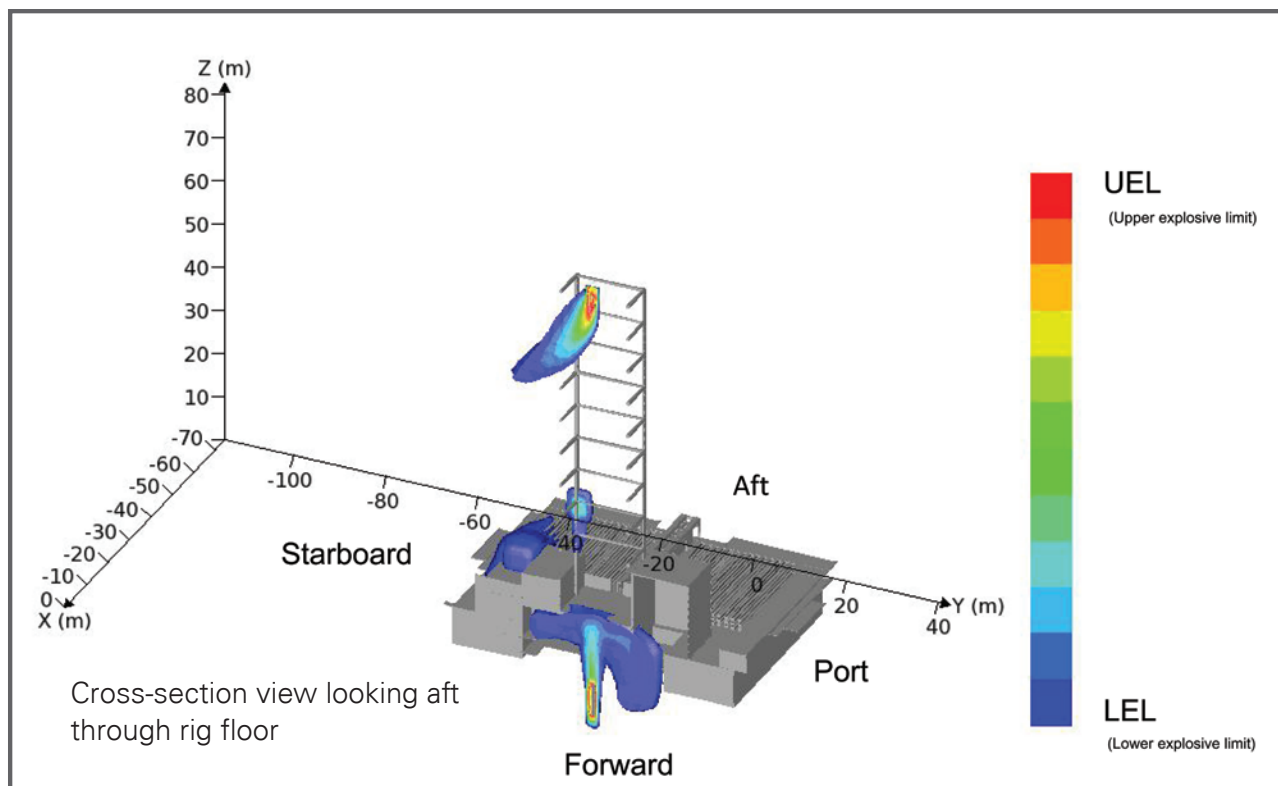
The graphics in *Figure 9* and *Figure 10* show the modeled outcomes of gas rapidly dispersing across the drilling rig. Gas could have also migrated into enclosed spaces under the deck through the mud system or through the HVAC supply fans for the engine rooms.

Figure 9. Vapor Dispersion at 100 Seconds.

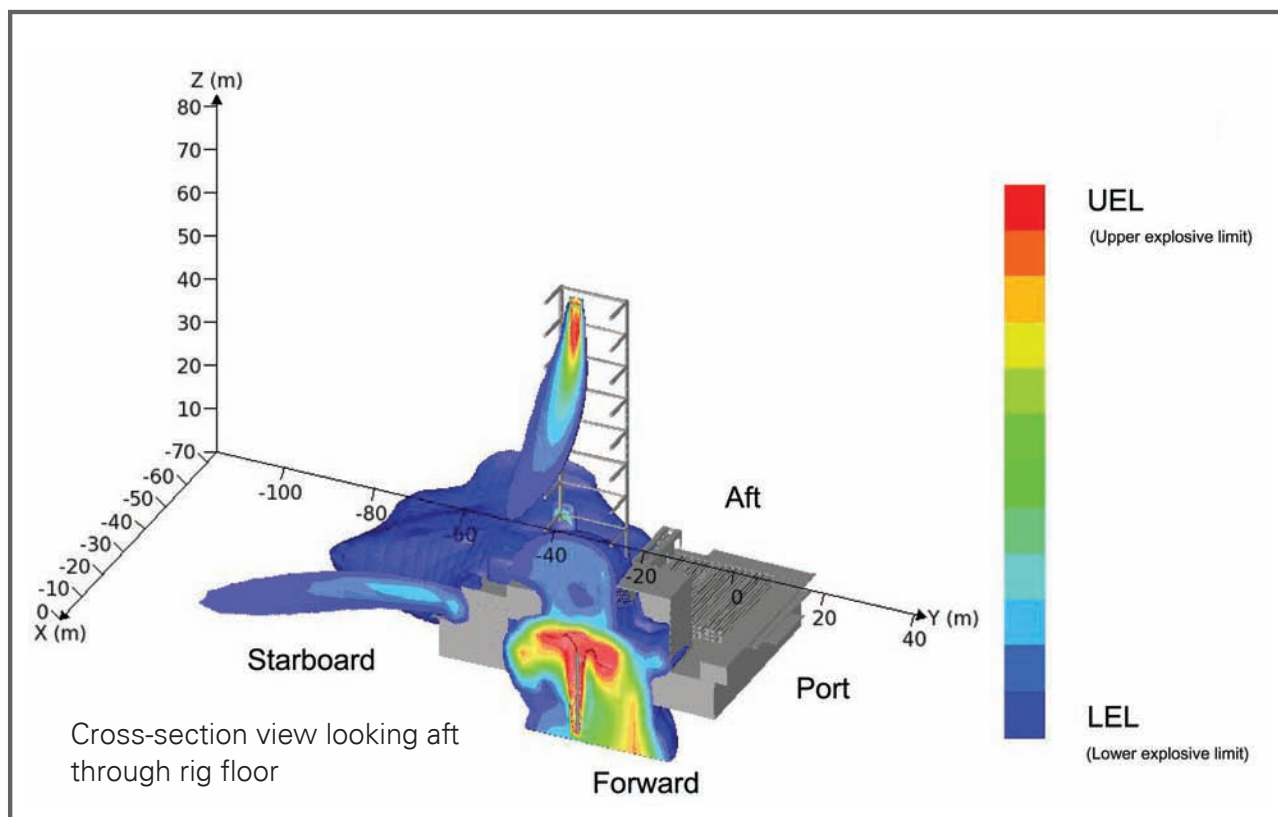
Figure 10. Vapor Dispersion at 240 Seconds.

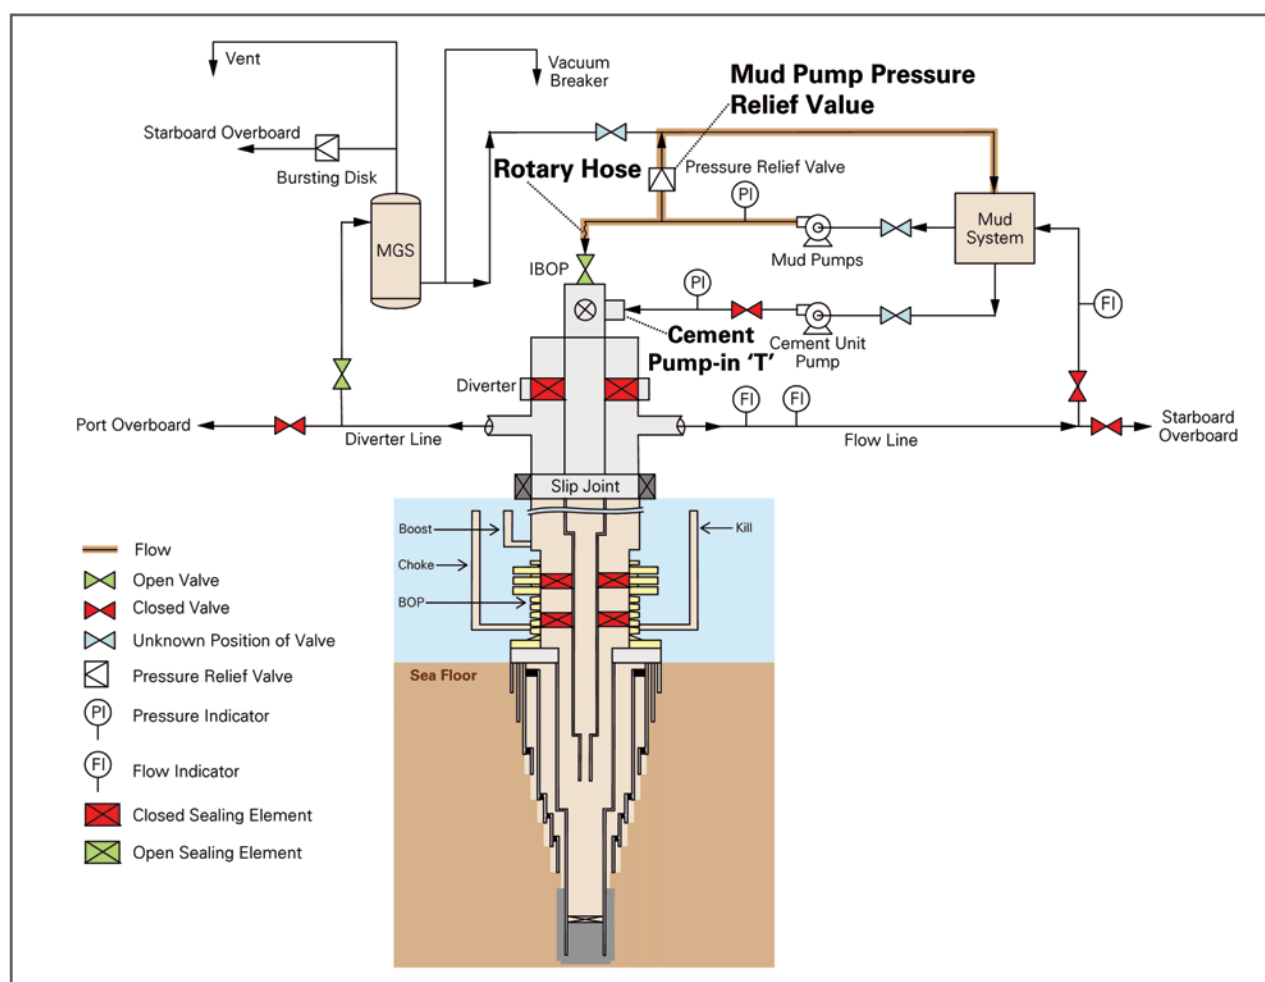
It was important to clarify the position of the internal blowout preventer (IBOP) valve, as this determines the number of potential flow paths to the surface if the BOP had closed and sealed. The simplified process flow diagram in *Figure 11* shows that there were two pressure indicators (PIs), each of which was recorded via the real-time data system. One PI measured drill pipe pressure from upstream of the IBOP, and one measured drill pipe pressure from downstream of the IBOP.

Figure 11. Relevant Surface Equipment Downstream of the IBOP at ~21:47.

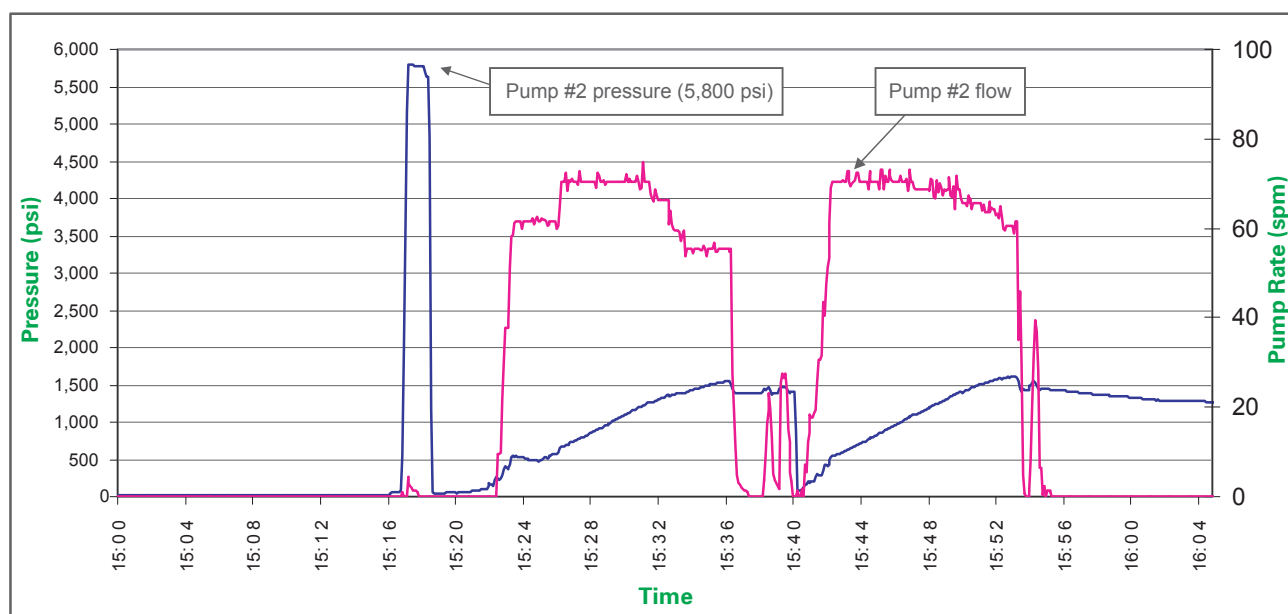
- Mud pump #2 was tested to 5,800 psi during the negative-pressure test procedure at 15:17 hours.
- While trying to start mud pump #2 at 21:17 hours, the pressure increased to 6,000 psi.

Figure 13. Mud Pump #2 Pressure Plot Showing Line Test During Negative-pressure Test.

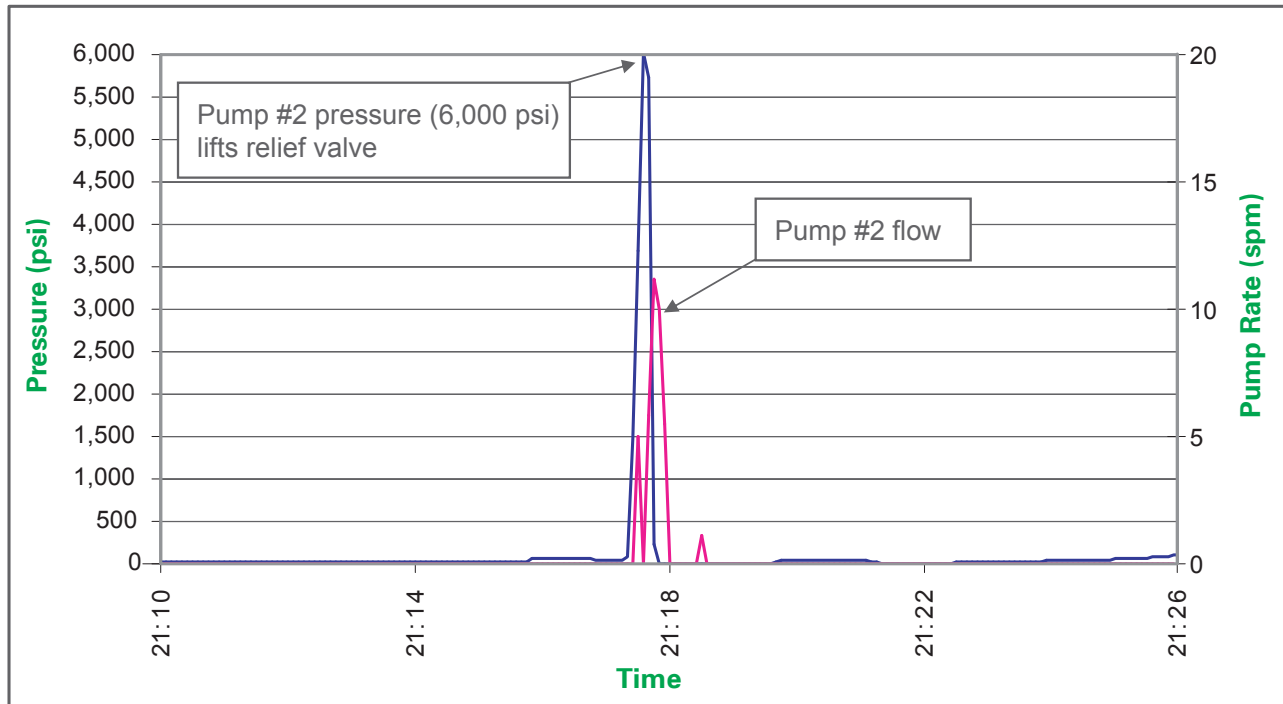
The investigation team believes that mud pump #2 was started against a closed discharge valve at 21:17 hours and the PRV lifted.

Figure 14. Mud Pump #2 Pressure Plot Showing Lift Pressure of PRV.

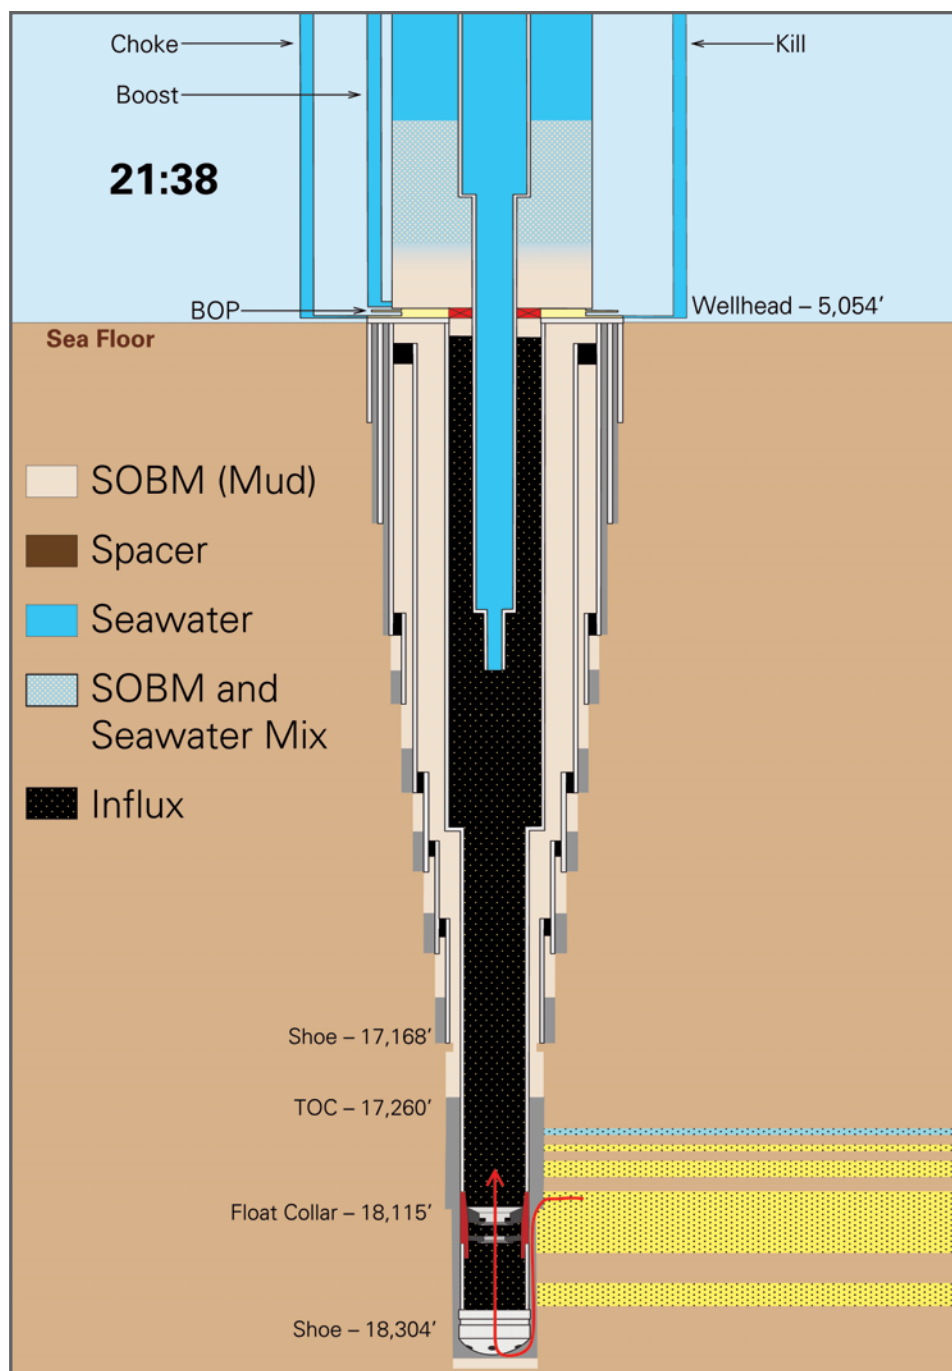
Figure 15 shows a view of the different fluids across the wellbore at 21:38 hours, if the BOP was closed, and illustrates that hydrocarbons would probably have been located below the BOP at that time. In the figure, a sharp interface among different fluids is shown for simplicity of illustration. In reality, there would have been varying degrees of fluid mixing.

Figure 15. Illustration of Wellbore and Position of Hydrocarbons at 21:38 Hours if BOP Was Closed.

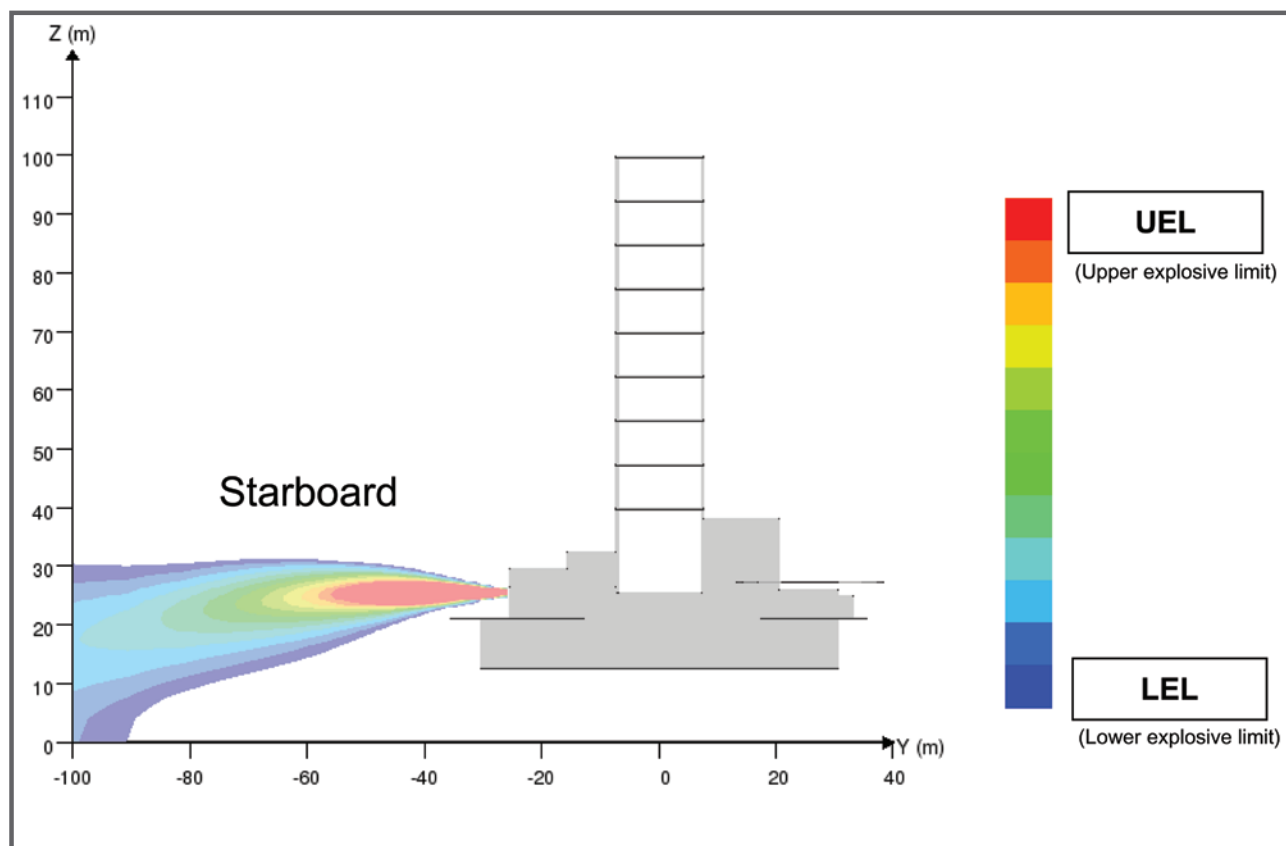
The investigation team has also concluded that if the well had been lined up to the starboard diverter rather than the MGS, the majority of the gas would have been diverted safely overboard. The pressure increase during the blowout may still have caused a failure of the riser slip joint seals, which would have allowed gas onto the rig floor through the moon pool. However, the majority of the gas would probably have vented through the starboard diverter, reducing the likelihood of hydrocarbons reaching an ignition source and may have reduced the consequences of the event.

Figure 16 shows the likely vapor dispersion pattern based on the orientation of the rig and the prevailing wind conditions on the evening of the accident.

Figure 16. Vapor Dispersion Case for Diverting to the Starboard Diverter.

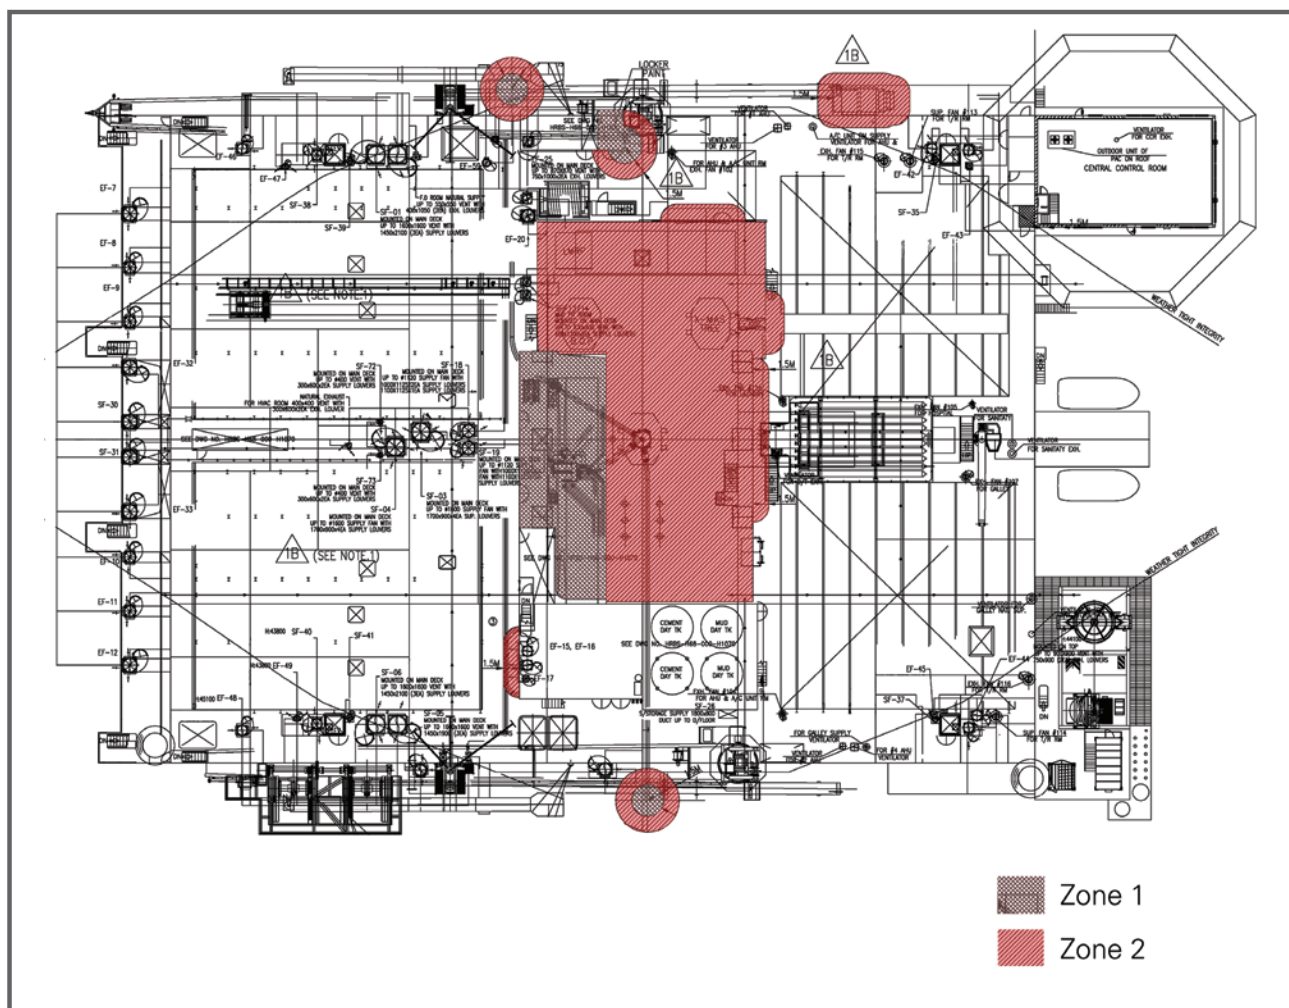
The extent of electrically classified areas on *Deepwater Horizon* appeared to be consistent with normal industry practices; however, for gas release events beyond the drill floor, multiple ignition sources could have existed. (Refer to Figure 17.)

Figure 17. Hazardous Area Classification—Main Deck.

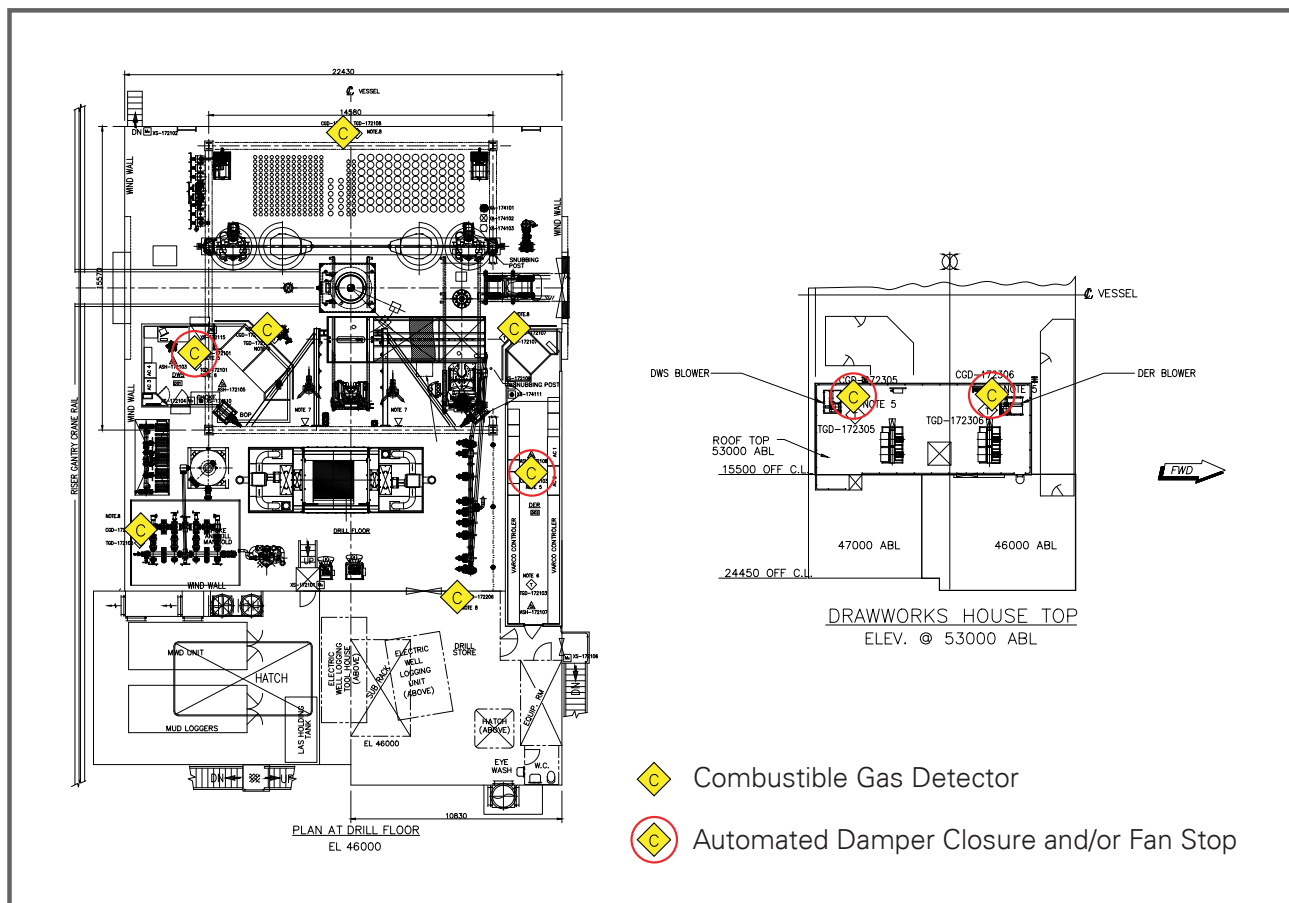
The physical locations of the CGDs are shown in *Figure 18* (drill floor and above), *Figure 19* (second deck) and *Figure 20* (main deck). These figures show the 13 CGDs that had automated actions and the 14 CGDs that did not.

Figure 18. CGD Locations—Drill Floor and Above.

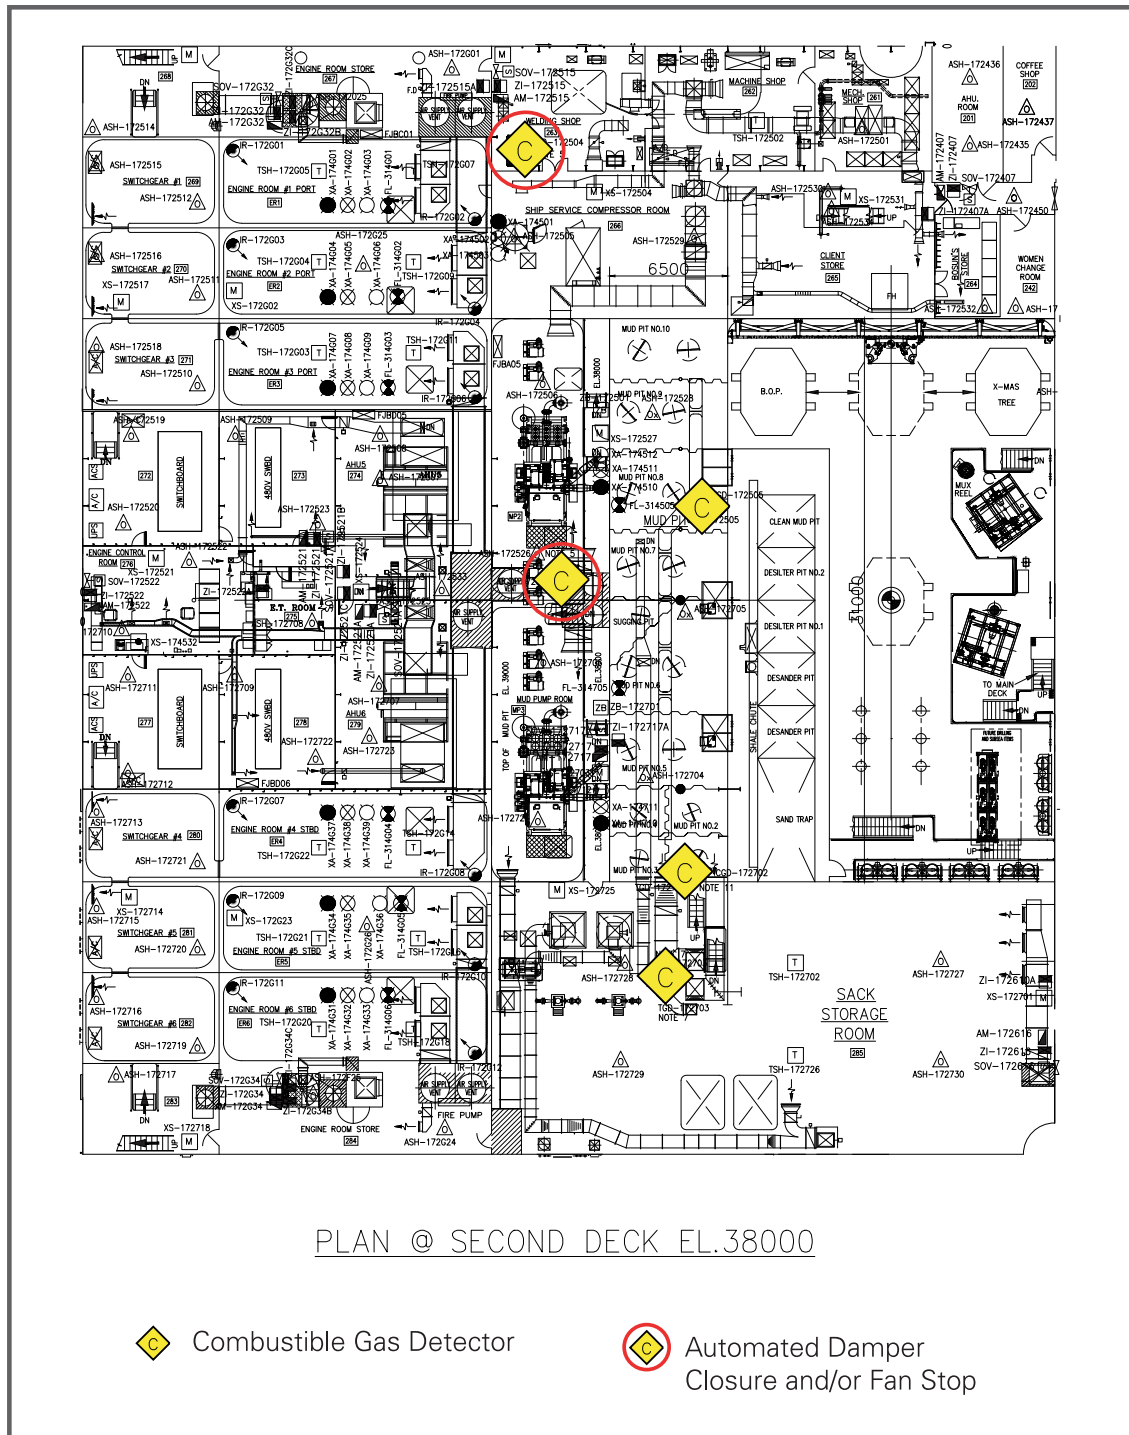
Figure 19. CGD Locations—Second Deck.

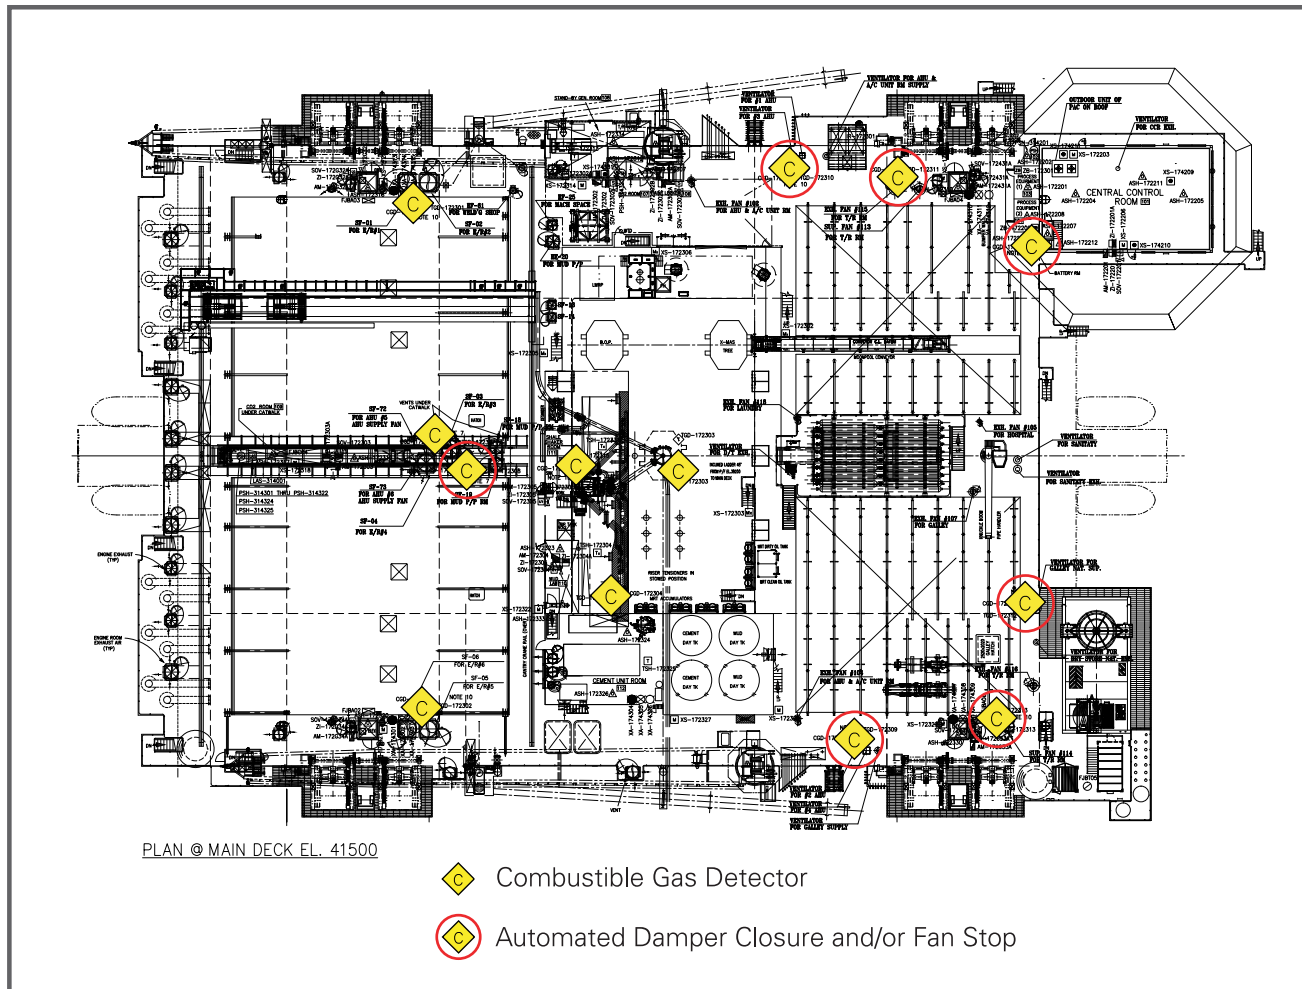
Figure 20. CGD Locations—Main Deck.

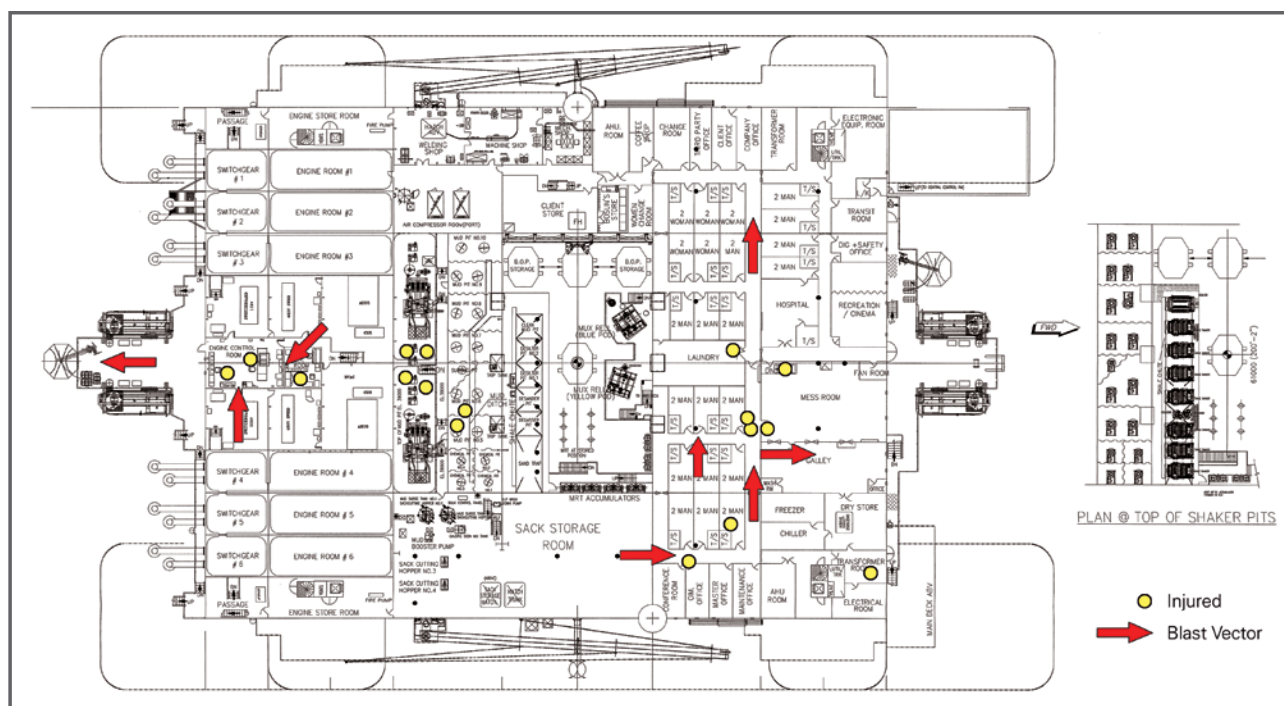
Figure 23. Second Deck Damage Vector Diagram.

A review of personnel injury locations (including fatalities) and facility damage accounts suggested that one likely epicenter of the explosion was in the starboard aft quadrant; this corresponded to the area of the rig containing engine rooms #3 and #6 (the running engines) and the mud pump rooms. The initial vapor release probably reached the HVAC intakes in this area. (Refer to Figure 22.)

The blast over-pressure that occurred at the second deck level created a pressure wave that caused significant damage to the aft starboard side of the accommodations area, where multiple personnel injuries occurred. This pressure wave also caused significant damage to the engine control room on the second deck level at the aft end of the rig. (Refer to Figure 23.)

There was at least one major explosion at the second deck level, which created significant over-pressure and caused structural damage.

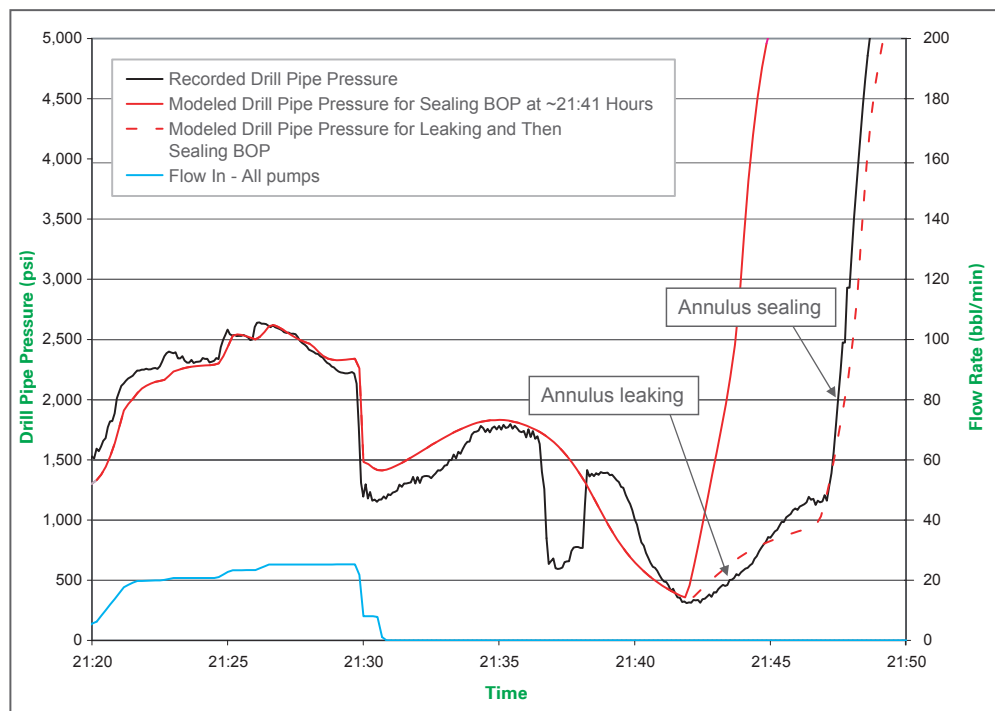
Figure 1. Drill Pipe Pressure—OLGA® Well Flow Modeling of Drill Pipe Pressure for a Closing BOP Versus Recorded Data.

The recorded surface data, from approximately 21:41 hours to 21:49 hours on April 20 (the time at which Sperry-Sun real-time data stopped transmitting), is critical to understanding the BOP operation prior to the explosions. The data suggests that the normal mode of BOP operation sealed the annulus less than 2 minutes prior to the loss of data transmission just before the explosions. (Refer to 6. *Modes of BOP Operation* of this analysis, which provides a discussion of BOP normal and emergency modes of operation.) The BOP closed, but it was slow to seal. Based on the evidence and analysis to date, it is not certain which BOP components were operated to seal the annulus prior to the explosions. It is likely that a variable bore ram (VBR) eventually sealed the annulus.

As established in *Analysis 5B.*, the rig crew activated the BOP at approximately 21:41 hours. *Figure 1* shows the results from the OLGA® well flow modeling of the BOP as activated at 21:41 hours and closing and sealing the annulus in 30 seconds (solid red curve). (Refer to *Appendix W. Report—Dynamic Simulations Deepwater Horizon Incident BP*) However, the recorded drill pipe pressure (solid black curve) indicates that the annulus was sealed approximately 5 minutes later than the OLGA® well flow modeling predictions. Further OLGA® well flow modeling of the BOP closing in 30 seconds, but allowing leakage past the annular preventer for 5 minutes before fully sealing the annulus, resulted in a drill pipe pressure (dashed red curve) that closely followed the recorded pressure. This analysis indicates that the BOP closed within the expected time, but it did not fully seal for another 5 minutes.

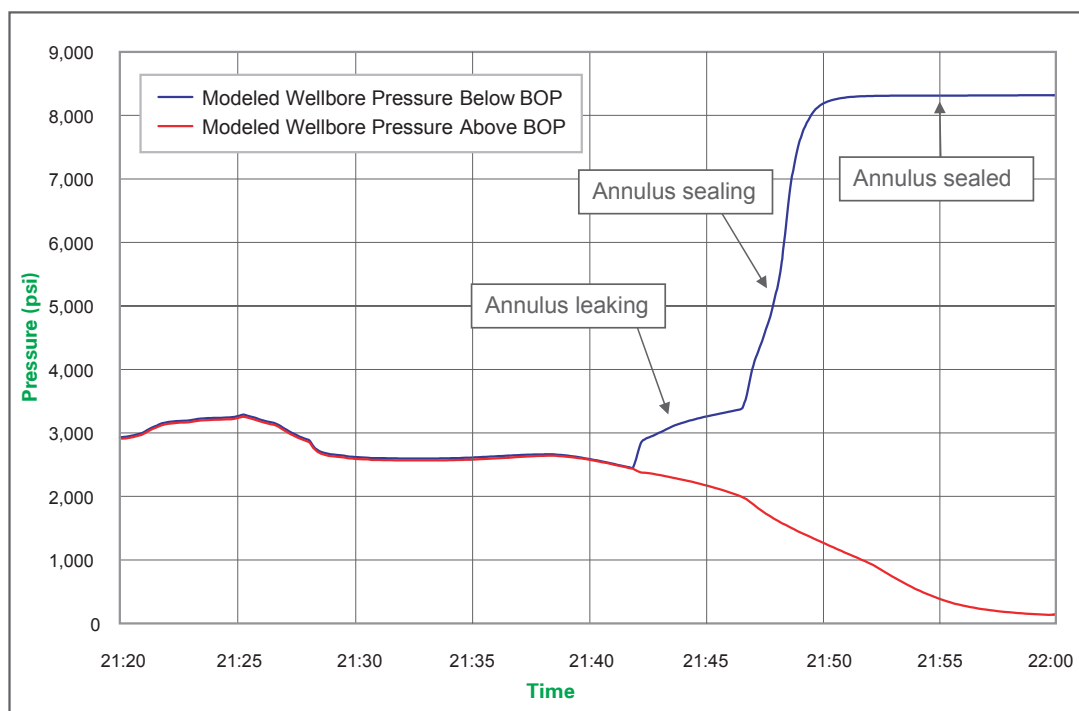
Figure 2. OLGA® Well Flow Modeling of Wellbore Pressure for a Leaking and Sealing Annular Preventer.

Wellbore pressure simulation using OLGA® well flow modeling indicates a differential pressure across the annular preventer of over 8,000 psi after the annulus was sealed. (Refer to Figure 2.) Given that the lower annular preventer was rated at 5,000 psi working pressure, it might not have held a differential pressure of over 8,000 psi. It is therefore less likely that the lower annular preventer would have sealed the annulus.

The annular preventer likely leaked for 5 minutes before the annulus was sealed. Given this finding combined with the evidence suggesting that at least one VBR could have been closed by the rig crew, it is likely that a VBR eventually sealed the annulus. (Refer to 4.1 of this analysis.) However, events subsequent to the explosion and fire could have impaired the integrity of the seal. (Refer to 4.2 *Status of the Drill Pipe Across the BOP After the Explosion* of this analysis.)

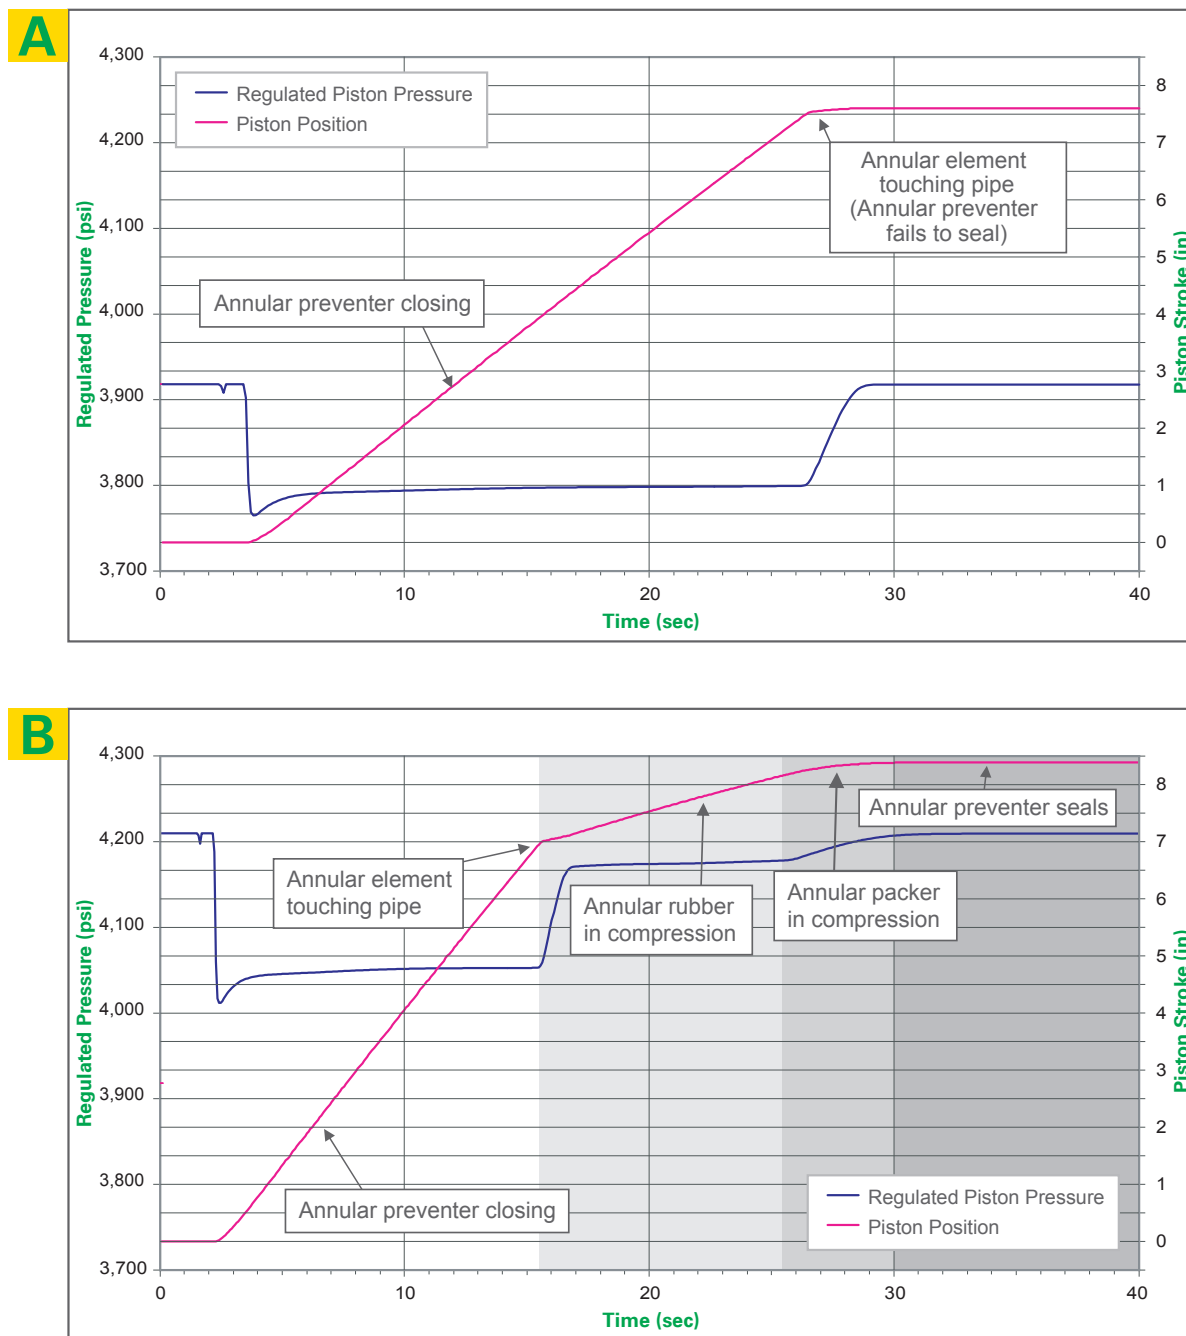
Figure 5. Hydraulic Analyses of an Annular Preventer.
(A) Regulated Pressure of 1,700 psi.
(B) Regulated Pressure of 2,000 psi.
 (All pressures in the figure include hydrostatic head at the seabed.)

Figure 5 shows the dynamic response of an annular preventer at 5,000 ft. water depth (WD) operating under 1,700 psi and 2,000 psi regulated closing pressures. (Refer to Figure 5.) (Hydraulic pressures in this analysis are quoted in terms of differential pressure, which is the difference between the hydraulic system pressure and the hydrostatic pressure at the sea bed.) The wellbore pressure at the time of the closure of the annular preventer was approximately 2,500 psi. To represent an annular preventer closing in a flowing condition, the simulated pressure in the BOP was increased from 2,500 psi to the shut-in pressure of approximately 8,000 psi as the annular preventer elastomeric element was about to touch the drill pipe.

The dynamic response of the annular preventer operating under 1,700 psi regulated pressure indicated that the annular preventer failed to seal due to rapid increase in wellbore pressure as shown in *Figure 5(A)*. Hydraulic analysis further indicates that an annular preventer would seal around the pipe under a regulated pressure setting of 2,000 psi, as shown in *Figure 5(B)*.
