Deepwater Horizon Accident Investigation Report

September 8, 2010

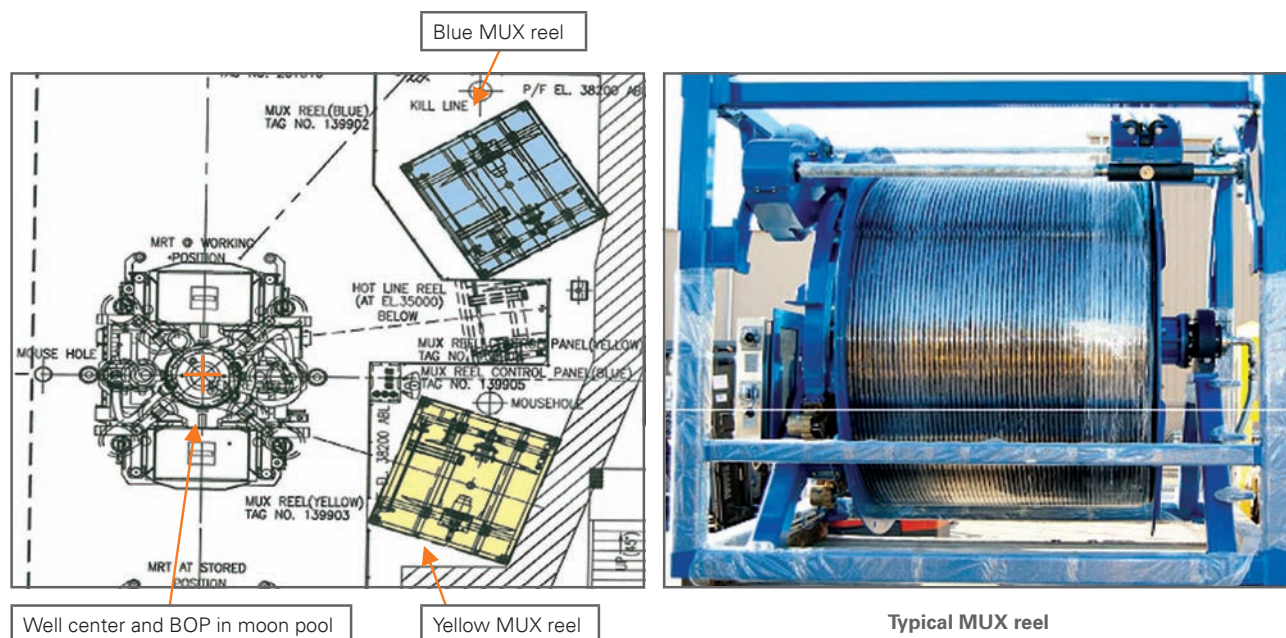
Figure 6. Moon Pool Layout Showing the Location of Blue and Yellow MUX Reels.

The subsea supervisor testified during the MBI hearings on May 26–29, 2010, that the TCP had a low accumulator alarm indicating loss of hydraulic power. The witness testified, “I hit the EDS button. Everything in the panel did like it was supposed to at the panel, but it never left the panel. I had no hydraulics.” This account suggests that the EDS did not initiate. Both methods, high-pressure BSR and EDS, would have required communication with the BOP control pod through MUX cables.

The MUX reels were located in the moon pool area within the explosion and fire zone. (Refer to Figure 6.) Since the MUX cables were not protected against explosions or fire, it is very likely that the early explosion and fire damaged the MUX reel slip rings and the cables to the extent that the communication line and electrical power required to initiate the high-pressure BSR and EDS functions were no longer available.

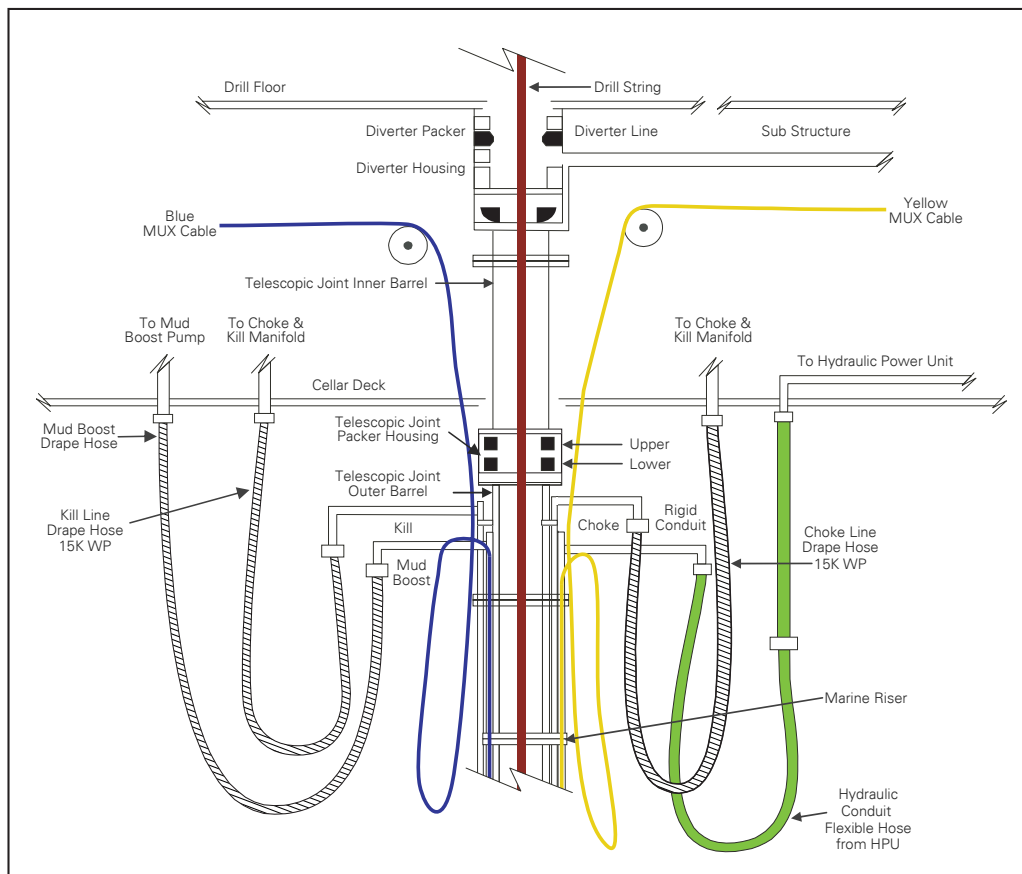
Figure 7. Typical Configuration of Flexible Hoses in the Moon Pool.
(Hydraulic conduit flexible hose is shown in green).

The AMF sequence is initiated when electrical power, communications and hydraulic pressure are lost to both pods. To initiate an AMF, all three services must fail (i.e., after damage to the MUX reels or cables and to the hydraulic conduit, caused by explosions and fire). As indicated in 3.1 of this analysis, the MUX cables, which carry electrical power and communications, were vulnerable to explosion and fire damage. Though the hydraulic conduit flexible hose was less vulnerable to damage than the MUX cables, it was located close to the MUX cables in the moon pool and could have been damaged by the explosions and fire. (Refer to Figure 7.)

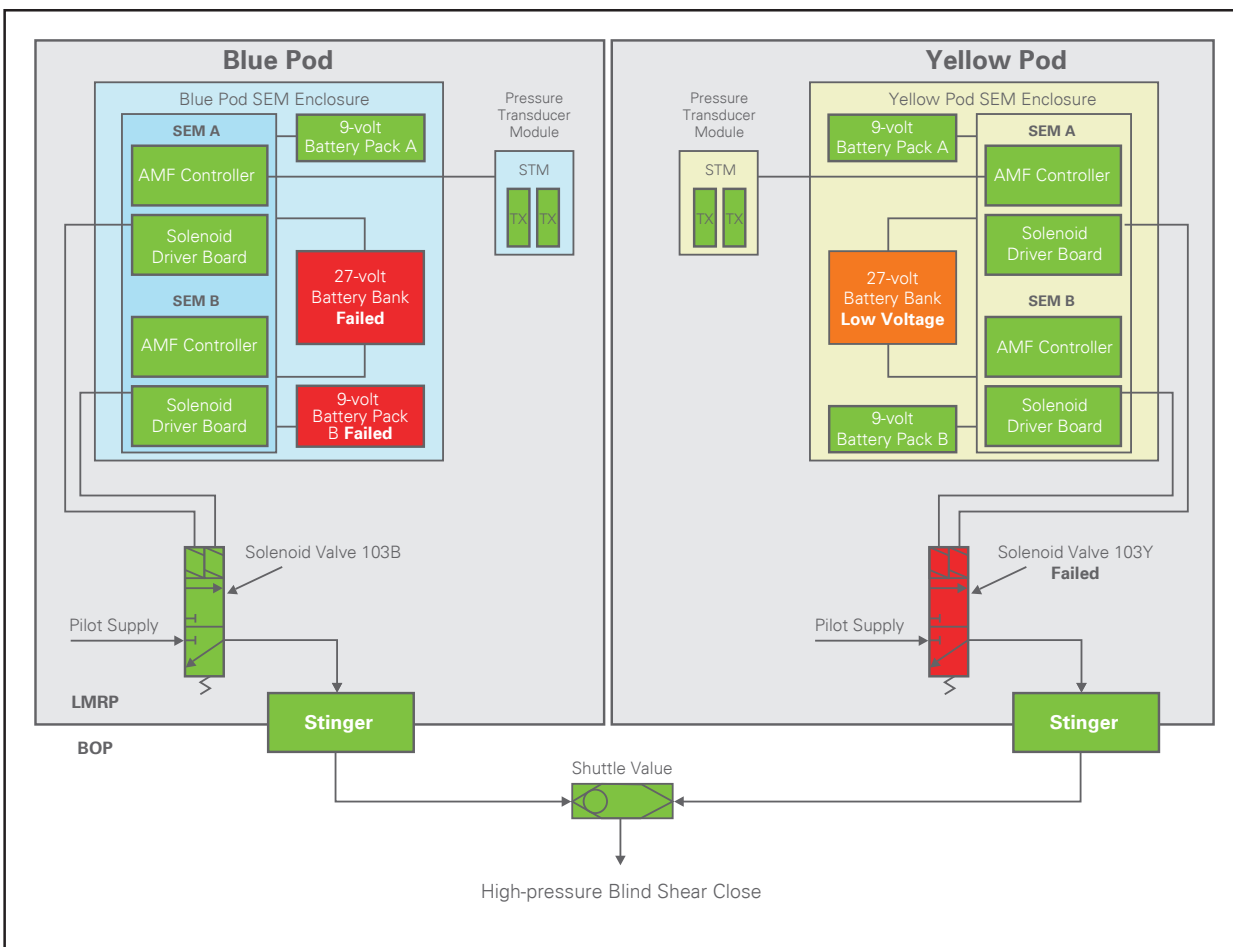
Figure 8. Simplified Schematic of the AMF Control System.

During the yellow pod test performed by Transocean and Cameron after the accident, both coils on solenoid valve 103 failed to energize, suggesting electrical coil faults. The investigation team found no evidence that this failure occurred after the accident; rather, the team concluded that this failure condition very likely existed prior to the accident. (Refer to 5.1 *Maintenance* of this analysis.) A faulty solenoid valve 103 would mean that the yellow pod could not have performed the AMF sequence, as no pilot

Figure 8 shows a simplified schematic of the AMF system. There were two 9-volt battery packs and a 27-volt battery bank (made up of 3 packs of 9-volt batteries connected in series) in each pod. These batteries were not rechargeable. The 9-volt AMF battery packs were used to power the AMF card processors. When the AMF was enabled, these batteries provided continuous power to the AMF cards. The 27-volt battery bank was used to provide power to the 24-volt rated AMF card relays, the pressure sensors and the solenoid valves that were used in the AMF sequence, including solenoid valve 103.

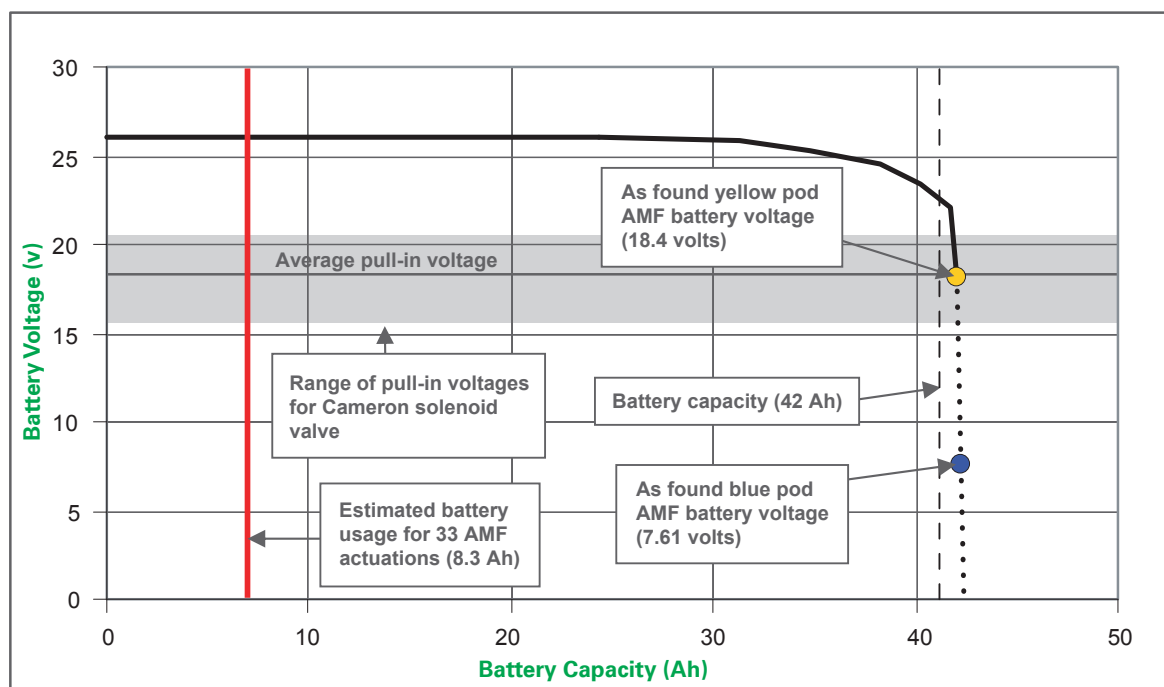
Figure 9. Discharge Curve for a 27-volt AMF Battery Bank.

In 2004, Cameron, the BOP manufacturer, issued an engineering bulletin, *EB 891D*, recommending that battery banks be replaced after one year of operation or when the number of actuations exceeds 33 for that year, whichever comes first. The discharge curve for a 27-volt battery bank indicates that after 33 actuations, the battery bank would have expended only 20% of its expected life, as measured in ampere hours (Ah). The measured charge of 7.61 volts on the 27-volt battery bank was past the expected annual usage and was beyond the design life of the battery bank. (Refer to Figure 9 and *Appendix X. Deepwater Horizon Blue Pod AMF System Batteries.*)

The investigation team considers that it is very likely that the charge at the time of the accident would have been insufficient to activate the AMF.

The available maintenance records from 2001 to 2010 indicate that during this period, the AMF batteries were changed at a frequency less than the manufacturer's recommendation. The BOP control diagnostic functionality did not include measuring the charge on the AMF batteries. Transocean maintenance records for AMF batteries are discussed in 5.1 of this analysis.

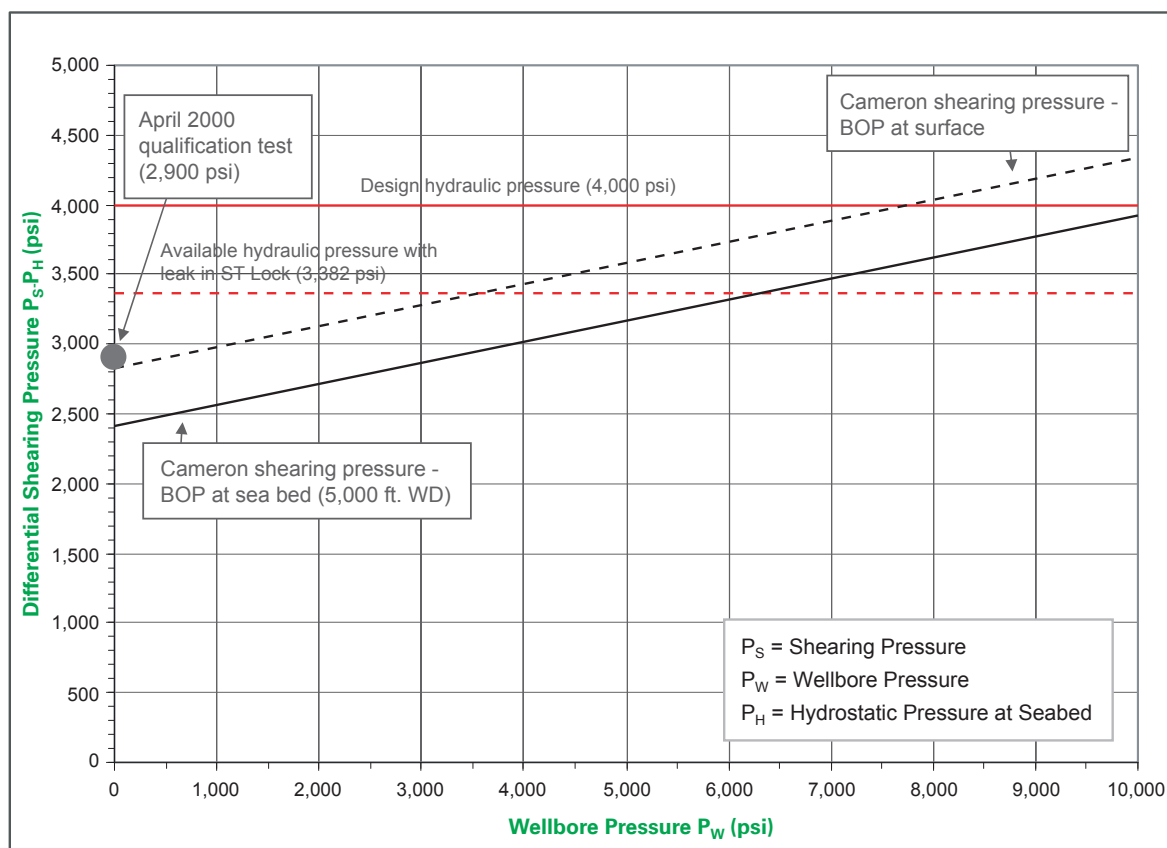
Figure 10. Shear Pressure Requirement for 5 1/2 in., 21.9 ppf, S-135 Drill Pipe.

Based on Cameron's shearing formula (*EB 702D, Revision B9*, dated January 21, 2008), the hydraulic pressure required to shear 5 1/2 in., 21.9 ppf, S-135 pipe at the surface is estimated as 2,840 psi. Cameron's shearing formula is plotted in *Figure 10* for varying wellbore pressures for a BOP at the surface (dashed black line) and a BOP at 5,000 ft. WD (solid black line). Shearing pressure is represented with respect to hydrostatic pressure at the sea bed. This formula takes into account the statistical variance in pipe wall thickness, material yield strength and ductility. A qualification test of *Deepwater Horizon* BOP BSRs was conducted at the surface in April 2000, when a joint of 5 1/2 in., 21.9 ppf, S-135 drill pipe was successfully sheared at a shearing pressure of 2,900 psi, which is slightly greater than the pressure predicted by Cameron's shearing formula.

It is not expected, therefore, that the increase in wellbore pressure would have been greater than 3,000 psi. *Figure 10* shows that at 4,000 psi design hydraulic pressure, the BSR should have been capable of shearing the 5 1/2 in. pipe. This assumes that there was no reduction in the available hydraulic pressure due to leaks or loss of BOP stack accumulator nitrogen pre-charge pressure.

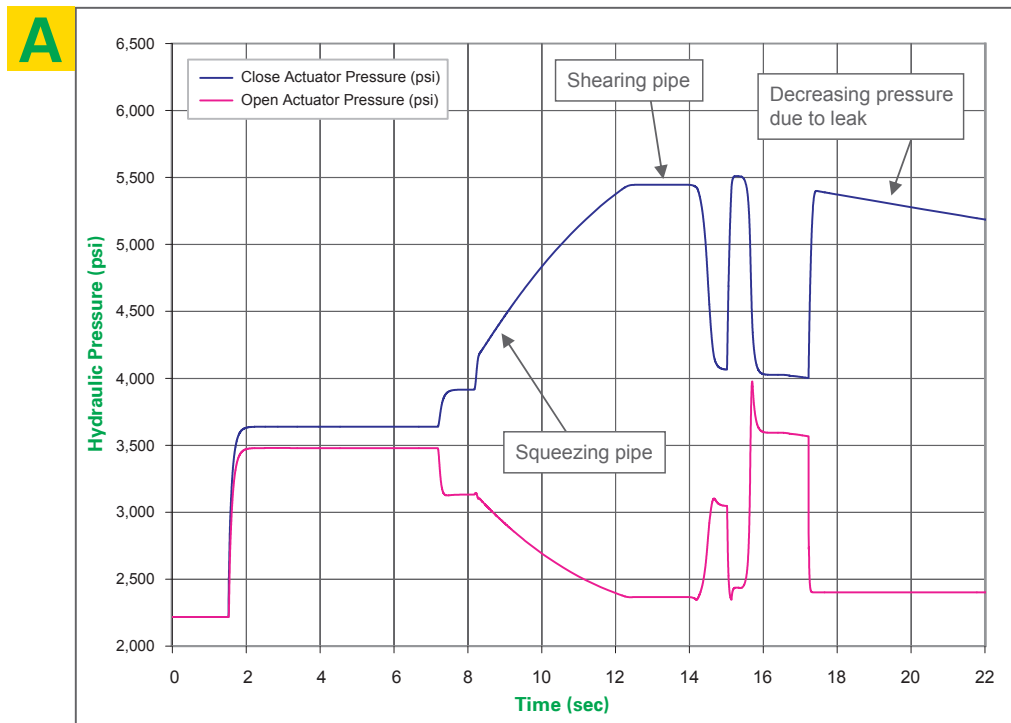
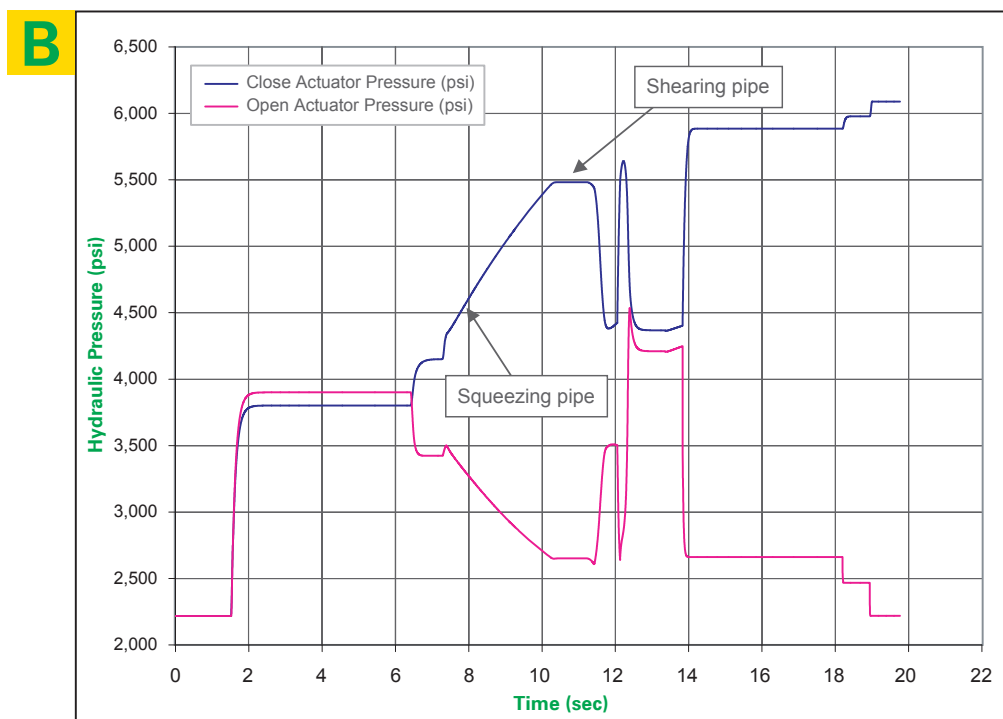
Figure 11. Hydraulic Analyses of BSR Closure Response (at a Wellbore Pressure of 3,000 psi and 5,000 ft. WD) **(A)** With and **(B)** Without a Leak in the ST Lock Hydraulic Circuit. (All pressures include hydrostatic head at the sea bed.)

Figure 11 shows the responses of the BSR with and without a leak in the ST lock hydraulic circuit. The analysis assumes a pipe shearing pressure derived using Cameron's formula for 5 1/2 in., 21.9 ppf, S-135 pipe at a wellbore pressure of 3,000 psi. *Figure 11(B)* illustrates that without a leak, there was sufficient pressure to shear and seal the drill pipe. In comparing *Figure 11(A)* and *Figure 11(B)*, the impact of a leak is seen to increase the time it takes to build up hydraulic pressure in the actuator to be able to shear the pipe (12.5 seconds versus 10.5 seconds). However, even with the presence of the leak, sufficient hydraulic pressure was achieved to complete the shearing operation. With the leak, the overall shearing operation would have taken 17 seconds to complete, whereas without a leak, shearing operations would have finished in 14 seconds.

The impact of the second leak on the BSR ST-lock circuit, potentially within an ST-lock sequence valve, could not be fully investigated without access to the BOP. (Refer to 5.2 of this analysis for further discussion of all leaks of which BP is aware.)

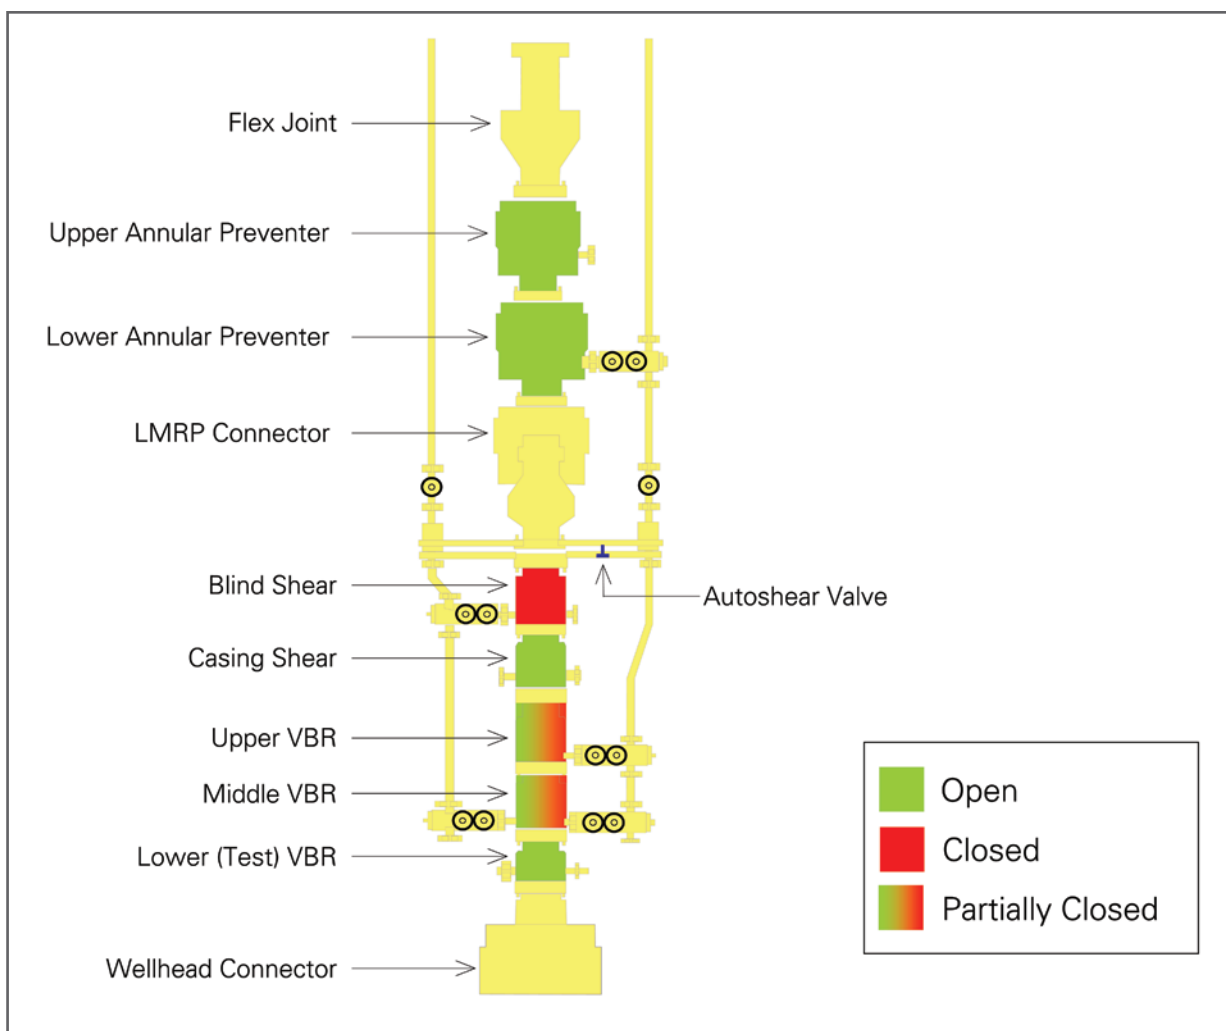
Figure 13. Likely Status of BOP Rams Immediately After Autoshear Initiation.

Based on these findings, the investigation team concluded that the upper, and possibly the middle, VBRs were likely closed by the rig crew.

Figure 13 shows the likely status of the BOP rams immediately after the initiation of autoshear.

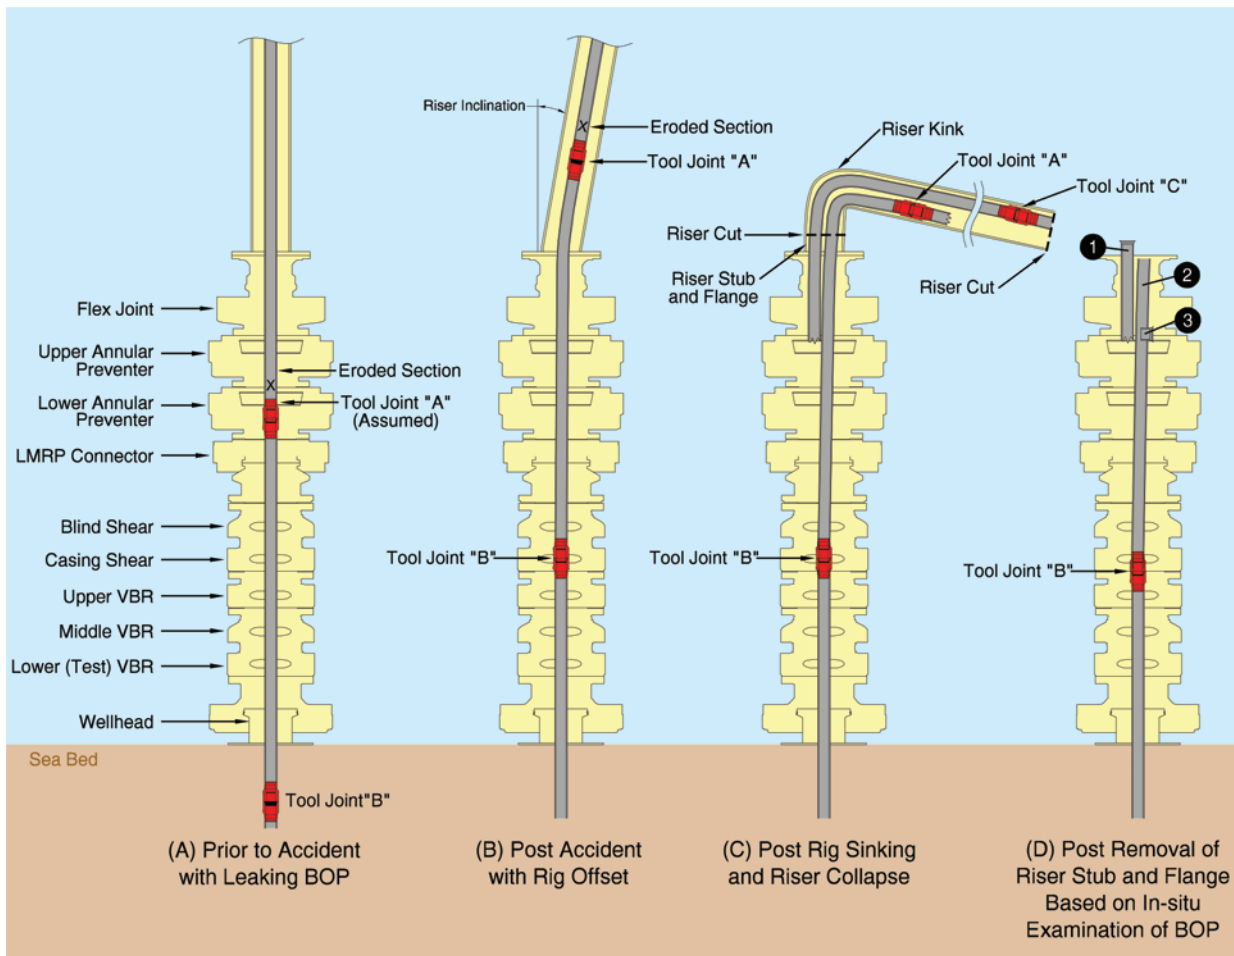
Figure 15. A Schematic of Drill Pipe Configuration Across the BOP Over Time.

The investigation team determined that this erosion may have occurred when the section of pipe was in the BOP, where it experienced extremely high flow velocities during the leaking of a ram or annular preventer, indicating that this section of drill pipe was continuous through the BOP. The approximately 22 in. long erosion zone could suggest that the erosion event took place in an annular preventer.

Assuming the erosion took place at the lower annular preventer, the right-hand pipe must have moved by approximately 25 ft. This could have happened as the rig drifted off location after power was lost. (Refer to time period [B] in Figure 15.) The metocean records indicate that the current velocity at sea level at the time of the accident could have been above 0.69 ft./sec. The investigation team did not have access to the vessel's hydrodynamic characteristics in order to perform a drift-off analysis of the rig. However, it is likely that a current of this magnitude would have caused the vessel to drift off after the power was lost at approximately 21:49 hours.

For the drill pipe to have moved upward by 25 ft., the next tool joint down the drill string (Tool Joint "B" in Figure 15 with an outside diameter of 7 in.), would have had to pass through the middle and upper VBRs. This could indicate that the ST locks were not operated when the rig crew likely attempted to close the VBRs, and the rams allowed the pipe to move upward through the BOP.

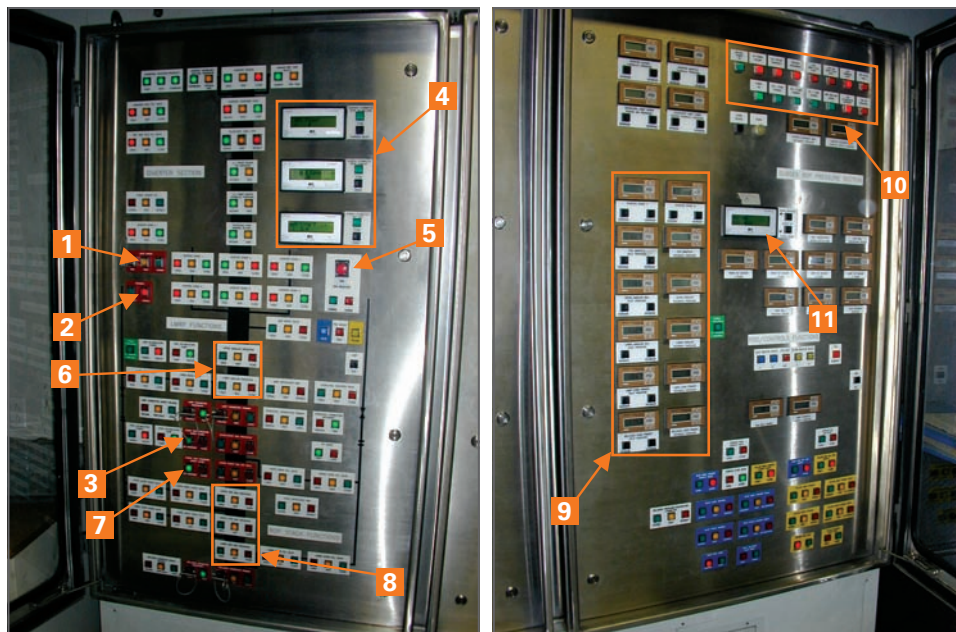
BOP Control Event Logger

Deepwater Horizon
BOP Control Panel (Left-hand side)

Deepwater Horizon
BOP Control Panel (Right-hand side)

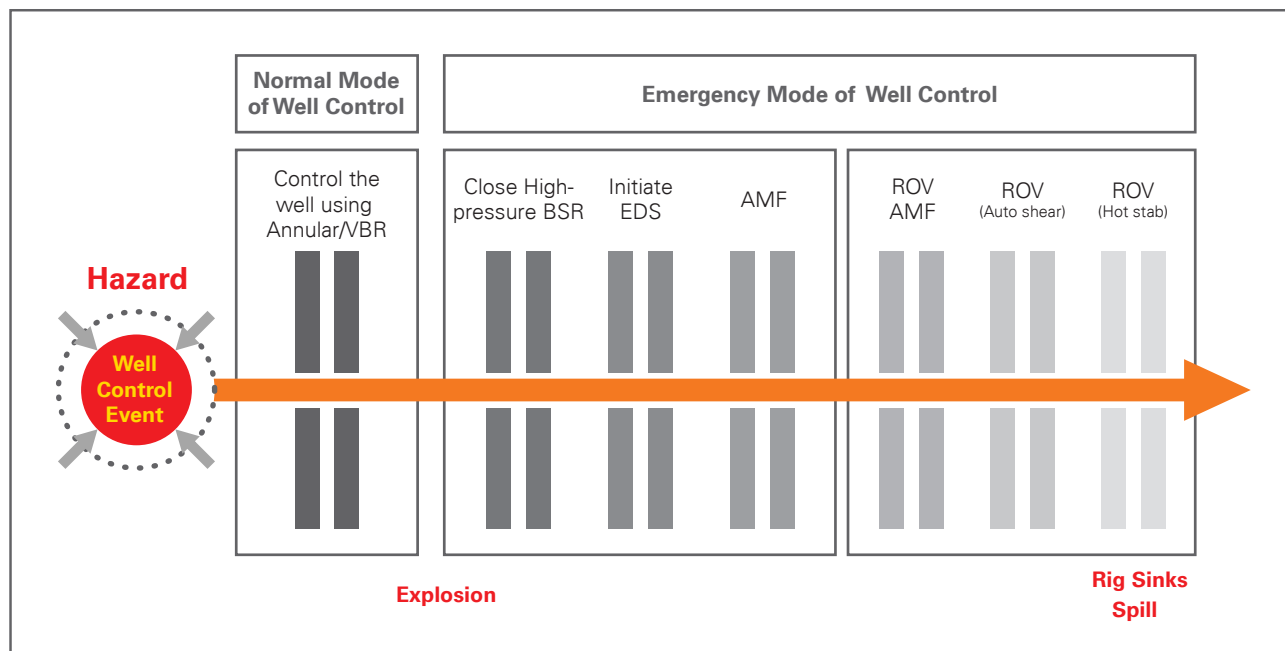
Figure 20. BOP Well Control Modes of Operation.

There were six possible methods of closing the BSR in emergency mode that pertain to this accident (refer to Figure 20):

- **EDS function (crew-initiated):** initiated by rig personnel from a control panel on the rig. EDS was primarily designed to mitigate the risk of losing containment as a result of the dynamic positioning system not being able to keep the rig on station. This function also requires at least one operational control pod and associated MUX cable. The sequence activates the high-pressure BSR. All three sets of accumulators provided hydraulic power for this activation of the high-pressure BSR. Witness accounts indicated that the subsea supervisor initiated this function from the TCP, but it would have been unsuccessful because the MUX cables had already been rendered inoperable due to the explosions and fire.

- **AMF:** an automatic means of closing the high-pressure BSR when electrical power, electronic communication and hydraulic pressure are all lost. AMF is designed to mitigate the risk caused as a result of catastrophic failure of the riser with the resultant reduction of hydrostatic head of mud in the riser to seawater hydrostatic head. This function had to be manually armed by rig personnel from the BOP control panel and required at least one operational control pod. The accumulators on the BOP stack were the only source of hydraulic power for this function. The investigation team concluded that the AMF very likely did not function due to the condition of critical components in the control pods.

- **ROV-initiated AMF:** a simulation of AMF conditions to close the high-pressure BSR by using an ROV to cut power/communication and hydraulic lines at the LMRP. This was attempted hours before the rig sank, but the investigation team concluded that the AMF very likely did not function due to the condition of critical components in the control pods.

- **ROV-initiated autoshear:** a simulation of the autoshear condition to close the high-pressure BSR by using an ROV to cut through the autoshear activation rod. Autoshear is designed to mitigate the risk of loss of containment as a result of an inadvertent disconnect of the LMRP from the BOP stack. The accumulators on the BOP stack were the only source of hydraulic power for this function. This ROV-initiated autoshear was attempted hours before the rig sank, and the investigation team concluded that the autoshear appeared to close the high-pressure BSR, but failed to seal the wellbore.

- **ROV-initiated BSR:** closure of the BSR by ROV hot stab using an ROV seawater pump or utilizing a separate hydraulic power supply provided by a bank of accumulators on the sea bed. This function required sufficient hydraulic power available from the ROV pump or bank of accumulators. Various attempts were made to close the BSR by ROV hot stab intervention prior to and after the rig sank, but all failed to seal the wellbore.

The rig crew attempted the normal mode of BOP system operation (using an annular preventer and possibly a VBR) prior to the accident. The emergency mode of well control shown in *Figure 20* relates to the period after the accident, but only the ROV hot stab intervention continued after the rig sank.

The effectiveness of the emergency system methods of operation available to rig personnel to isolate the wellbore was lost due to damage resulting from the explosions.

This interdependency of BOP operating modes means that single failures could have affected multiple modes of BOP operation.

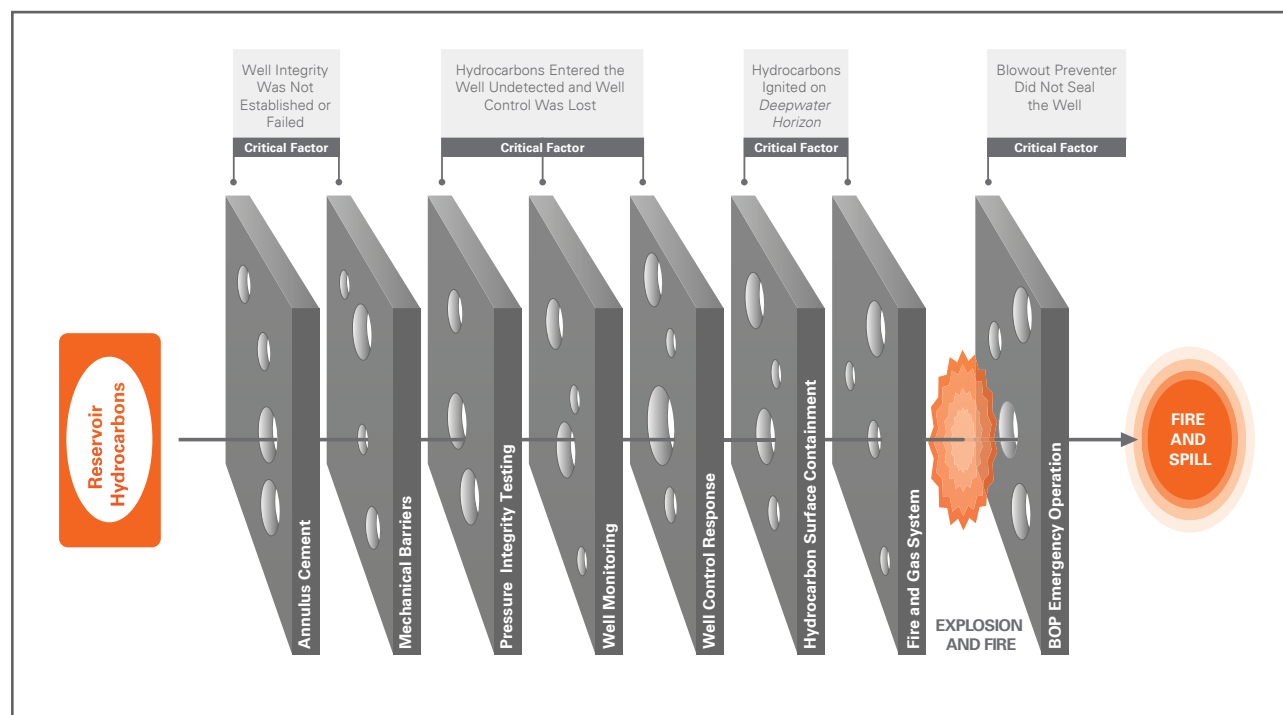
Figure 1. Barriers Breached and the Relationships of Barriers to the Critical Factors.

The purpose of these recommendations is to enable prevention of similar accidents occurring in the future by strengthening the defensive physical or operational barriers needed to eliminate or mitigate hazards. (Refer to Figure 1.) The recommendations are intended to provide a basis for the consideration of actions that can be implemented by both BP and by the contractor community that provides critical services and products to BP's exploration and production operations.
