QUALITY SYSTEM COMPLIANCE VENDOR / SUPPLIER AUDIT REPORT

Qantas Airways Limited

**Contracted Maintenance – SIAEC Singapore "D" Check on
Qantas Aircraft VH-OJO V/C: T7105**

AQD Audit ID: 06/SPT/10

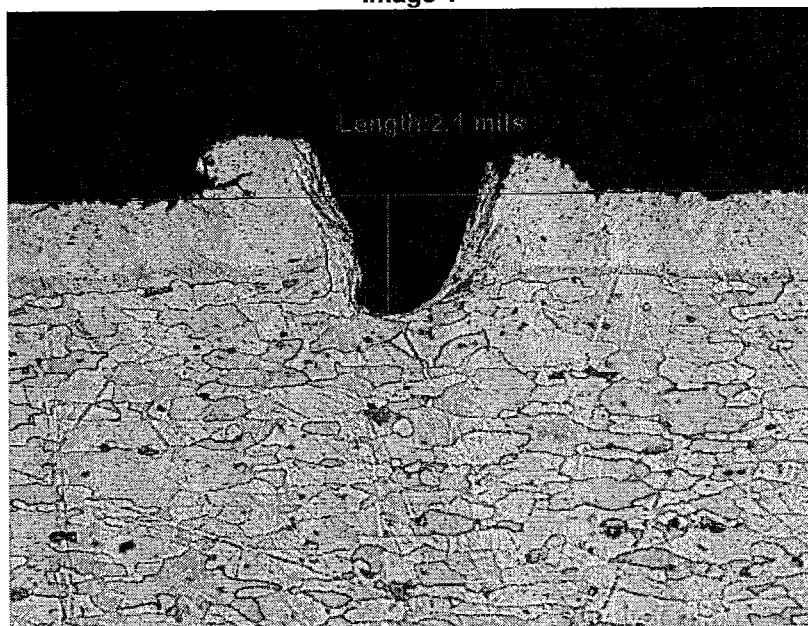
Image 1

The above is a cross sectioned Scribe Line, showing the damage below the surface. Note this scribe goes below the Protective Cladding and down into the pure Aluminum. Boeing requires the depth of the Scribe BELOW THE UNDAMAGED SURFACE. Hence in the above image a "Base Line" has been drawn. This was a flat sheet of Aluminum. Easy! In practice on an Aircraft nearly all surfaces have a curvature! This must be allowed for.

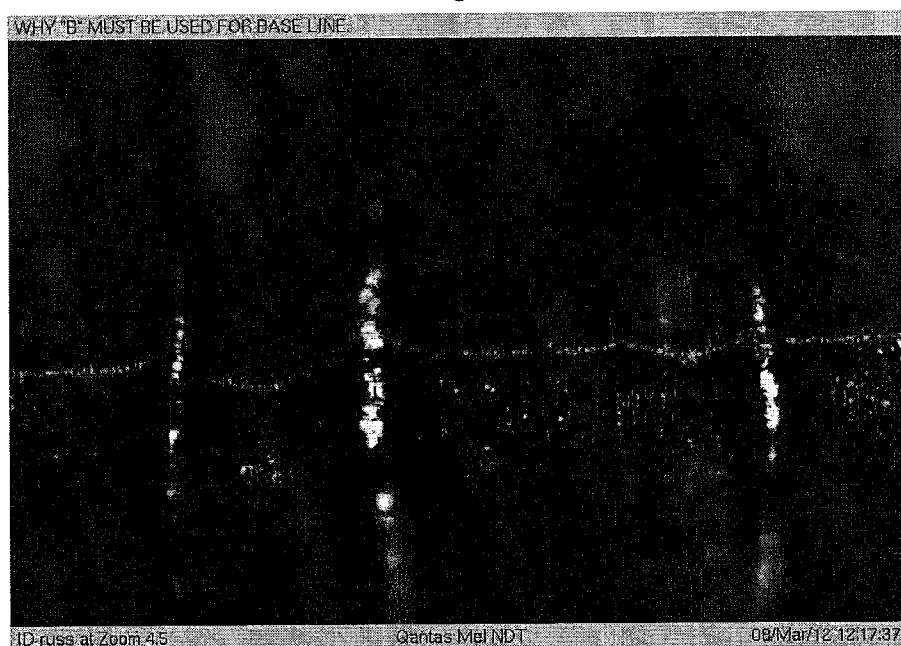
Image 2

Above is the RAW captured Image, shows 3 "Lands with damage between them". The Base line is required to join undamaged surfaces. Hence we draw the Base Line as shown below.

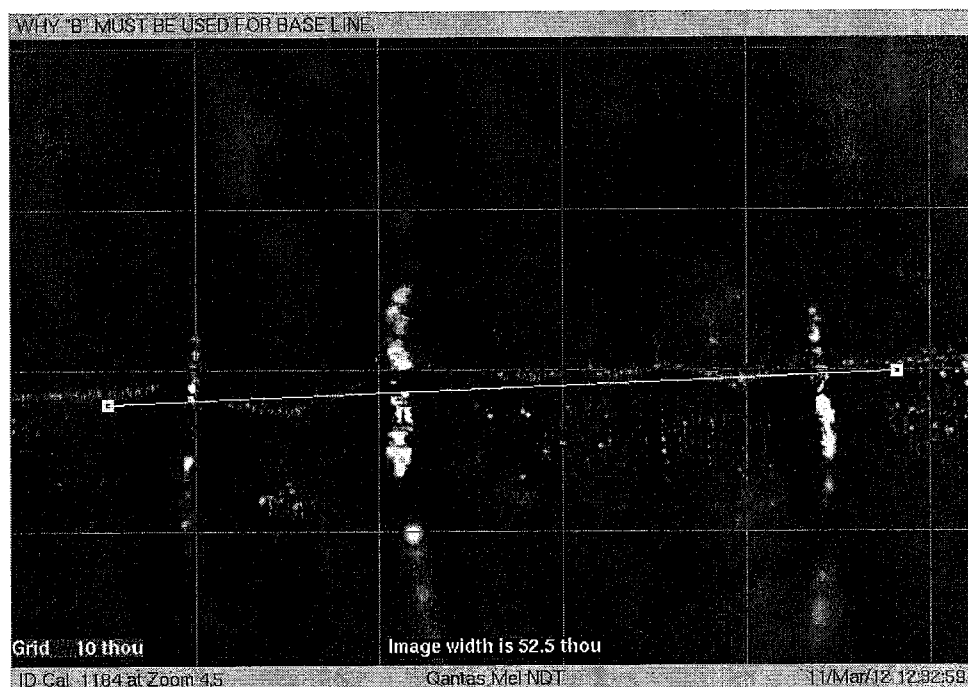
Image 3

The damage that is of concern is always BELOW this Line!

Note that this line is NOT drawn as a vector, but as a "stair case approximation".
