# **QUALITY SYSTEM COMPLIANCE VENDOR / SUPPLIER AUDIT REPORT**

**Qantas Airways Limited**

**Contracted Maintenance – SIAEC Singapore "D" Check on  
Qantas Aircraft VH-OJO V/C: T7105**

**AQD Audit ID: 06/SPT/10**

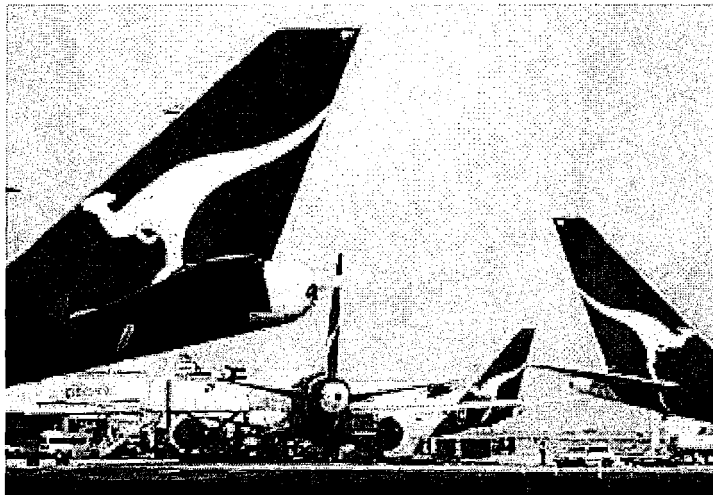
Deadly ... an overseas maintenance crew sealed off a Qantas jet's back-up oxygen supply. Source: No credit

A leaked maintenance report on the Airbus seen by the Herald Sun and dated March 11 says: "On investergation (sic) found crew oxy bottle shutoff valve in the closed position and lockwired."

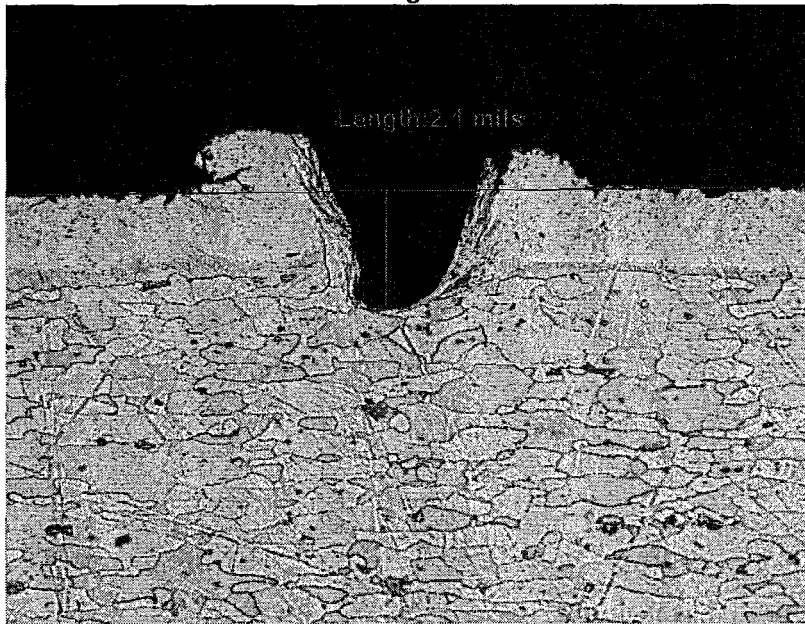
Image 1

The above is a cross sectioned Scribe Line, showing the damage below the surface. Note this scribe goes below the Protective Cladding and down into the pure Aluminum. Boeing requires the depth of the Scribe **BELOW THE UNDAMAGED SURFACE**. Hence in the above image a "Base Line" has been drawn. This was a flat sheet of Aluminum. Easy! In practice on an Aircraft nearly all surfaces have a curvature! This must be allowed for.

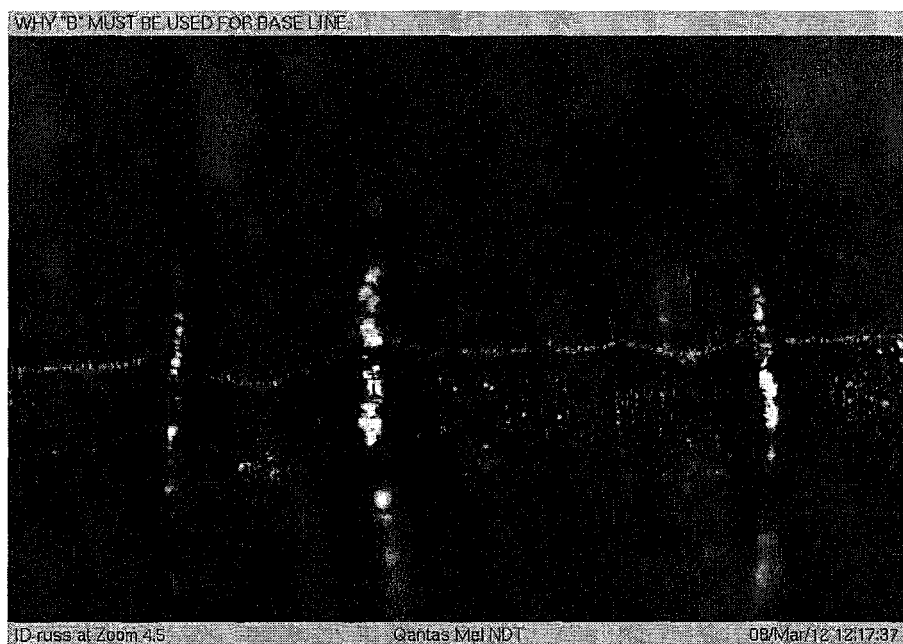
Image 2

Above is the RAW captured Image, shows 3 "Lands with damage between them". The Base line is required to join undamaged surfaces. Hence we draw the Base Line as shown below.

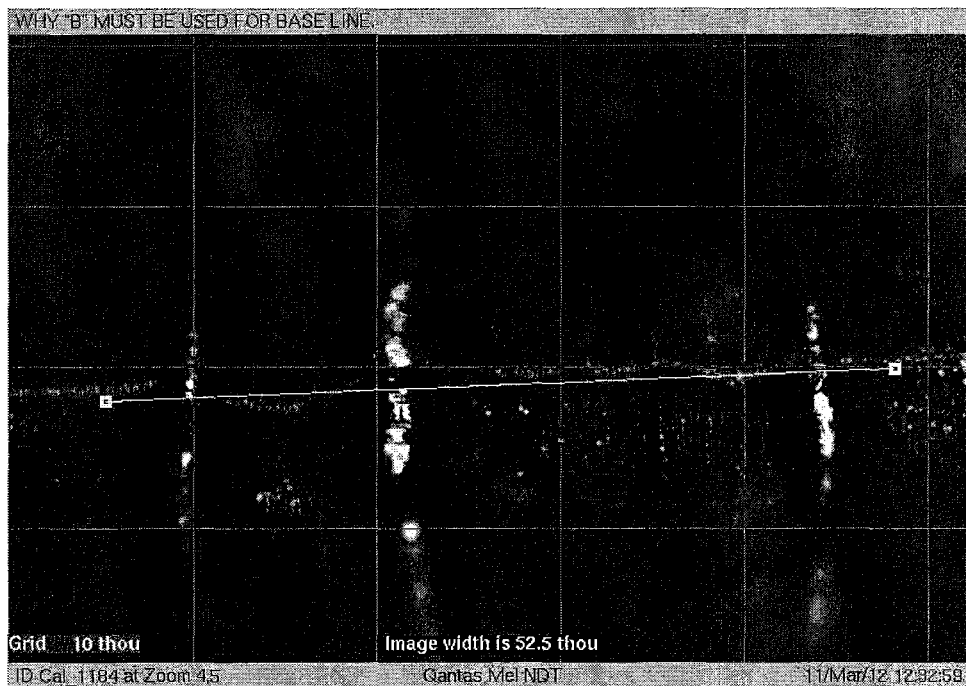
**Image 3**

The damage that is of concern is always BELOW this Line!

**Note that this line is NOT drawn as a vector, but as a "stair case approximation".**

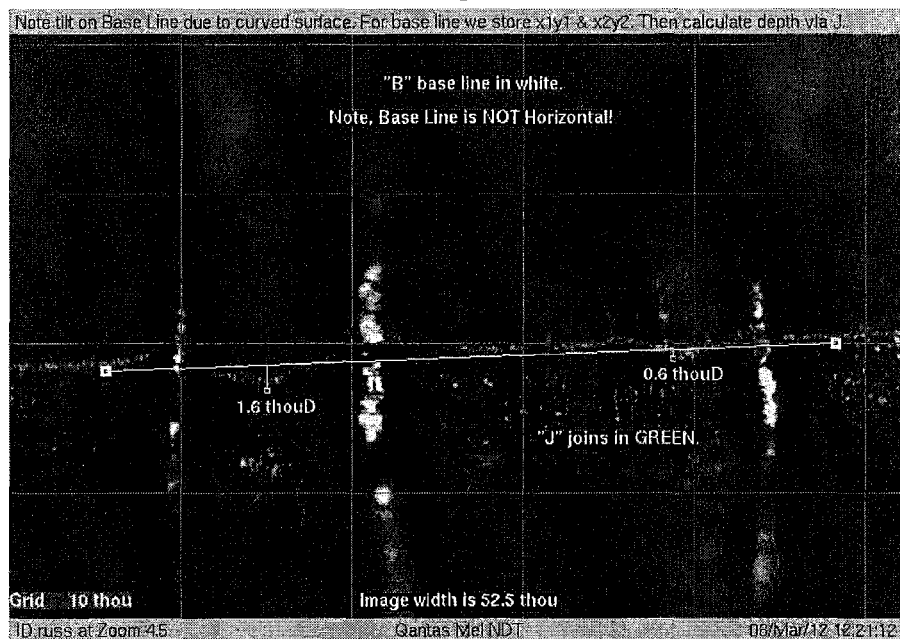
**Image 4**

Note that a "J" line just touches the base line, no small square is shown.

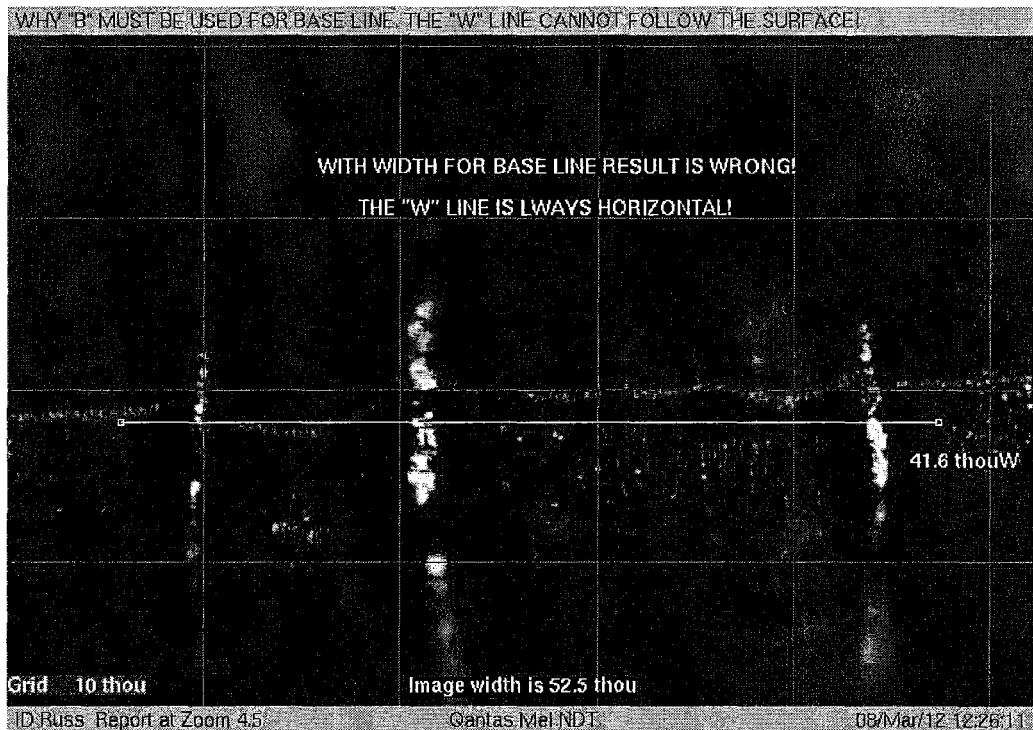
**Image 5**

This line cannot be used to reference the damage of the Scribe Line!

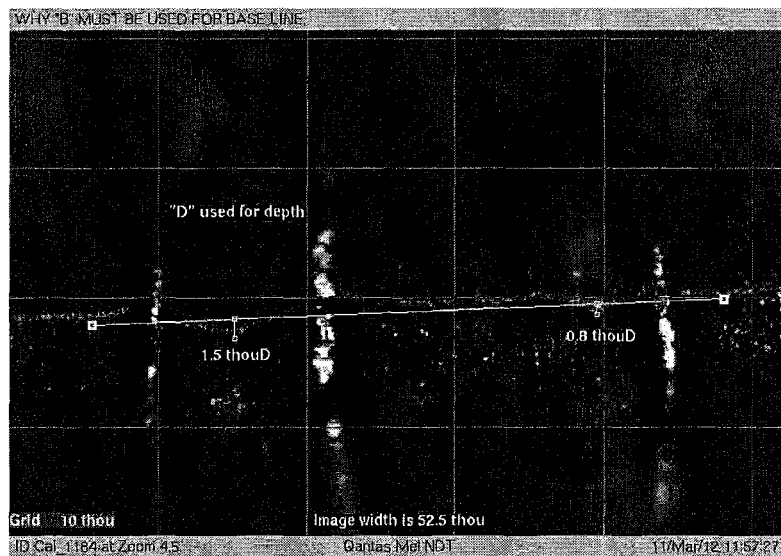
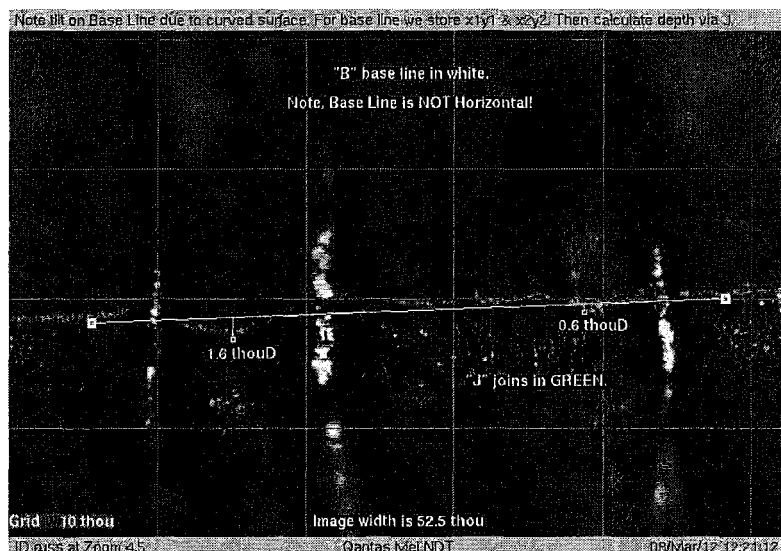
As can be seen from the above two samples, the top one with "D", the lower with "J", only a small difference. But "J" is more accurate!

To clear the confusion we always train to use "J".
