QUALITY SYSTEM COMPLIANCE VENDOR / SUPPLIER AUDIT REPORT

Qantas Airways Limited

**Contracted Maintenance – SIAEC Singapore "D" Check on
Qantas Aircraft VH-OJO V/C: T7105**

AQD Audit ID: 06/SPT/10

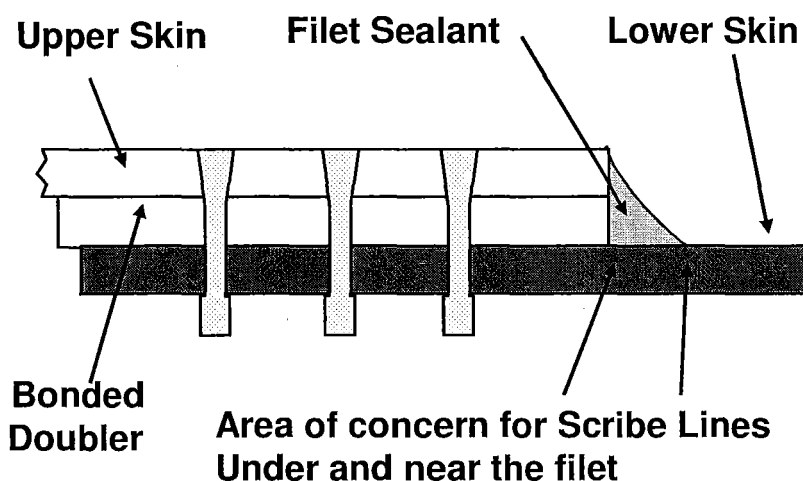
Drawing 1

Typical 737 Lap Joint Detail

The above shows the structure of the bonded doubler on a 737 Lap Joint, on the 737-700 each sheet is close to 40 thou in thickness, the step should therefore be in the order of 80 thou, NOT 25 thou as per **Image 1**.

It is my considered opinion that this error should have been rapidly noted by the personal conducting the Inspection. Also QC at MAS should have detected the error.

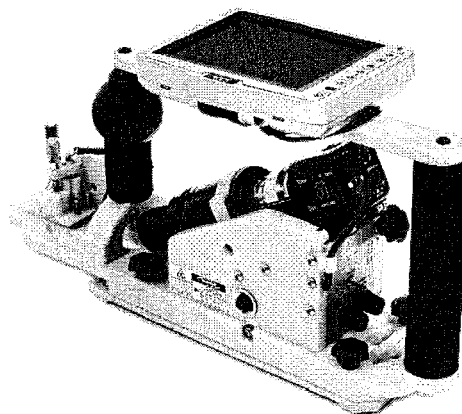
The major difficulty in using the LMM is the depth of field at full zoom which gives an image magnification of approximately $M=170$.

The width of the viewed section of metal when at full Zoom (4.5) is about 52.5 thou. Or about 1.3mm. The depth of field is only 6 thou, or about 0.15mm. **This is very small.** Therefore the LMM MUST be held STEADY! The weight of the LMM is 1.9kgms. Therefore after 10 to 20 mins a rest is needed. Various techniques are taught in the training class to make the task as easy as possible. One MAJOR recommendation pointed out in training is the use of a TEAM to carry out the Inspection. The recommended team is 3 persons. But always no less than 2! The solution is that the team rotate inspection duties! Highly important is that all team members have all the required knowledge and skills to take any role in the Inspection. Critical is that the team member holding the LMM is supported by at least 1 other team member. The technique being "One Holds the LMM, the Other Adjusts as required." The reason that we suggest 3 team members is operational safety. The third person maintains "Situational Awareness". He watches out for cables around feet, etc. His position is recommended always to be close to the InspectCam to assist with pressing the store key! It has been observed that most users have adopted a 3 team approach.

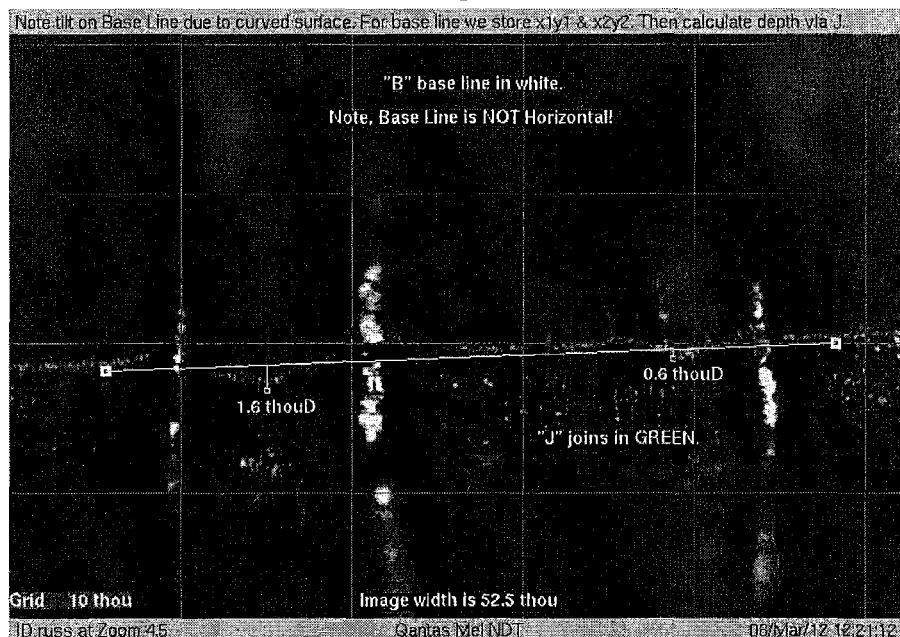
Image 4

Note that a "J" line just touches the base line, no small square is shown.
