# Post Incident Analysis Report

**MFB Burnley Complex  
450 Burnley Street  
Richmond VIC 3121**

**Lacrosse Docklands  
673-675 La Trobe Street, Docklands  
25 November 2014**

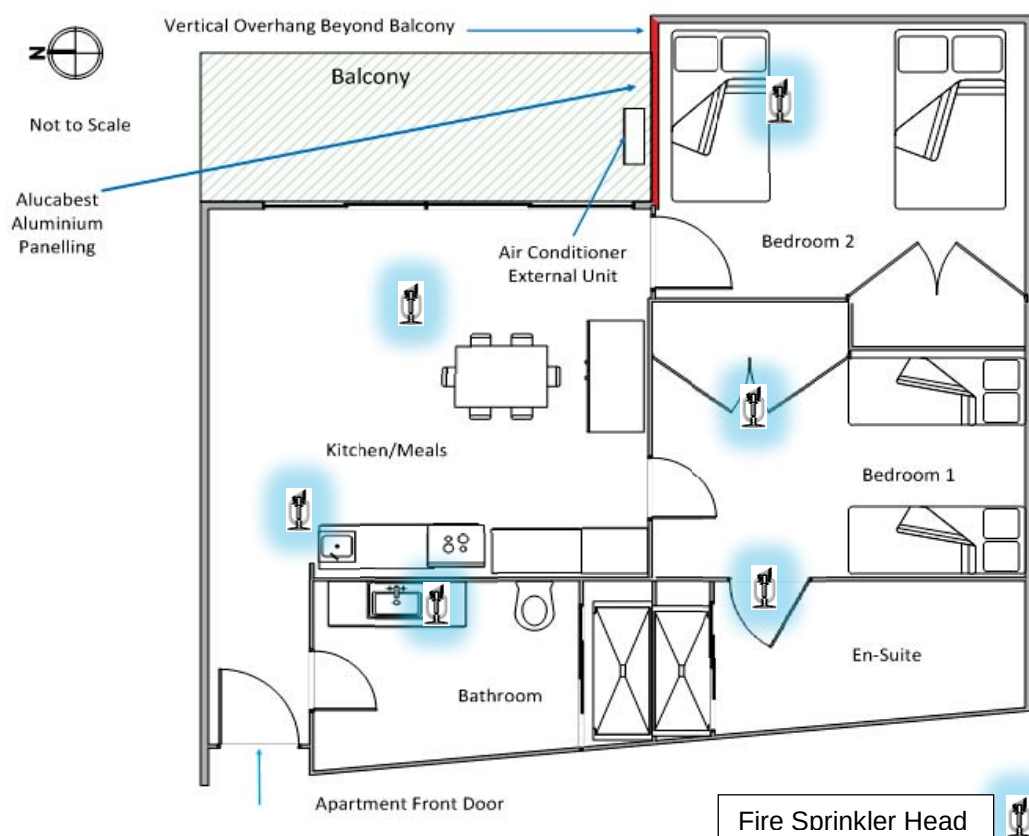
Figure 1 – General floor layout of apartment 805

At approximately 01:30 hours on the morning of Tuesday 25 November 2014, an occupant from Apartment 805 of the building, claims he investigated the smell of smoke. After checking the kitchen and making sure the gas stove was turned off, he returned to bed. Sometime later, the same occupant was woken by two other house mates who had discovered the fire burning on the balcony.

From inside the apartment, he could see a fire on the right hand side (south) of the balcony. The occupants of the apartment unsuccessfully attempted to extinguish the fire using a container of water.

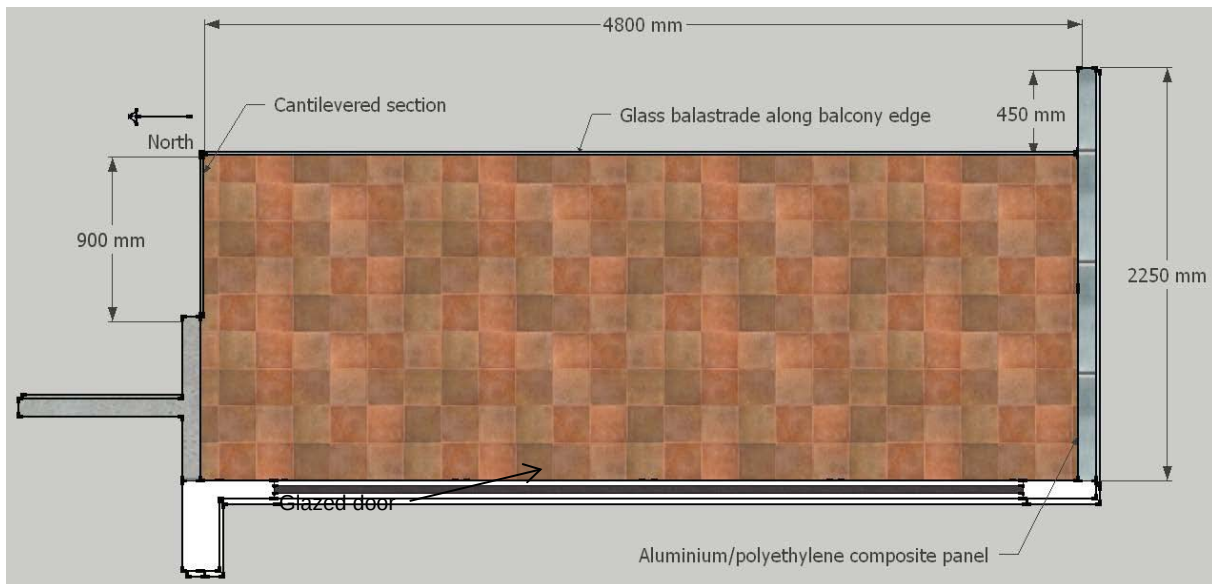
Figure 7 - Balcony Plan view

The apartments known as Apartments 605 to 2105 are located in vertical alignment from the 6<sup>th</sup> floor to the 21<sup>st</sup> floor on the east façade of the building. They include suspended concrete balconies of approximately 1.8 metres deep x 4.7 metres wide. A double-glazed sliding door assembly is fitted in the external wall of the building and provides access to the balcony.

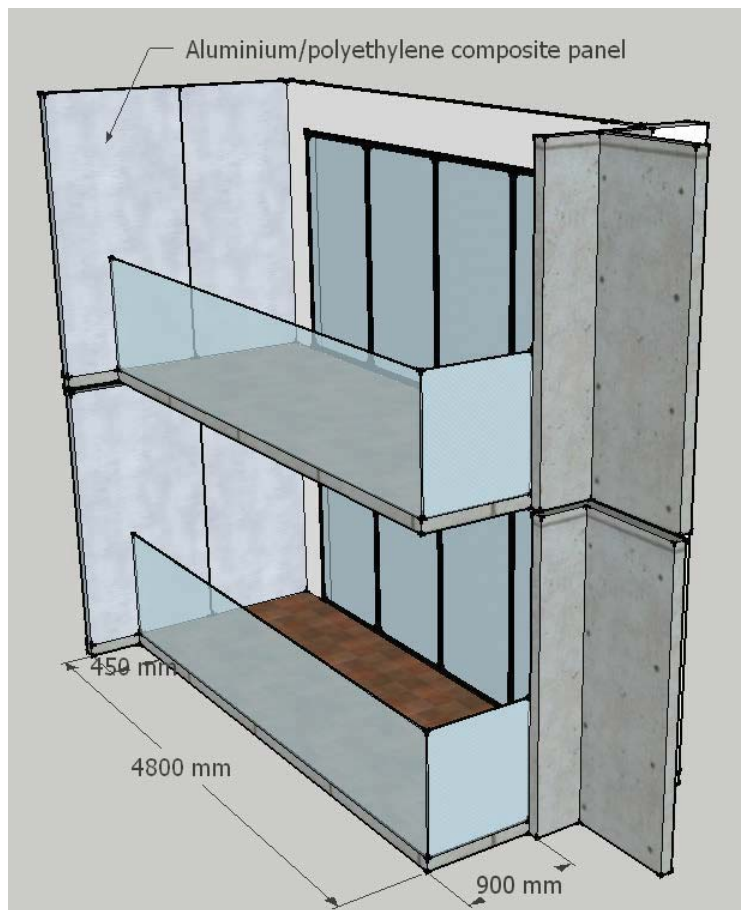
Figure 8 - Simplistic 3D interpretation of the balcony layout

The northern end of these balconies are bounded by 900mm concrete panels, which leaves the remaining 900mm balcony depth cantilevering out beyond the building face. A 1 metre high glazed balustrade is fitted to the remaining northern edge of the balconies and returns along the length of the eastern edge and butts into the southern wall.

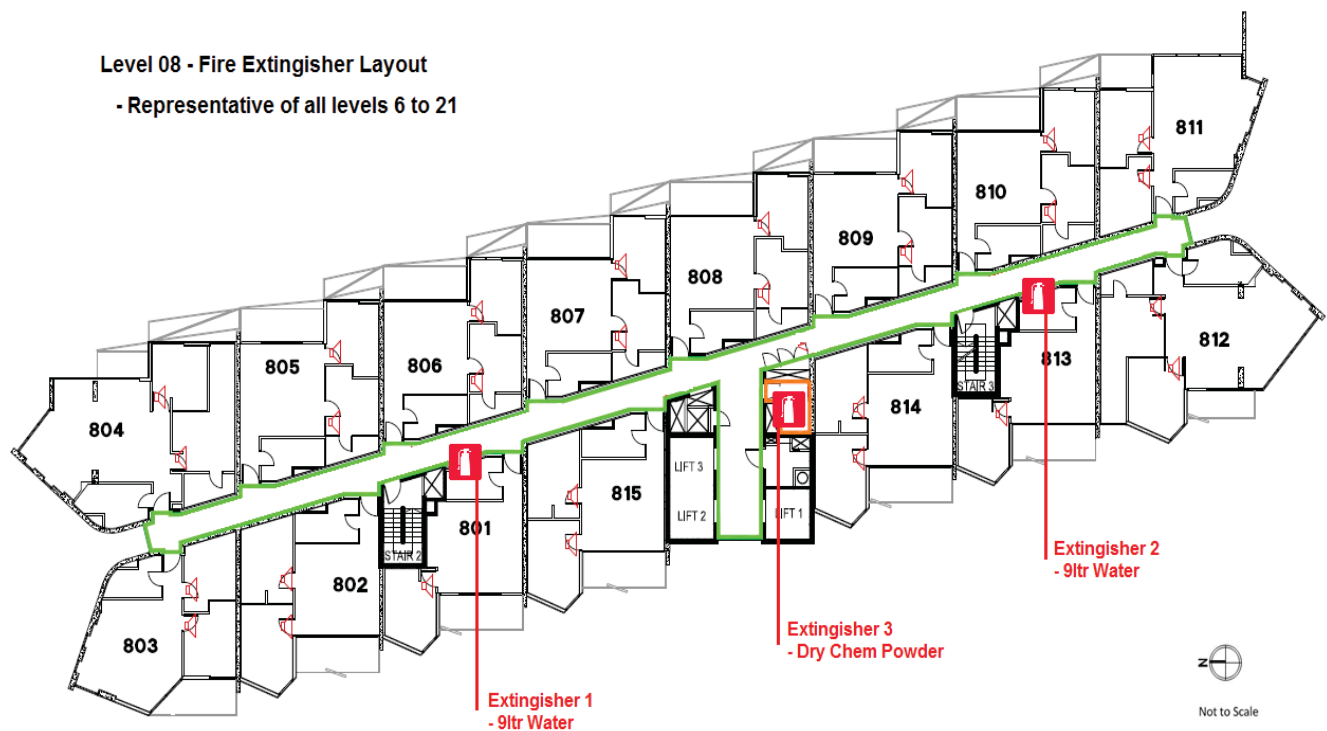
Figure 12 - Fire extinguisher layout

This Standard states that each extinguisher shall be located in a conspicuous and readily accessible position and extinguishers shall not be located in positions where access could present a hazard to the potential user.

In this instance, a number of the purposely designed extinguisher enclosure housing Extinguishers 1 and 2 shown in [Figure 12 \(refer previous page\)](#), were being used by occupants as storage areas thus blocking access to the extinguishers.

It was noted during investigations that extinguisher three (as shown in [Figure 12](#)) on all residential levels was locked within a service room where they were inaccessible to occupants and fire-fighters.

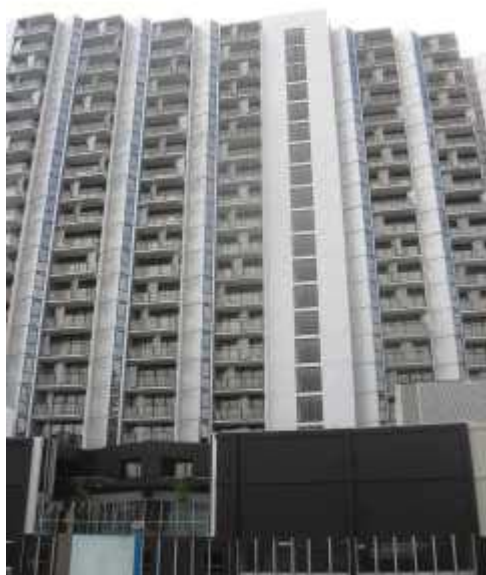
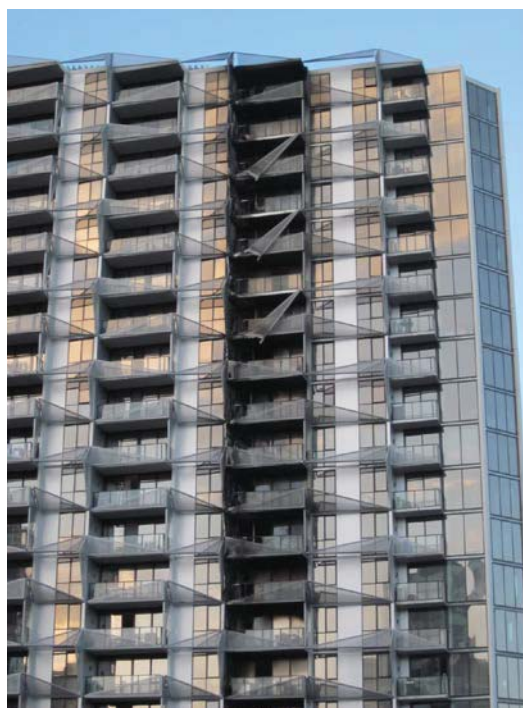
**Photo Prior To Fire**

**Photo Post Fire**

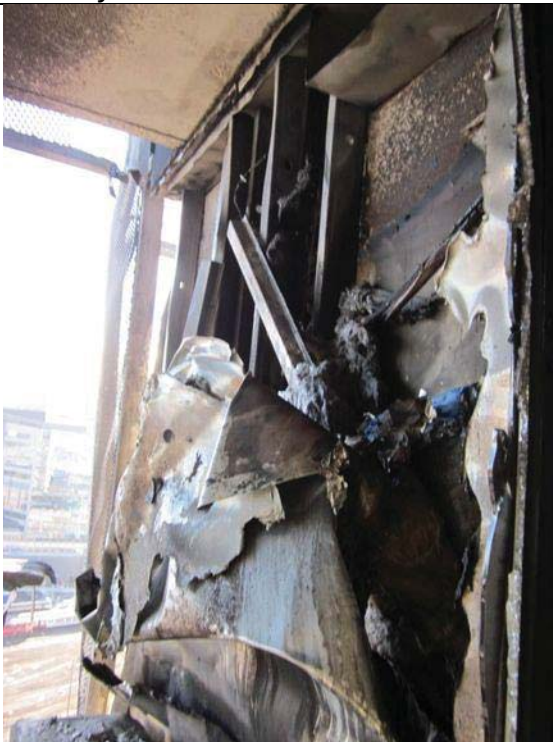
Wall between bedroom and balcony. Construction lightweight wall with steel studs, aluminium type external cladding plasterboard to internal. Material stored on balcony.

External wall at upper height

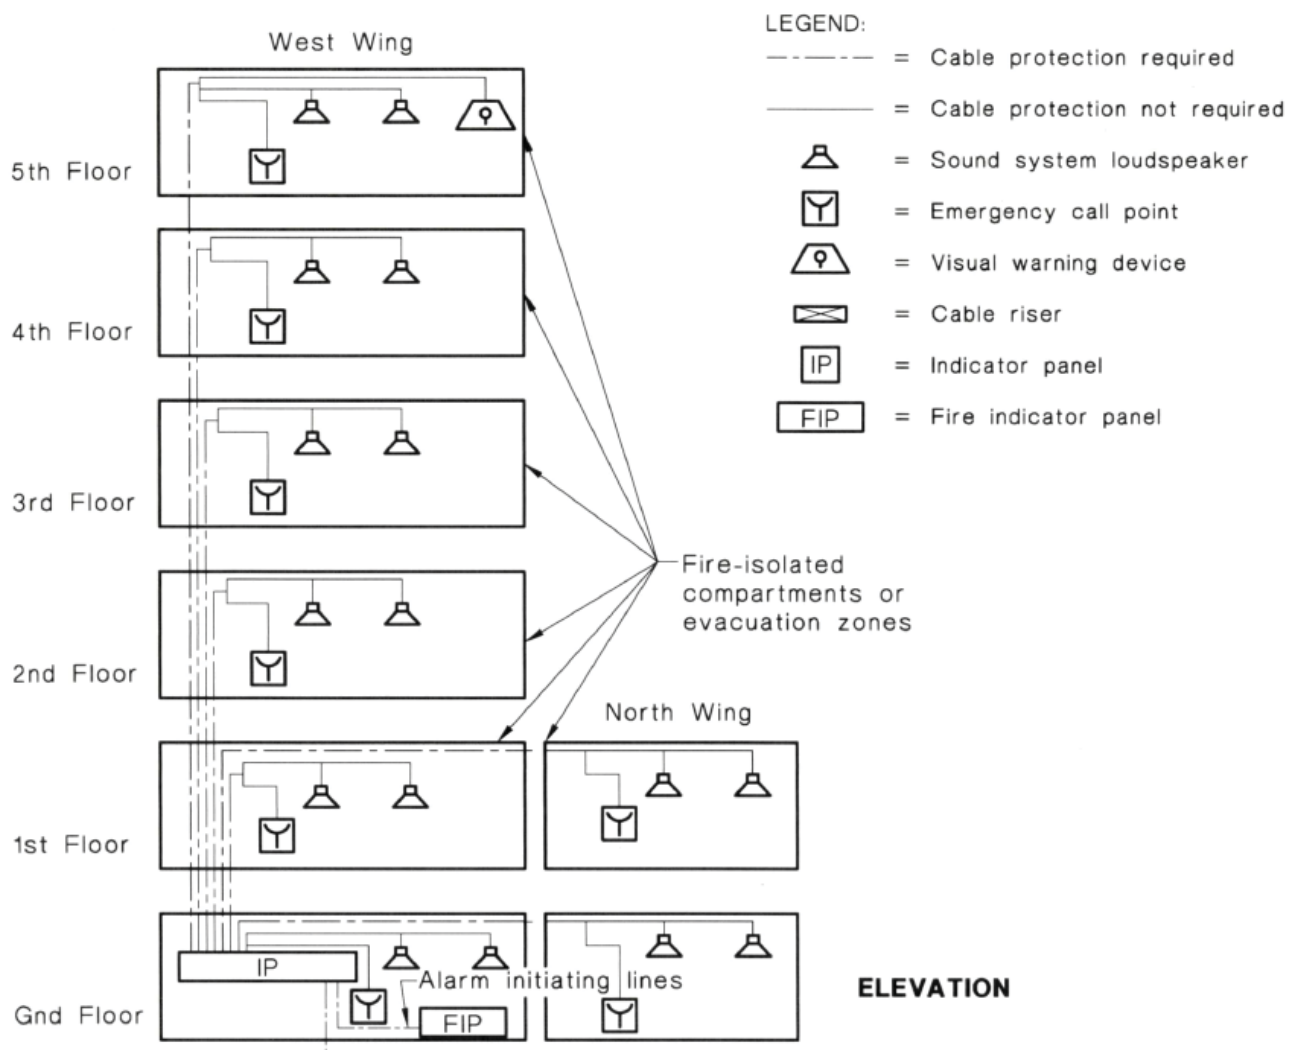
Figure 17 - Wiring diagram for EWIS

The EWIS system is designed and installed as per Australian Standard AS1670.4. This Standard requires all wiring between the EWIS's main panel and the evacuation zone to be fire rated. The zone wiring itself is not required to be fire rated, instead non-fire rated thermal plastic sheath (TPS) wire is used. Refer to [Appendix 6 figure 17](#).

This figure is an extract from Australian Standard AS1670.4-2004 (page 20 Figure 4.1). The figure depicts which EWIS wires are required to be protected from fire and which are not required to be protected.

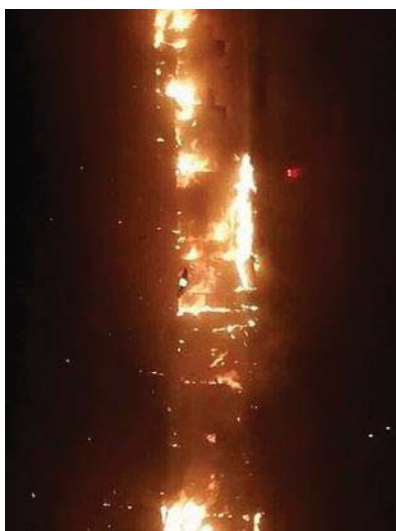
### Torch Tower Dubai 21 February 2015

- o 79 Storey residential;
- o Reported as same façade material as the other Dubai fires shown - Aluminium/polyethylene composite panel facade;
- o Fire Origin 52nd floor
- o Rapid vertical spread up the façade of the building and significant flaming falling debris

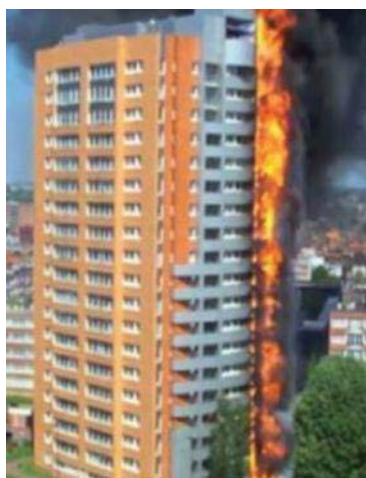
### Mermoz Tower, Roubaix, France, 2012

- o 18 storey residential building;
- o Aluminium/polyethylene composite panel facade;
- o Fire origin – 2nd storey balcony;
- o Fire description - “rapid vertical flame spread to the top of the building within a few minutes”.

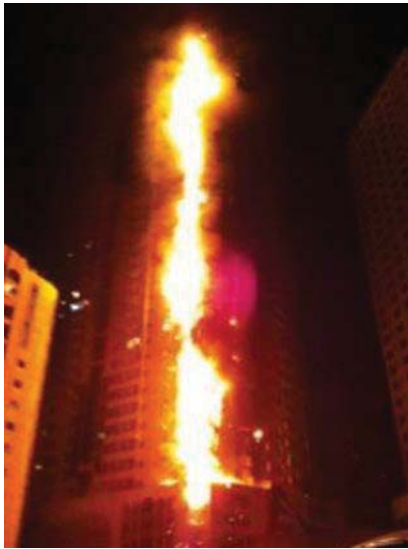
### Al Tayer Tower, Sharjah, 2012

- o 40 storey residential building containing 6 carpark levels;
- o Aluminium/polyethylene composite panel façade;
- o Fire origin – 1st storey balcony;
- o Fire cause – “discarded cigarette landing on the balcony which contained cardboard boxes and plastics”;
- o Fire description – “vertical fire spread on the metal composite cladding to the top of the building”;

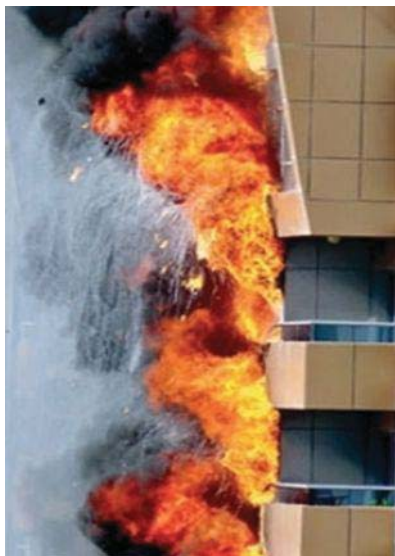
### Saif Belhasa Building, Tecom, Dubai 2012

- o 13 storey residential building;
- o Aluminium/polyethylene composite panel façade;
- o Fire origin – 4th floor;
- o Fire description – “fire rapidly spread to reach the top of the building”

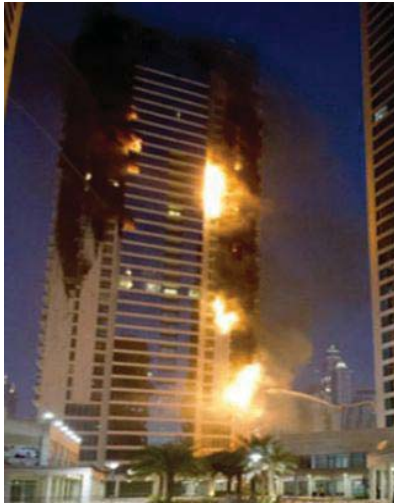
### Tamweel Tower, Dubai, 2012

- o 34 storey residential building (contains mixed use)
- o Aluminium/polyethylene composite panel façade;
- o Fire origin – roof level
- o Fire description - “spread down the exterior of the building.”

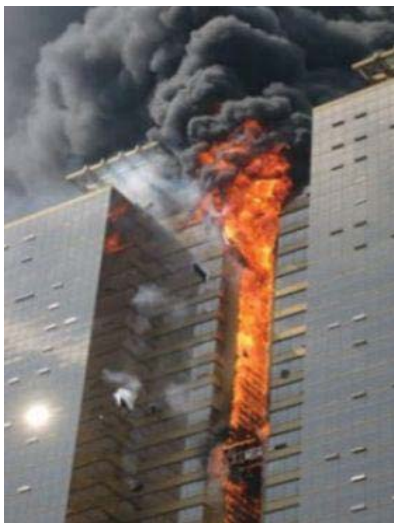
### Wooshin Golden Suites, Busan South Korea

- o 42 storey residential building (contains mixed use);
- o Aluminium/polyethylene composite panel façade;
- o Fire description - “spread vertically upward on the façade reaching the top of the building”
- o Fire origin - fourth floor;
