Post Incident Analysis Report

**Lacrosse Docklands
673-675 La Trobe Street, Docklands
25 November 2014**

Point of Interest: Rapid external fire spread in a high-rise apartment building resulting in a mass evacuation

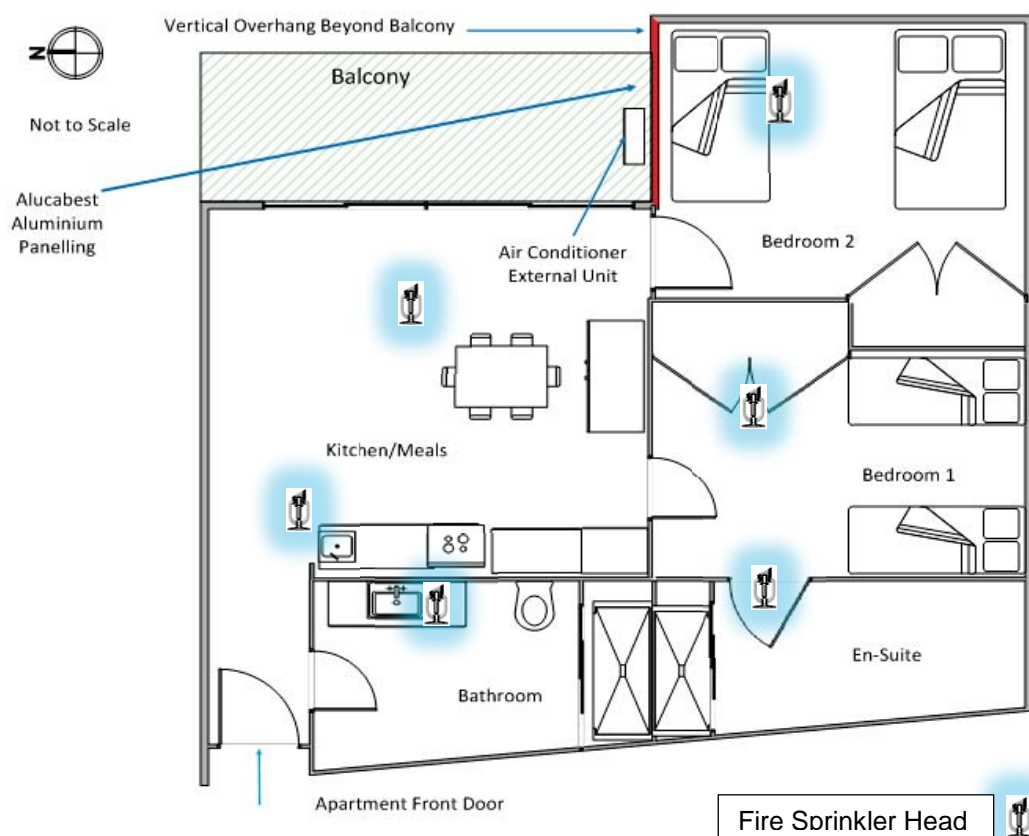
Figure 1 – General floor layout of apartment 805

At approximately 01:30 hours on the morning of Tuesday 25 November 2014, an occupant from Apartment 805 of the building, claims he investigated the smell of smoke. After checking the kitchen and making sure the gas stove was turned off, he returned to bed. Sometime later, the same occupant was woken by two other house mates who had discovered the fire burning on the balcony.

From inside the apartment, he could see a fire on the right hand side (south) of the balcony. The occupants of the apartment unsuccessfully attempted to extinguish the fire using a container of water.

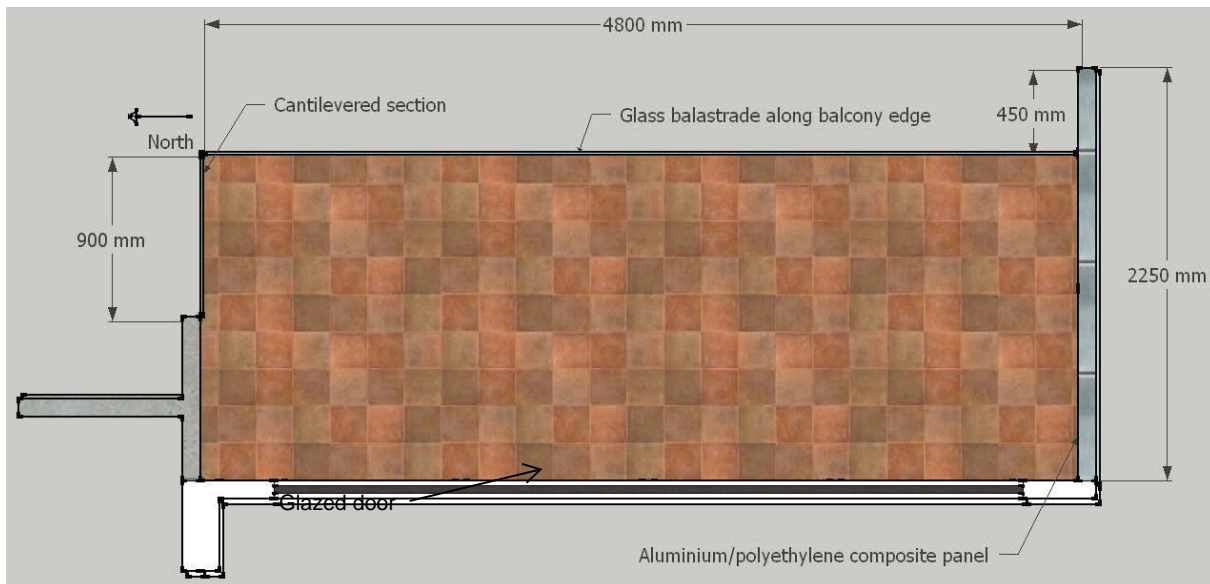
Figure 7 - Balcony Plan view

The apartments known as Apartments 605 to 2105 are located in vertical alignment from the 6th floor to the 21st floor on the east façade of the building. They include suspended concrete balconies of approximately 1.8 metres deep x 4.7 metres wide. A double-glazed sliding door assembly is fitted in the external wall of the building and provides access to the balcony.

The northern end of these balconies are bounded by 900mm concrete panels, which leaves the remaining 900mm balcony depth cantilevering out beyond the building face. A 1 metre high glazed balustrade is fitted to the remaining northern edge of the balconies and returns along the length of the eastern edge and butts into the southern wall.

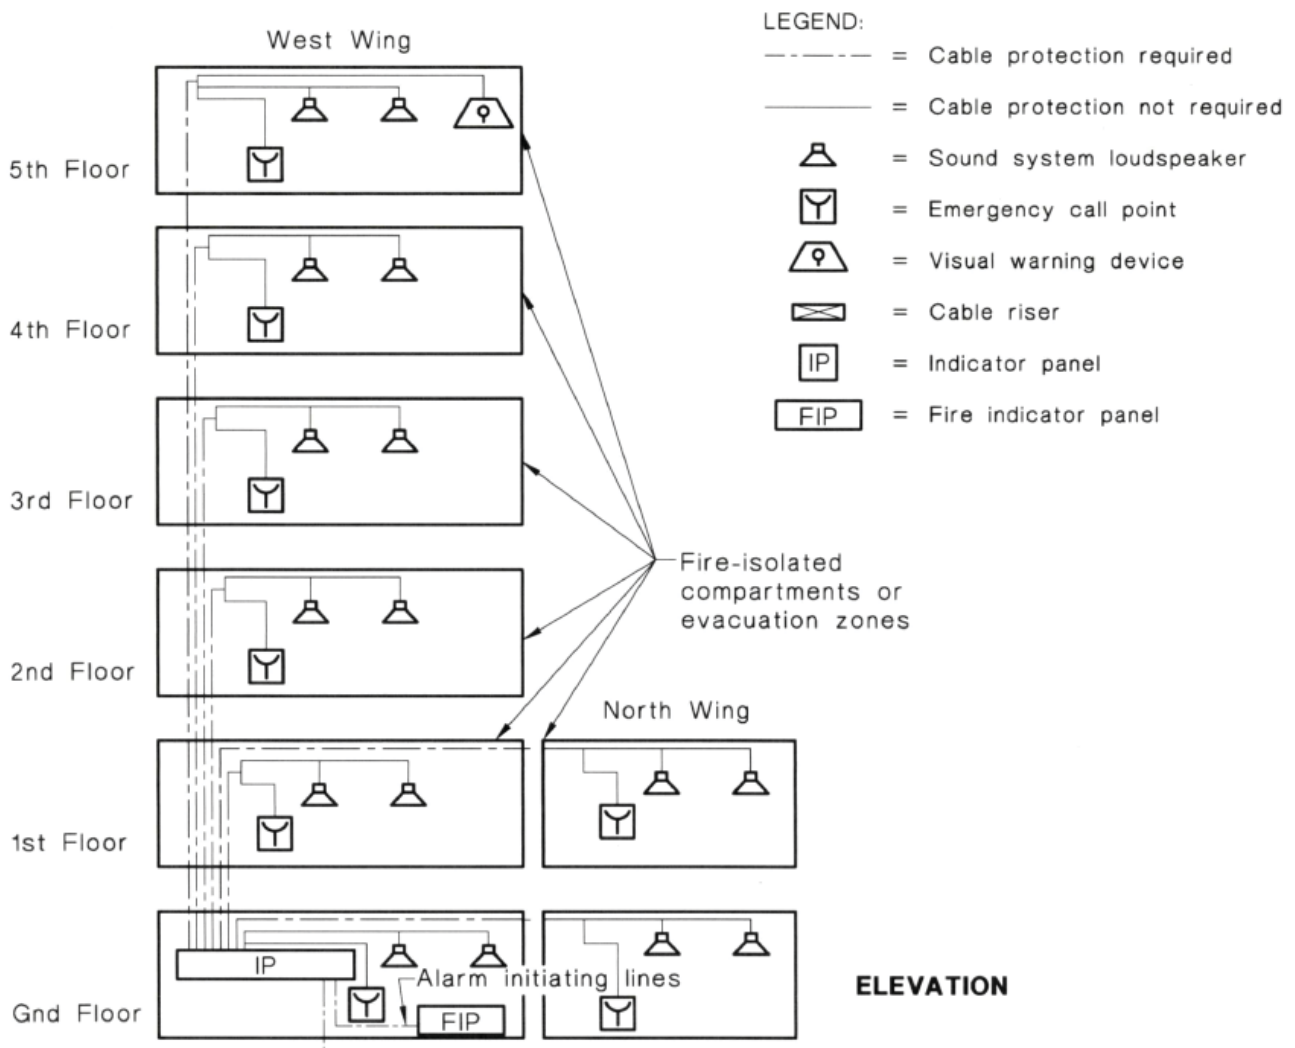
Figure 17 - Wiring diagram for EWIS

The EWIS system is designed and installed as per Australian Standard AS1670.4. This Standard requires all wiring between the EWIS's main panel and the evacuation zone to be fire rated. The zone wiring itself is not required to be fire rated, instead non-fire rated thermal plastic sheath (TPS) wire is used. Refer to [Appendix 6 figure 17](#).

This figure is an extract from Australian Standard AS1670.4-2004 (page 20 Figure 4.1). The figure depicts which EWIS wires are required to be protected from fire and which are not required to be protected.

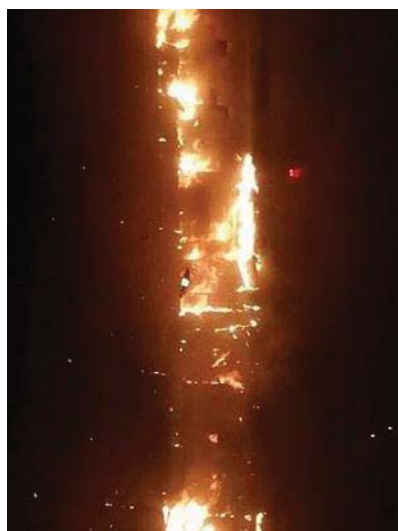
Torch Tower Dubai 21 February 2015

- 79 Storey residential;
- Reported as same façade material as the other Dubai fires shown - Aluminium/polyethylene composite panel facade;
- Fire Origin 52nd floor
- Rapid vertical spread up the façade of the building and significant flaming falling debris

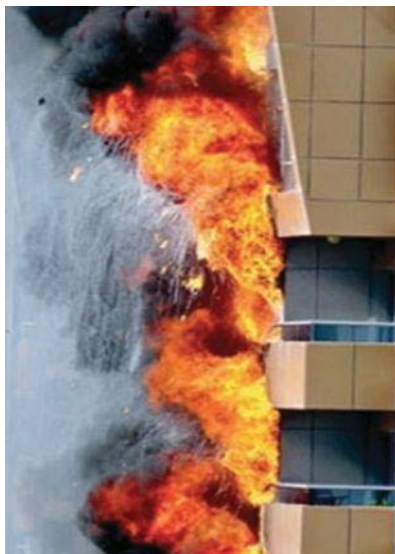
Saif Belhasa Building, Tecom, Dubai 2012

- *13 storey residential building;*
- *Aluminium/polyethylene composite panel façade;*
- *Fire origin – 4th floor;*
- *Fire description – “fire rapidly spread to reach the top of the building”*

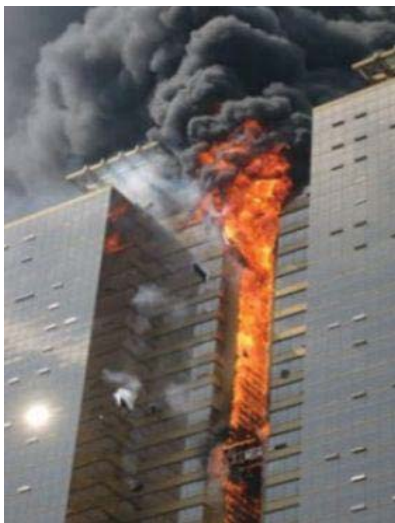
Wooshin Golden Suites, Busan South Korea

- *42 storey residential building (contains mixed use);*
- *Aluminium/polyethylene composite panel façade;*
- *Fire description - “spread vertically upward on the façade reaching the top of the building”*
- *Fire origin - fourth floor;*

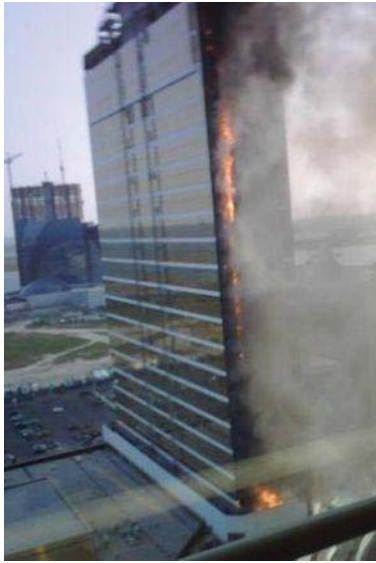
Water Club Tower, Atlantic City, USA

- *41 storey building under construction;*
- *Aluminium/polyethylene composite panel façade;*
- *Fire origin - internal fire on the 3rd floor;*
- *Fire description – “fire spread vertically and rapidly reached the top of the building”.*
