# *Deepwater Horizon* Accident Investigation Report

September 8, 2010

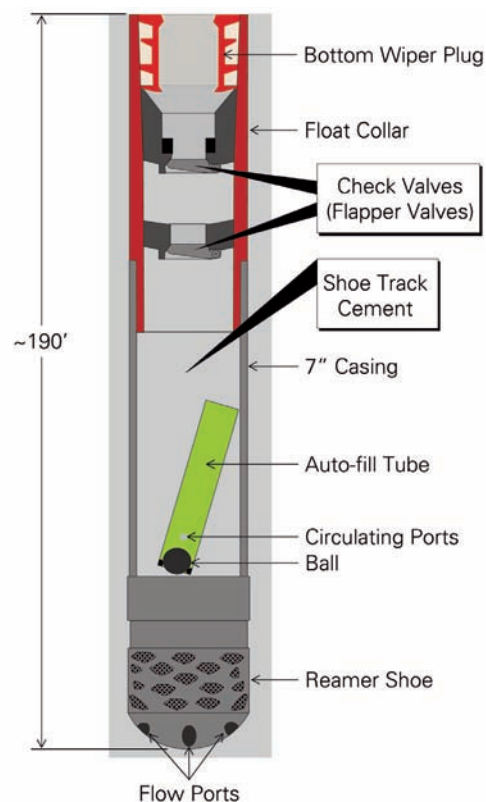
**Figure 2.** Shoe Track Barriers.

Based on available evidence, hydrostatic pressure calculations, OLGA® well flow modeling and analysis of data from the Macondo well static kill on August 4, 2010, hydrocarbons entered the casing through the shoe track. Therefore, the shoe track cement and the float collar must have failed to prevent this ingress. The investigation team has not established whether this failure was attributable to the design of the cement, contamination of the cement by mud in the wellbore, commingling of cement with nitrogen due to nitrogen breakout from the nitrified foam cement slurry, swapping of the shoe track cement with the mud in the rathole (bottom of the well) or some combination of these factors.

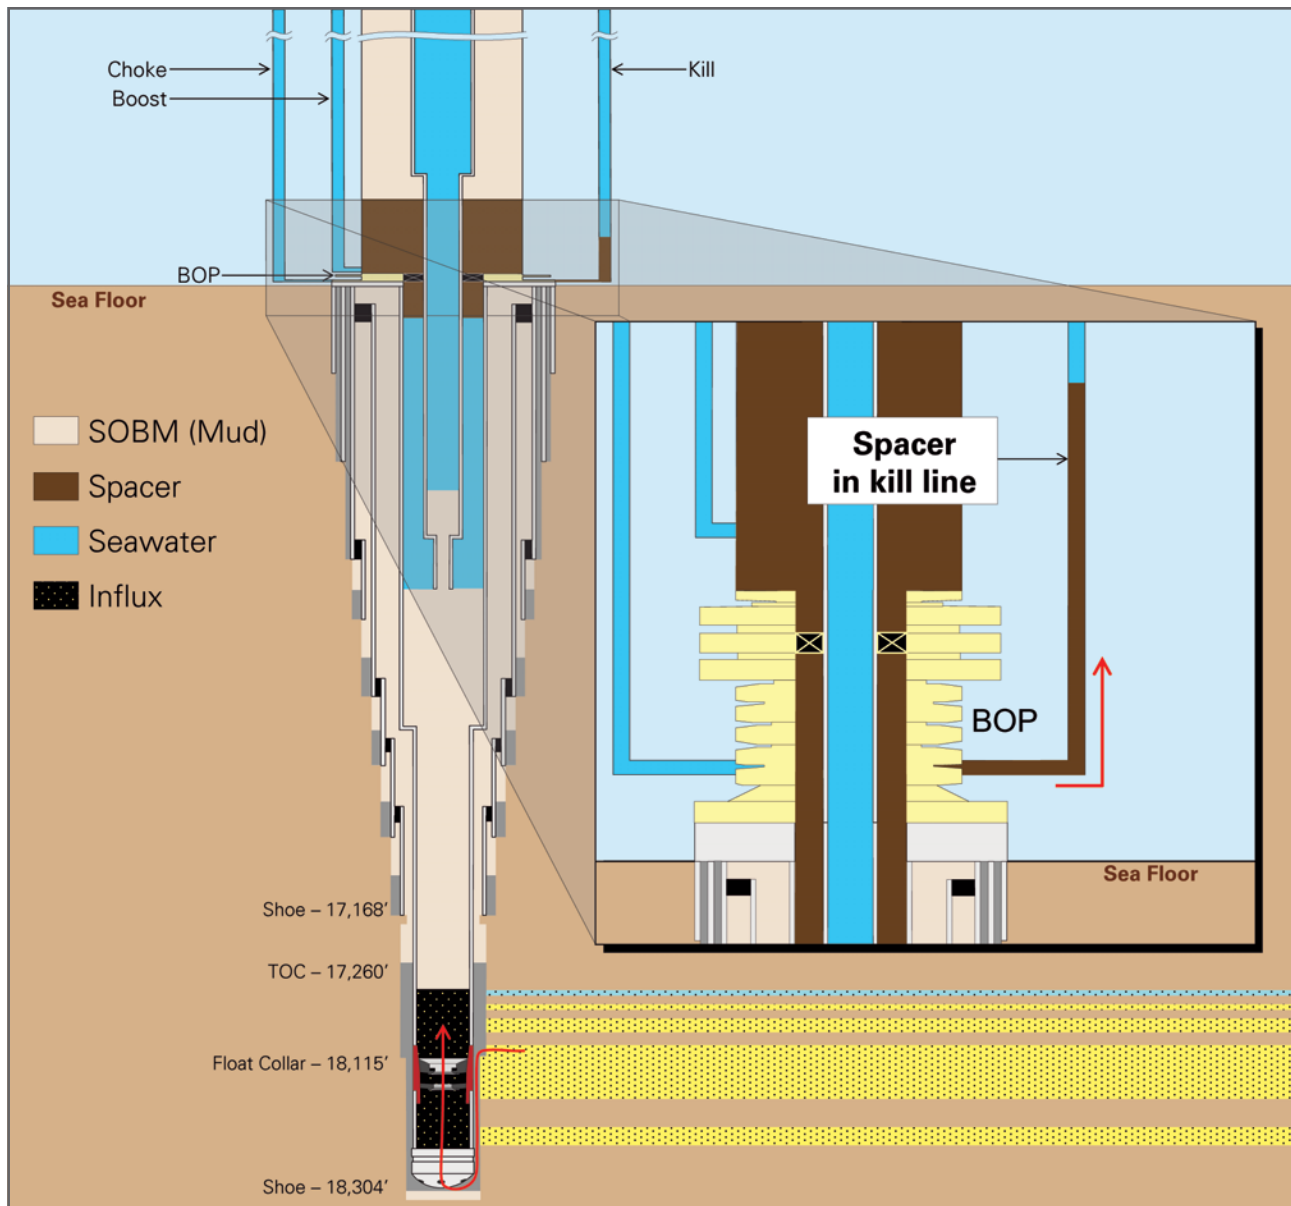
**Figure 3.** Possible Movement of Spacer into the Kill Line.

From 18:00 hours to 18:35 hours, the drill pipe pressure increased from approximately 50 psi to 1,400 psi. To resume the negative-pressure test, the kill line was filled and then opened, 0.2 bbls flowed, and no further flow was observed from the kill line during a 30-minute period of monitoring. The drill pipe pressure was constant at 1,400 psi.

This pressure of 1,400 psi on the drill pipe was misinterpreted by the rig crew and the well site leaders. According to witness accounts, the toolpusher proposed that the pressure on the drill pipe was caused by a phenomenon referred to as ‘annular compression’ or ‘bladder effect.’ The toolpusher and driller stated that they had previously observed this phenomenon. After discussing this concept, the rig crew and the well site leaders accepted the explanation. The investigation team could find no evidence that this pressure effect exists.

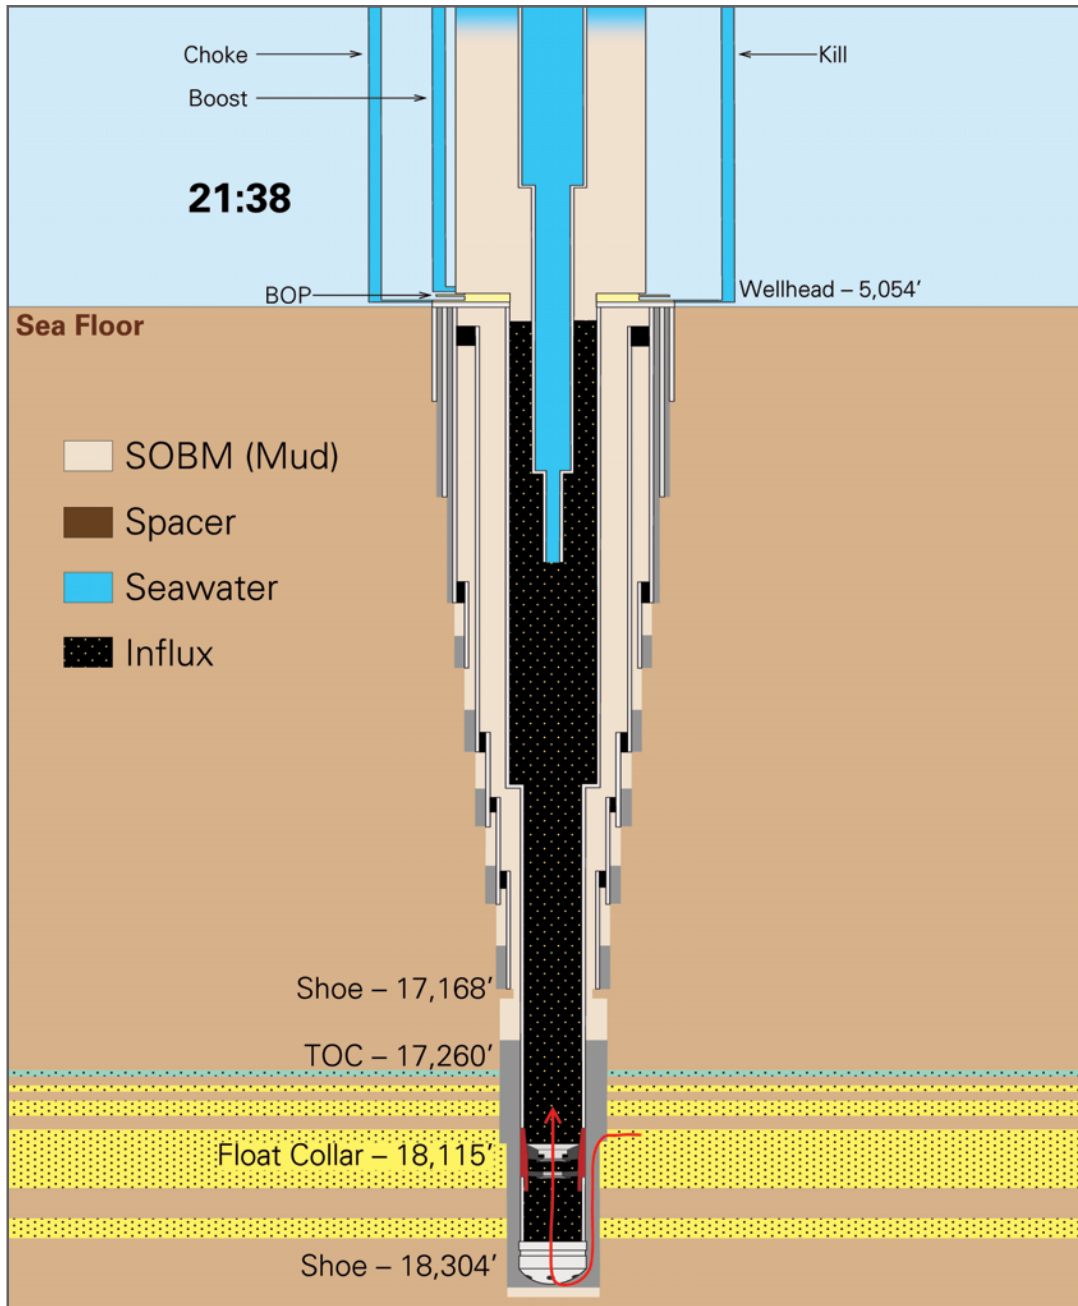
**Figure 4.** Hydrocarbons Entering the Riser.

Analysis indicates that the first indications of flow from the well could be seen in the real-time data after 20:58 hours. The rig crew and mudloggers either did not observe or did not recognize indications of flow until after hydrocarbons entered the riser at approximately 21:38 hours. The first well control response likely occurred at 21:41 hours.

The *Transocean Well Control Handbook* stated that the well was to be monitored at all times. However, the policy did not specify how to monitor the well during in-flow testing, cleanup or other end-of-well activities.

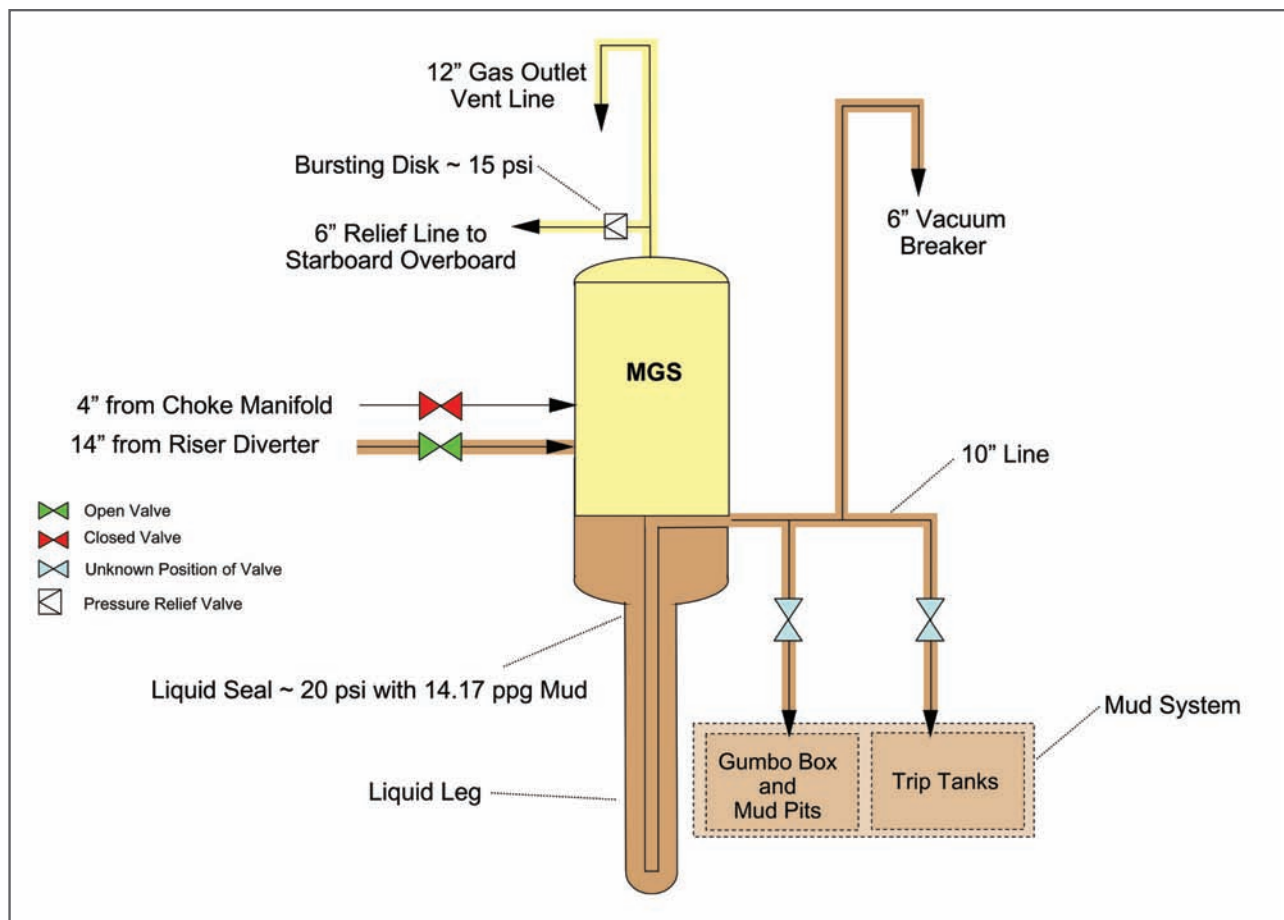
Figure 5. Mud Gas Separator.

The diversion of fluids overboard, rather than to the MGS, may have given the rig crew more time to respond and may have reduced the consequences of the accident.

Transocean's shut-in protocols did not fully address how to respond in high flow emergency situations after well control has been lost. Well control actions taken prior to the explosion suggest the rig crew was not sufficiently prepared to manage an escalating well control situation.

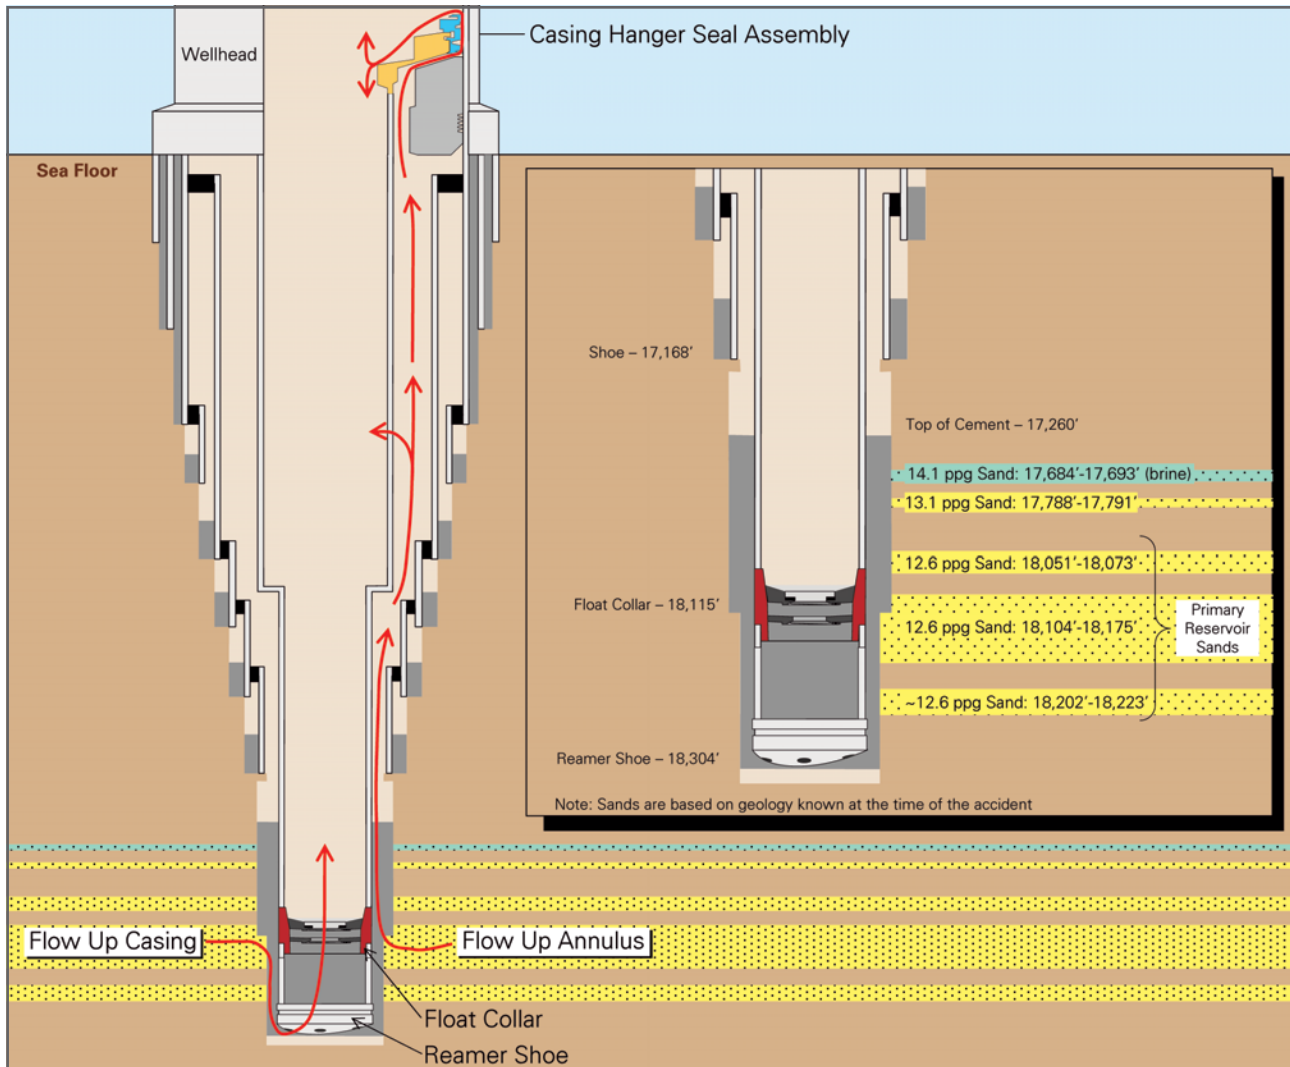
**Figure 1.** Hydrocarbon Zones and Potential Flow Paths.

The annulus cement barrier failed to prevent hydrocarbons from entering the annulus after cement placement. The investigation team assessed possible failure modes and paths that led to hydrocarbon migration from the formation into the wellbore. (Refer to Figure 1.)

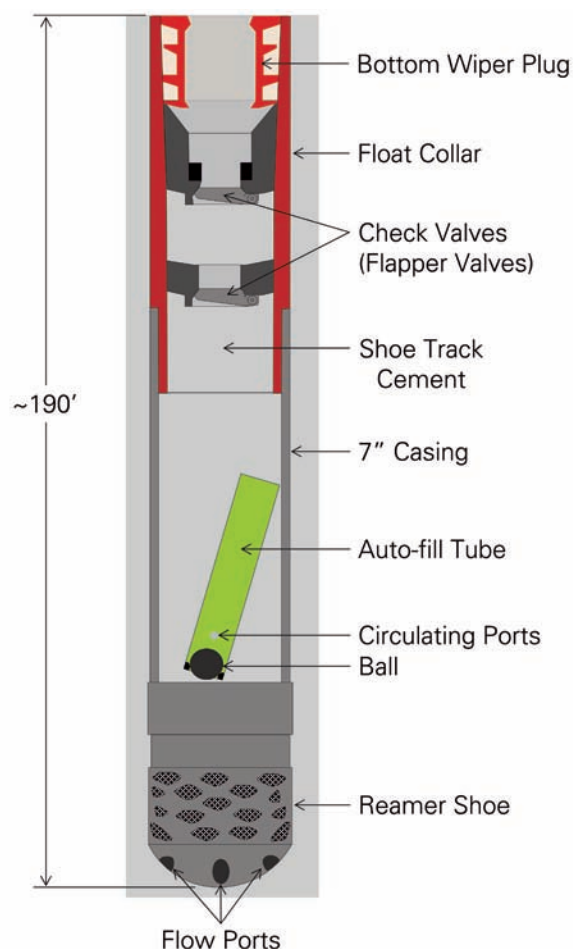
Figure 4. Shoe Track.

Based on available evidence, hydrostatic pressure calculations, OLGA® well flow modeling and analysis of data from the Macondo well static kill on August 4, 2010, hydrocarbons entered the casing through the shoe track. Therefore, the shoe track cement and the float collar must have failed to prevent this ingress. The investigation team has not

established whether this failure was attributable to the design of the cement, contamination of the cement by mud in the wellbore, commingling of cement with nitrogen due to nitrogen breakout from the foam cement slurry, swapping of the shoe track cement with the mud in the rathole (bottom of the well), or some combination of these factors.

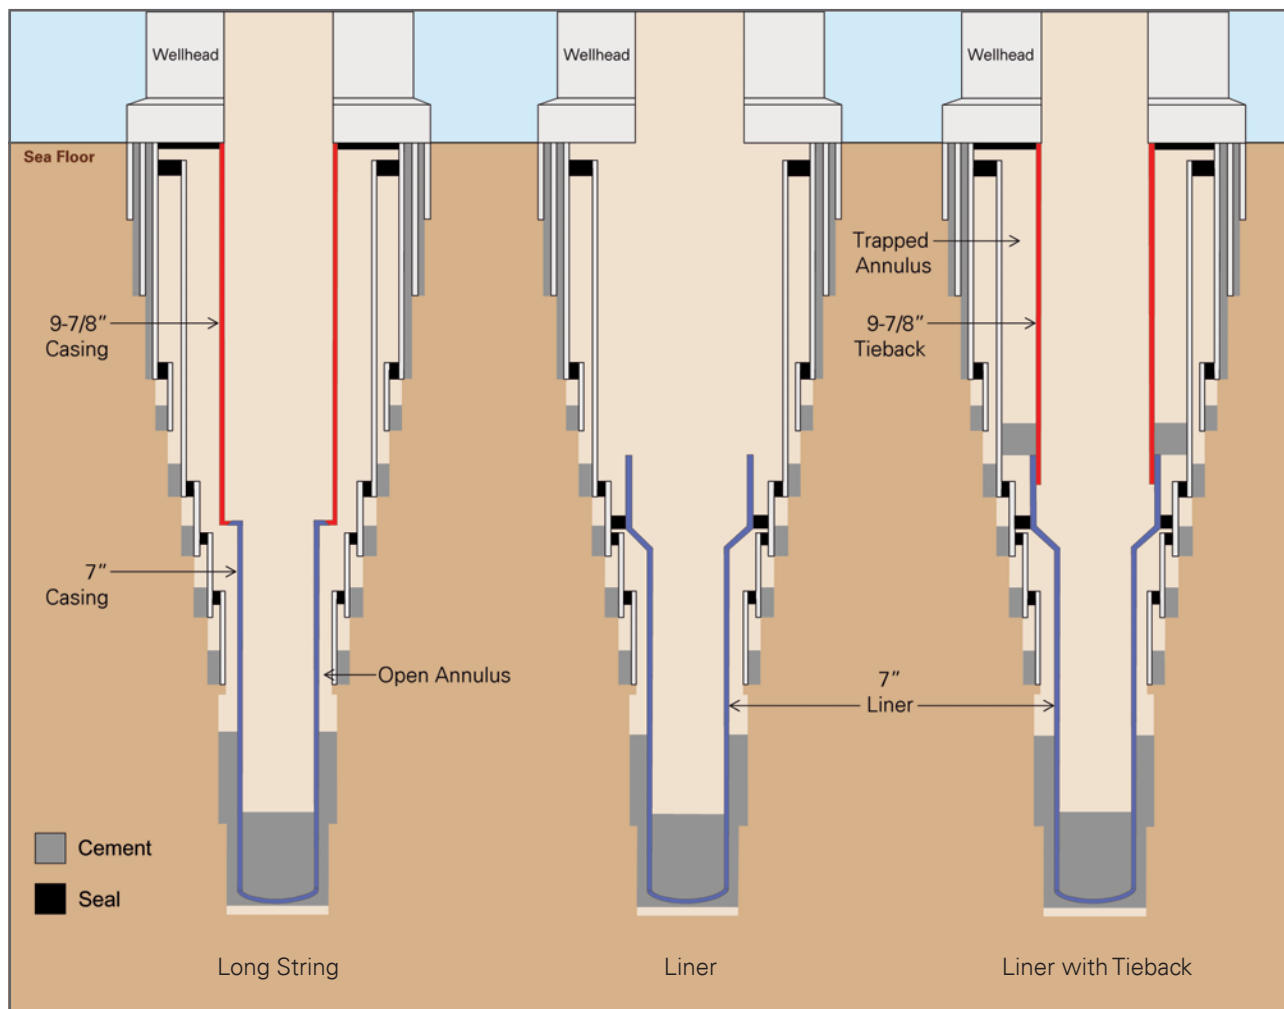
**Figure 6.** Long String, Liner and Liner with Tieback.

The investigation team reviewed the decision to install a 9 7/8 in. x 7 in. long string versus a 7 in. liner that would be tied back to the wellhead at a later date. (Refer to Figure 6.) Installing a long string would prepare the well for later production. Installing a liner would require installation of a tieback at a later date before production could start. During temporary abandonment, the top of the long string would be sealed at the casing hanger in the wellhead, while the liner would be sealed at the downhole liner hanger.

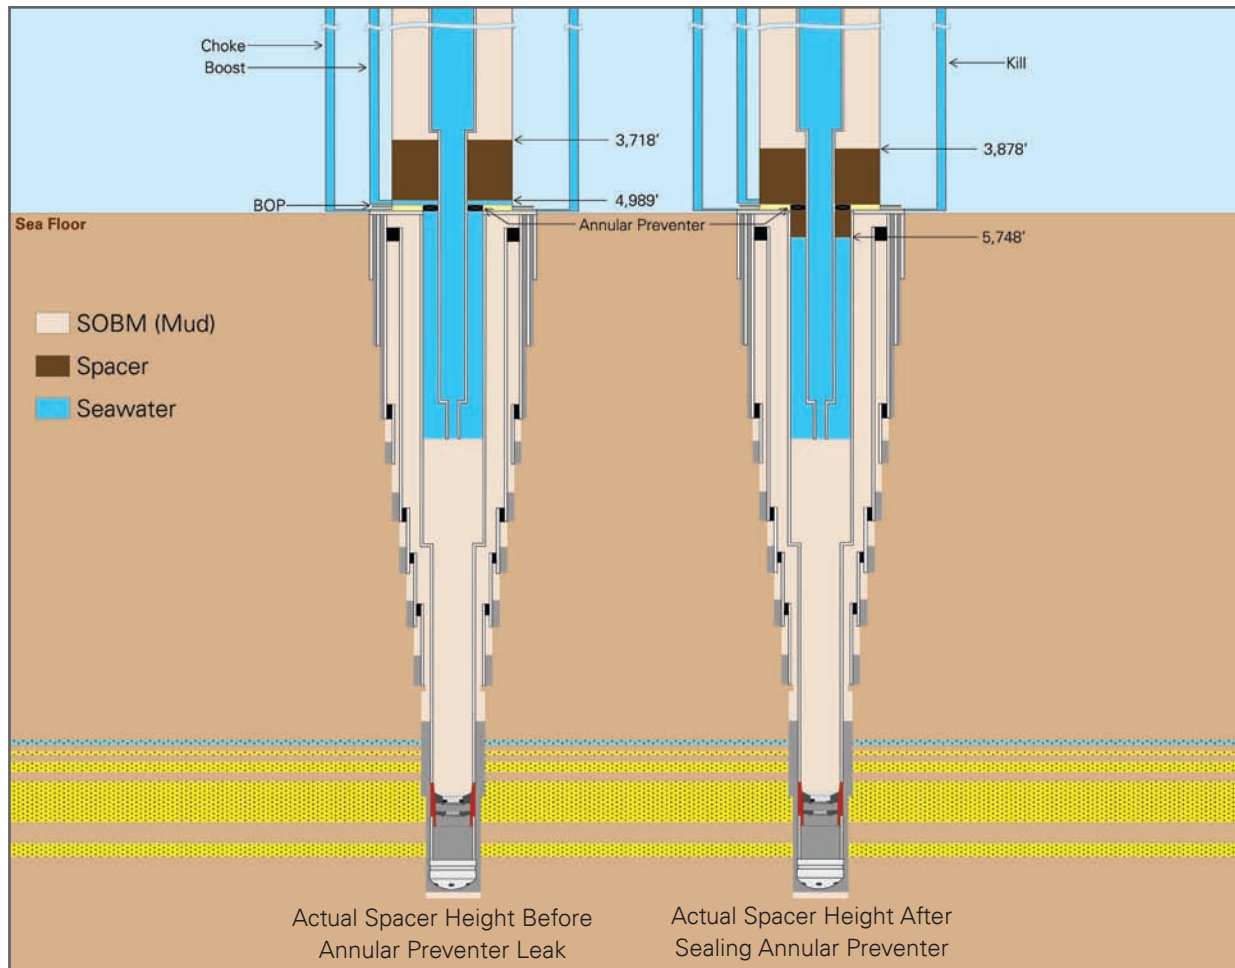
**Figure 2.** Spacer Placement.

- During the initial attempted negative-pressure test on the drill pipe, the annular preventer was closed, but it failed to seal on the drill pipe, resulting in approximately 50 bbls of spacer leaking past the annular preventer into the BOP during the bleed-off of drill pipe pressure. The investigation team believes that the spacer or spacer/seawater interface was across the BOP during the negative-pressure test procedure. (Refer to *2.3 Opened the Drill Pipe to Bleed Pressure* of this analysis.) The bottom of the spacer, therefore, was not above the upper annular preventer as intended. *Figure 2* shows the actual spacer placement before and after sealing the annular preventer.

- The presence of the spacer across the kill line inlet could have complicated the interpretation of the negative-pressure test. (Refer to *2.5 Continued the Negative-pressure Test on the Kill Line* of this analysis for a discussion of the anomalous pressure readings during the negative-pressure test.)

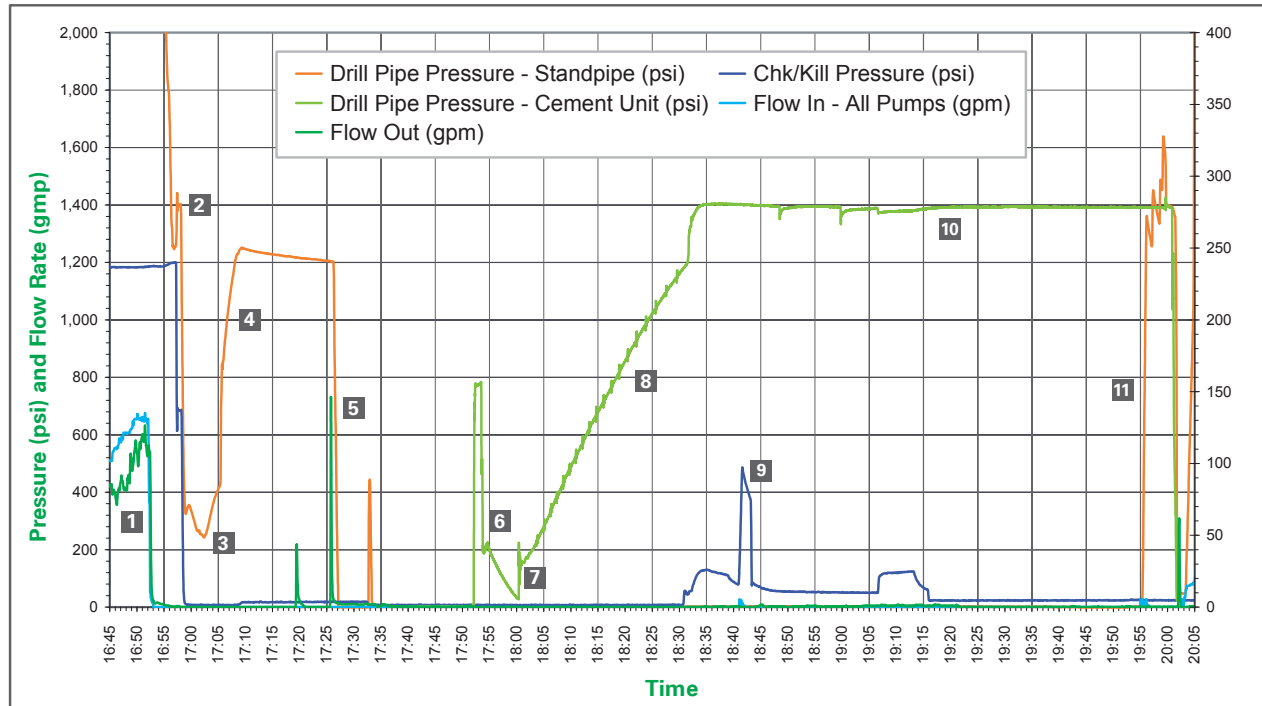
A successful negative-pressure test is indicated by no flow from either the kill line or the drill pipe; however, there was 1,400 psi on the drill pipe, an indication of communication with the reservoir.

| <p><b>1</b> Spacer displacement complete; mud pumps stopped.</p> <p><b>2</b> Annular preventer closed; attempt to bleed drill pipe pressure to zero.</p> <p><b>3</b> Drill pipe pressure decreases to only 273 psi; annular preventer leaking.</p> <p><b>4</b> Drill pipe pressure increases as annular preventer leaks; hydraulic closing pressure increased to seal annulus.</p> <p><b>5</b> Drill pipe pressure bled to zero for negative-pressure test.</p> <p><b>6</b> Decision made to conduct negative-pressure test via kill line; kill line opened; 3 bbls to 15 bbls bled to cement unit.</p> | <p><b>7</b> Shut in kill line at cement unit, drill pipe pressure starts to increase.</p> <p><b>8</b> Drill pipe pressure slowly increases to 1,400 psi.</p> <p><b>9</b> Fluid pumped into kill line to confirm full; kill line opened to mini trip tank for monitoring.</p> <p><b>10</b> Discussion ongoing about 'annular compression' and 'bladder effect' while monitoring kill line; drill pipe pressure static at 1,400 psi.</p> <p><b>11</b> Negative-pressure test concluded, declared a success; preparation made to continue displacement.</p> |

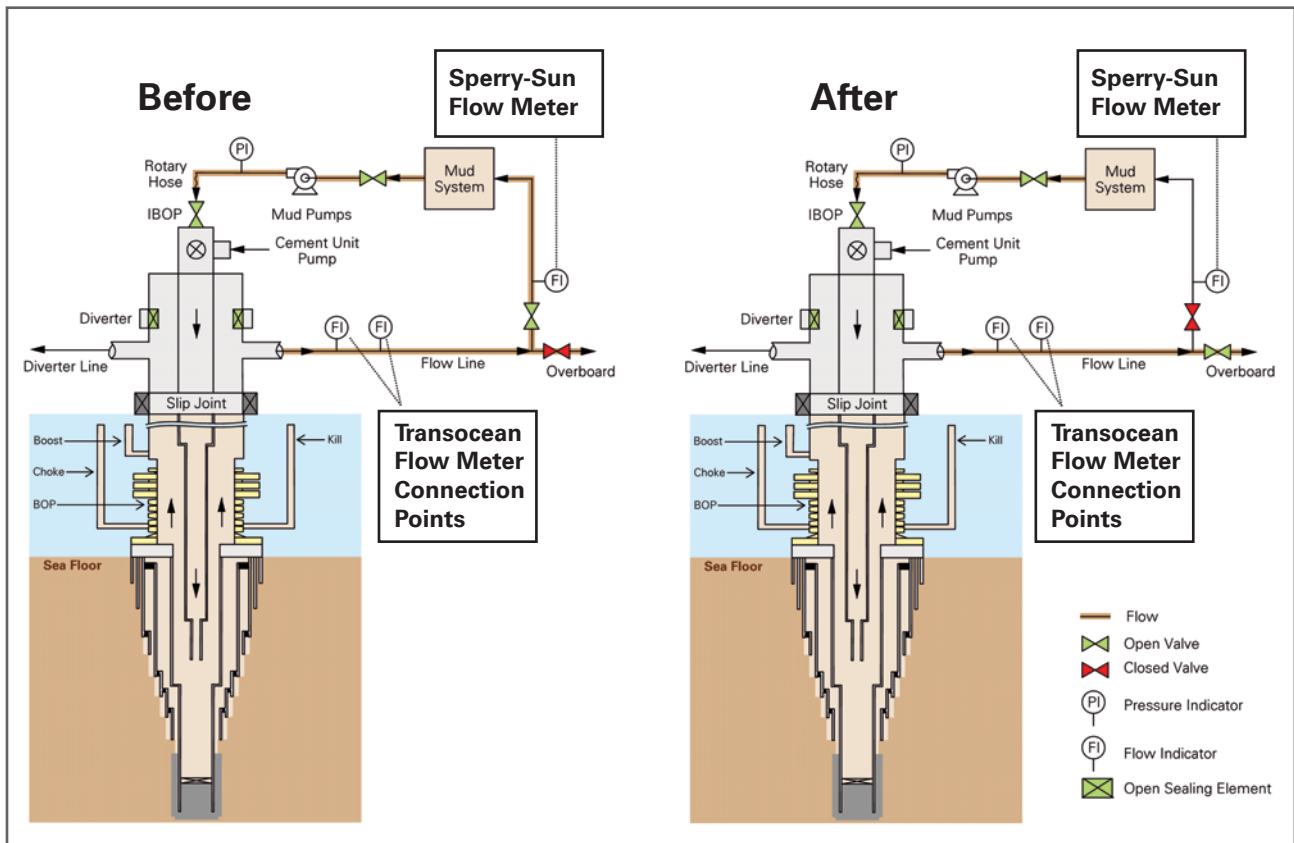
The driller should have been able to monitor flow from the well, even after routing the flow overboard. Even though the Sperry-Sun flow meter was not sensing flow after 21:10 hours, information available to the investigation team showed that separate Transocean flow sensors would have been available to the driller. (Refer to Table 1 and Figure 11.)

Figure 11. Flow Path Before and After Routing the Spacer Overboard.

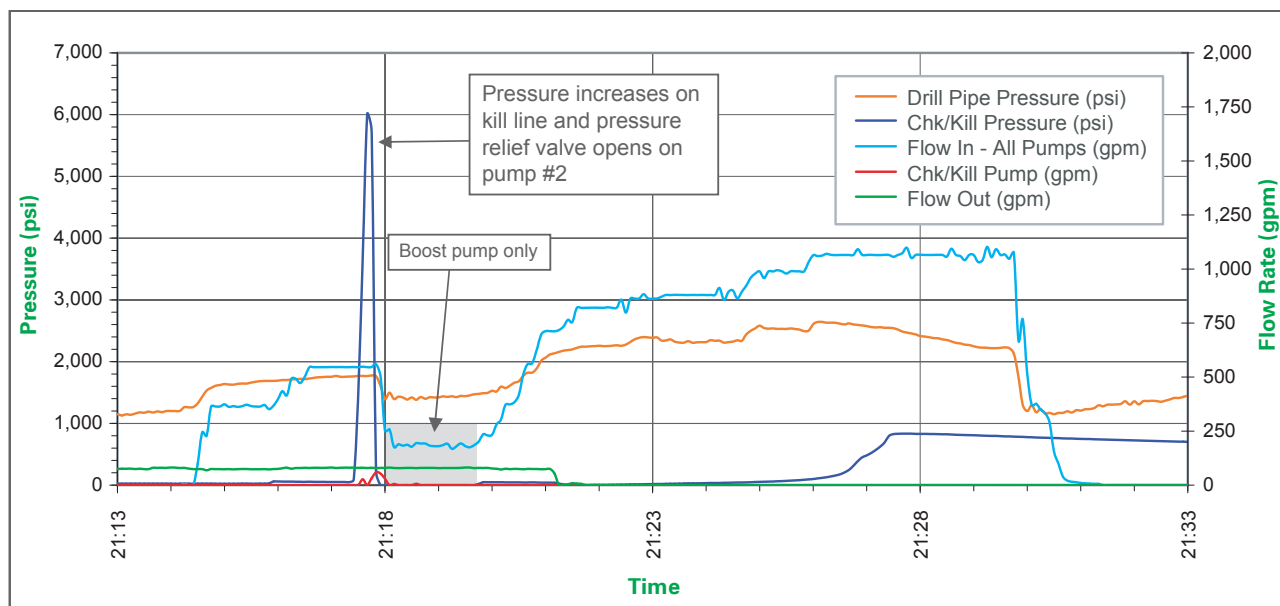
- An analysis of real-time data combined with MBI testimony suggested that the rig crew was trying to bring mud pump #2 online at 21:17 hours (32 minutes before the explosion). The pump was likely started against a closed valve, lifting the pressure relief valve (PRV). (Refer to Figure 13.)
- Mud pumps #2, #3 and #4 were all shut down, and pump #1 continued to pump into the boost line. Three minutes later, pumps #3 and #4 were put back online, and several personnel were investigating the problem with pump #2. This was another operation that potentially distracted the rig crew from monitoring the well.

Figure 13. Mud Pump #2 Pressure Increase at 21:17 Hours (Real-time Data).

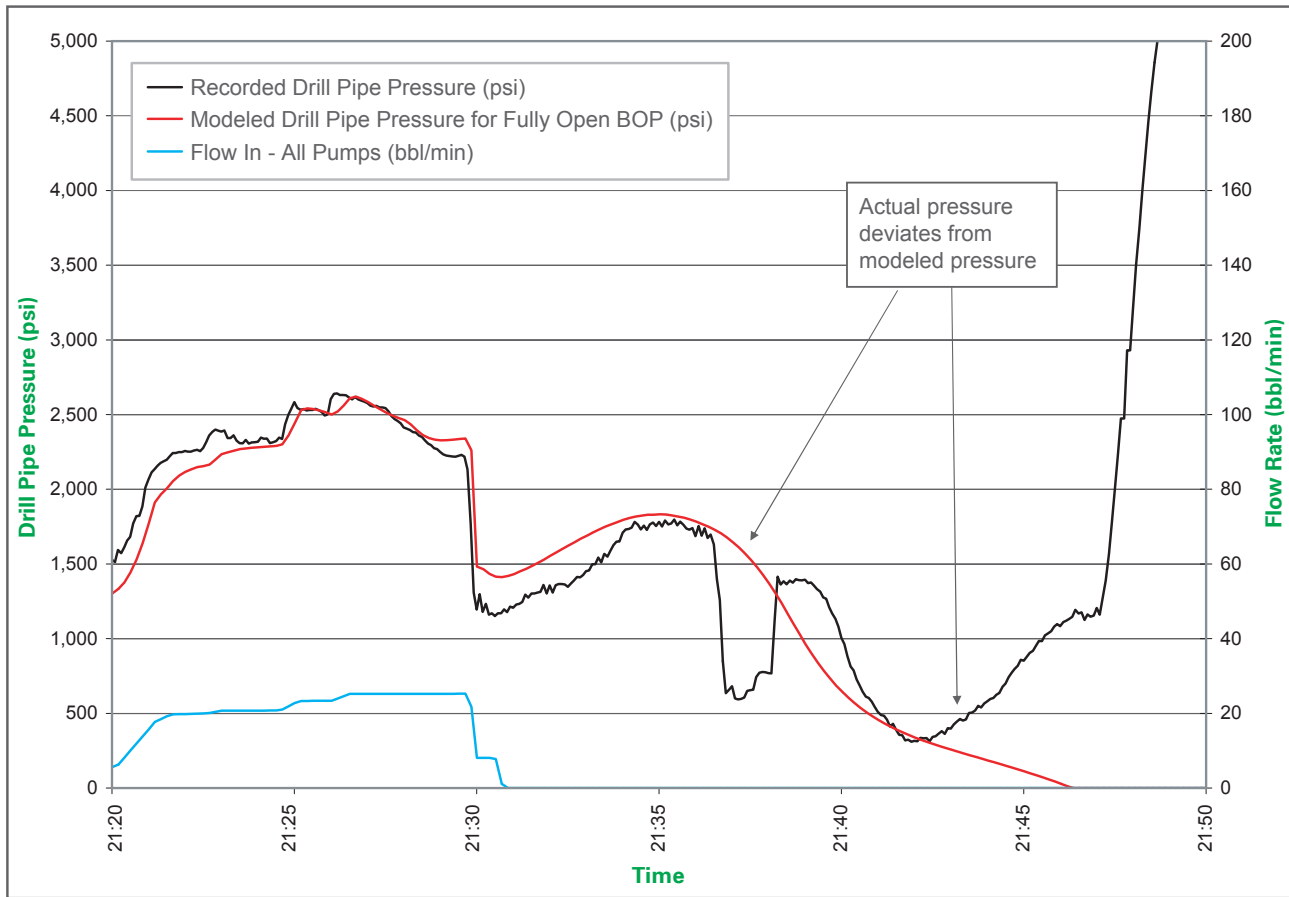
- As mentioned previously, at approximately 21:33 hours (approximately 21:30 hours per MBI testimony), the chief mate observed the toolpusher and the driller discussing 'differential pressure' on the well. This coincided with the real-time data showing the drill pipe pressure increasing at this time.
- The OLGA® well flow modeling predicted the pressure responses from 21:31 hours to 21:42 hours fairly accurately, with the exception of the sudden pressure changes shown in the real-time data from 21:36 hours to 21:38 hours. (Refer to Figure 14 for specific readings.)

**Figure 14.** OLGA® Well Flow Modeling for Flow Condition with an Open Annular Preventer.

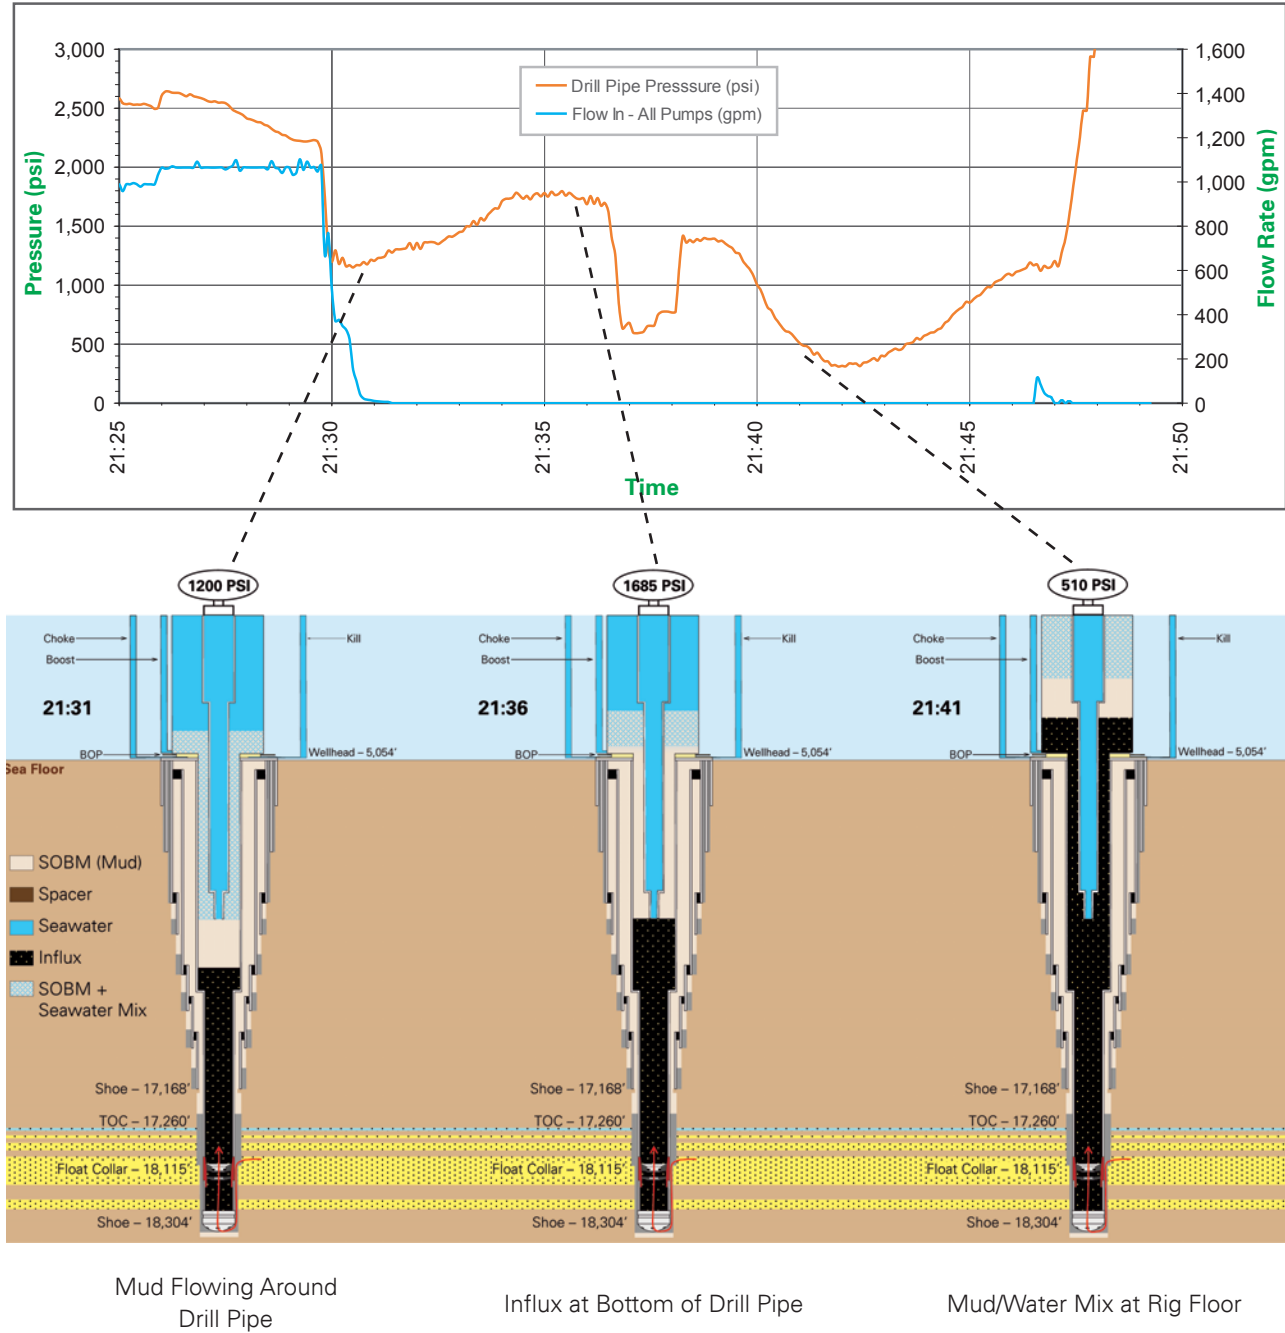
- The rig crew may have conducted this bleed-off when they were investigating the 'differential pressure.' This action would not be consistent with a rig crew responding to a recognized well control condition.
- Other than the sudden pressure changes between 21:36 hours and 21:38 hours (interpreted to be the bleed-off of the drill pipe pressure), the drill pipe pressure increased until 21:35 hours as 14.17 ppg mud rose above the stinger and then declined after that as hydrocarbons rose above the stinger.
- Modeling indicated that this fluctuation was consistent with the change in fluid densities (spacer, seawater, mud and hydrocarbons) moving through the various cross-sectional areas in the well. *Figure 16* illustrates the hydrostatic changes occurring in the well and the corresponding pressure responses.

**Figure 16.** Modeled Pressure Responses Resulting from Hydrostatic Changes in the Wellbore.

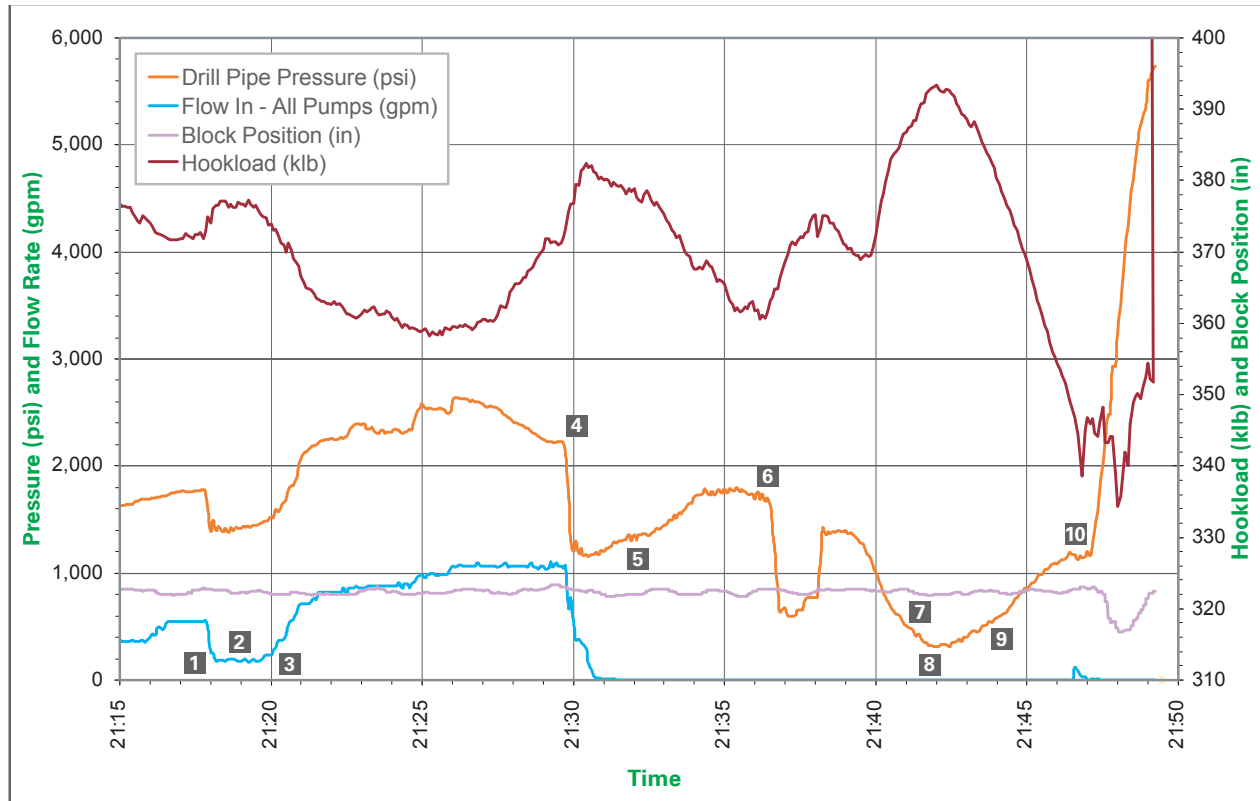
- Analysis shows that to create the pressure increase observed on the drill pipe from 21:42 hours to 21:47 hours, the annular preventer was over 99% closed (but not fully sealed) around the drill pipe. If the annular preventer was fully closed and sealed during this time period, the pressure increase would have been more immediate. (Refer to *Analysis 5D. The Blowout Preventer Did Not Seal the Well* of this section for a detailed explanation.)

- One of two possible actions would have caused the rapid pressure increase to 5,730 psi from 21:47 hours to 21:49 hours:
  - The rig crew possibly first closed an annular preventer and then closed a VBR in accordance with Transocean’s protocol for handling well control events.

- The rig crew possibly first closed an annular preventer and then increased its closing pressure to create a seal.

| <ul style="list-style-type: none"> <li><b>1</b> Pressure relief valve on pump #2 opens; toolpusher called to rig floor.</li> <li><b>2</b> All pumps shut down except boost pump.</li> <li><b>3</b> Assistant driller called to pump room.</li> <li><b>4</b> Pumps shut off.</li> <li><b>5</b> Toolpusher and driller discuss 'differential pressure.'</li> <li><b>6</b> Opening of 4" surface line to bleed pressure.</li> </ul> | <ul style="list-style-type: none"> <li><b>7</b> Mud/water flows onto rig floor and then unloads through the derrick.</li> <li><b>8</b> Diverter and annular preventer activated; diverted to mud gas separator.</li> <li><b>9</b> Well site leader and senior toolpusher receive calls from rig floor; annular preventer attempting to close.</li> <li><b>10</b> BOP sealing.</li> </ul> |

**Figure 17.** Interpretation of Well Control Response (Real-time Data).

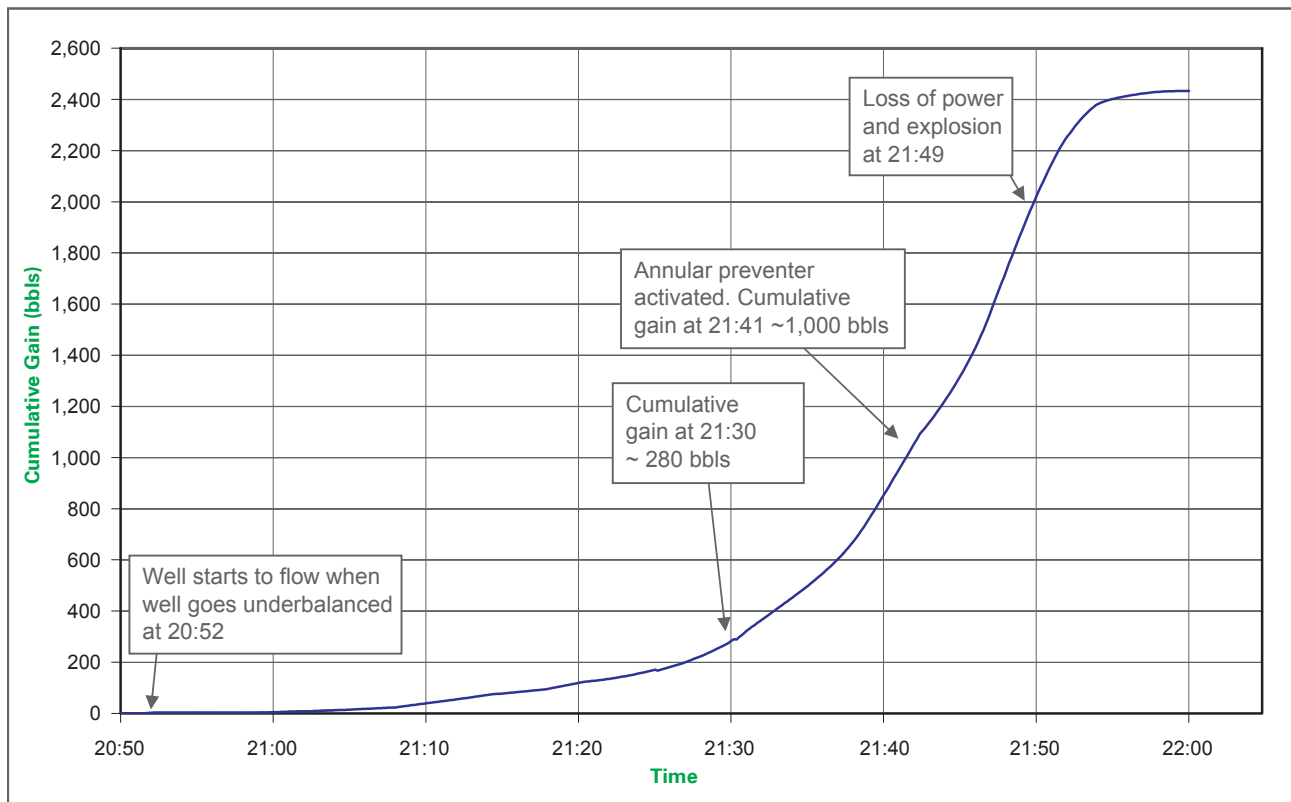
When the annular preventer was activated at approximately 21:41 hours, the model estimated the influx volume to be approximately 1,000 bbls. By the time the explosion occurred at approximately 21:49 hours, the model estimated the gain to be approximately 2,000 bbls. (Refer to Figure 18 for the cumulative gain over time.)

**Figure 18.** OLGA® Well Flow Modeling Prediction of Cumulative Gain Excluding Pumped Volumes 20:52 Hours–21:49 Hours.

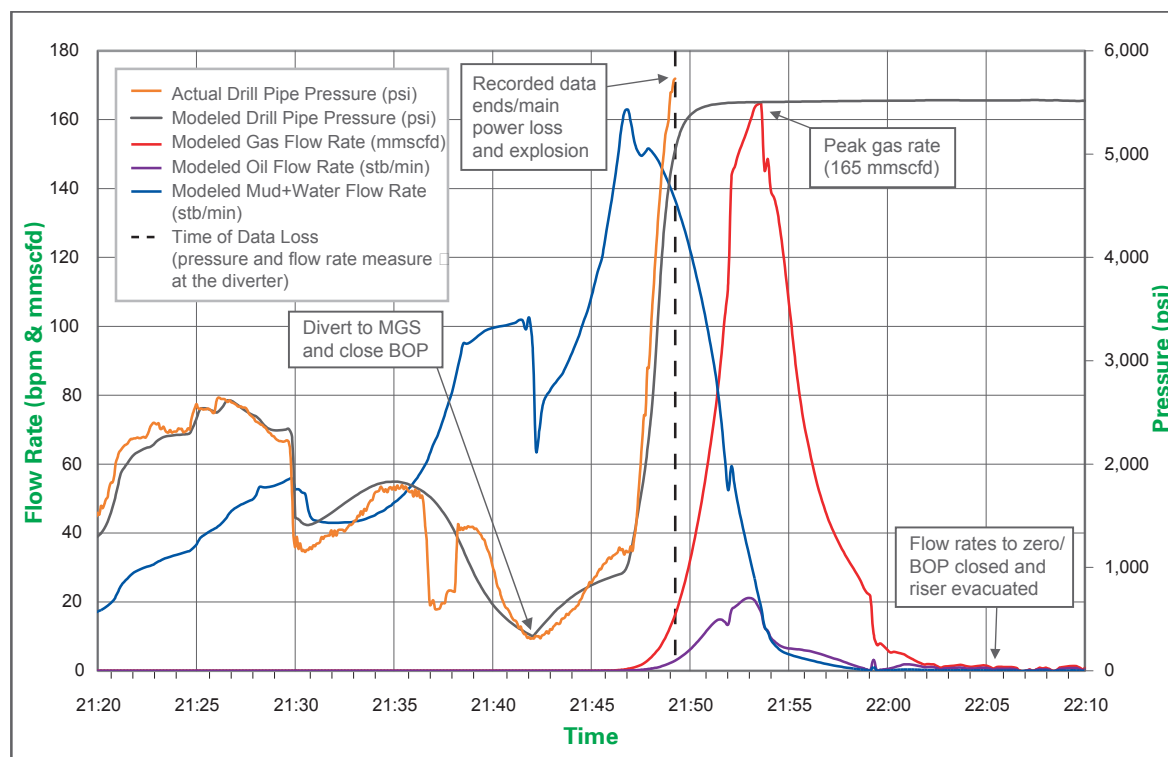
*Figure 1* shows the predicted flow rates of mud/water, gas and oil. At approximately 21:46 hours, the gas reached the surface, and over a 5-minute period the flow of gas increased to more than 140 mmscfd. Simultaneously, the flow of mud and water to the surface reduced from 140 bpm to 20 bpm. The modeled timeline of flow to the surface aligns with eyewitness accounts described in *Table 1*.

**Figure 1.** OLGA® Well Flow Modeling Prediction of Fluid Outflow from the Riser.

Based on the assumption that the BOP remained closed and sealed around the drill pipe, *Figure 1* shows that predicted flow tails off approaching 22:00 hours, though it is evident from the actual event that this did not occur. (Refer to *Appendix W. Report–Dynamic Simulations Deepwater Horizon Incident BP.*) The failure modes that may have allowed the flow to continue are described in *3.5 Sustaining the Flow Following the Closure of the BOP* of this analysis.

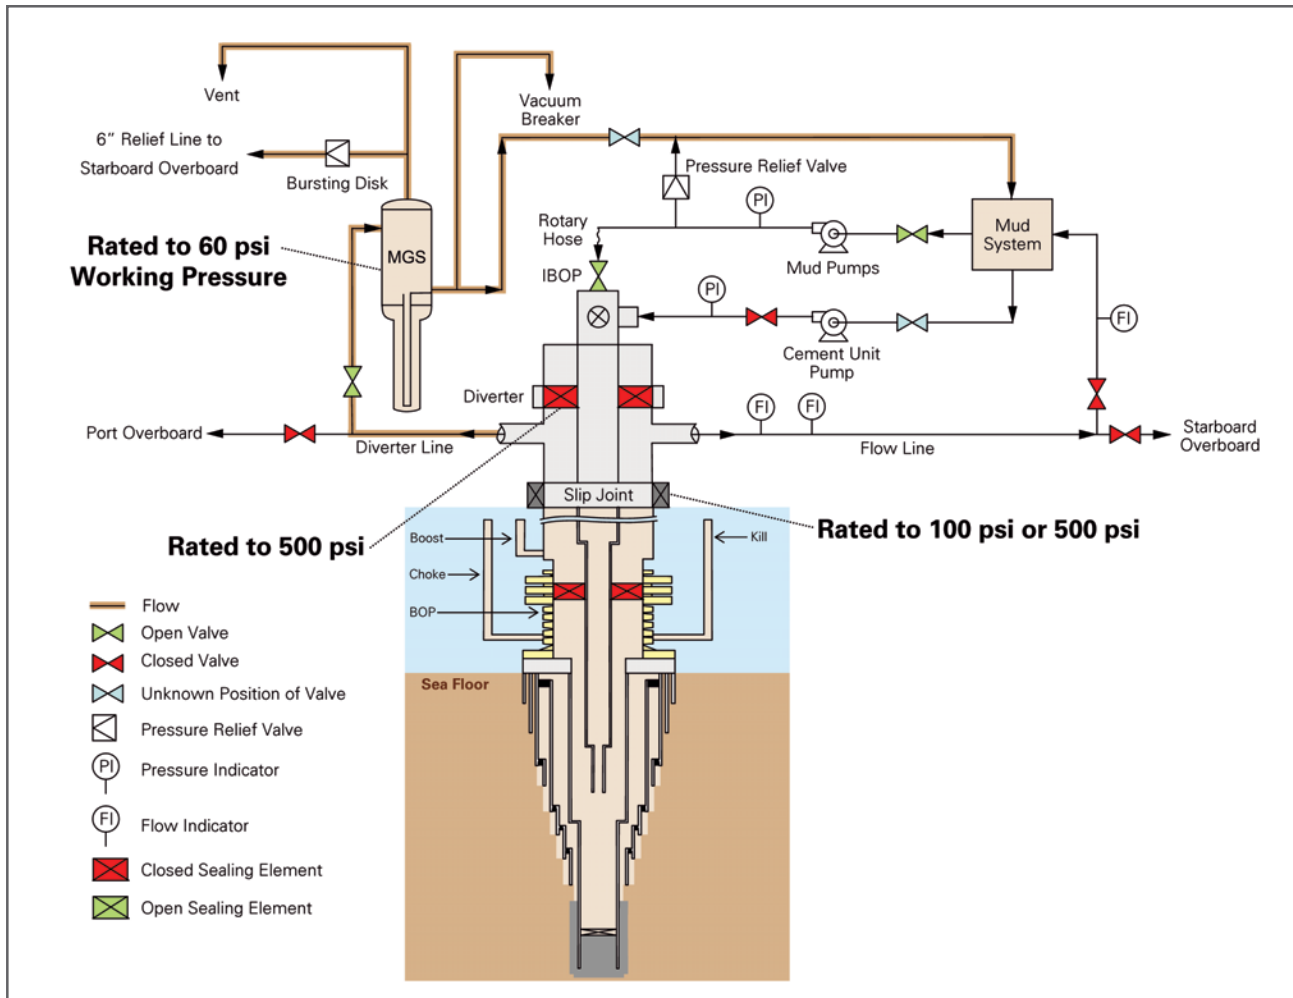
*Figure 2* is a simplified diagram of the equipment that was involved in the well control event following the selection of the MGS. (Refer to *Figure 2.*)

Witness accounts support the view that the diverter was activated and the flow diverted to the MGS at approximately 21:41 hours.

**Figure 2.** Simplified Process Flow Diagram of Selected *Deepwater Horizon* Surface Equipment.

Based on these modeled pressures, it appears that some of the surface equipment could have begun to fail and release hydrocarbons. (Refer to Figure 2.) The two most vulnerable pieces of equipment were the MGS vessel, which was rated for 60 psi; and, if selected in low-pressure mode, the riser slip joint seal, which was rated for 100 psi.
