# *Deepwater Horizon* Accident Investigation Report

September 8, 2010

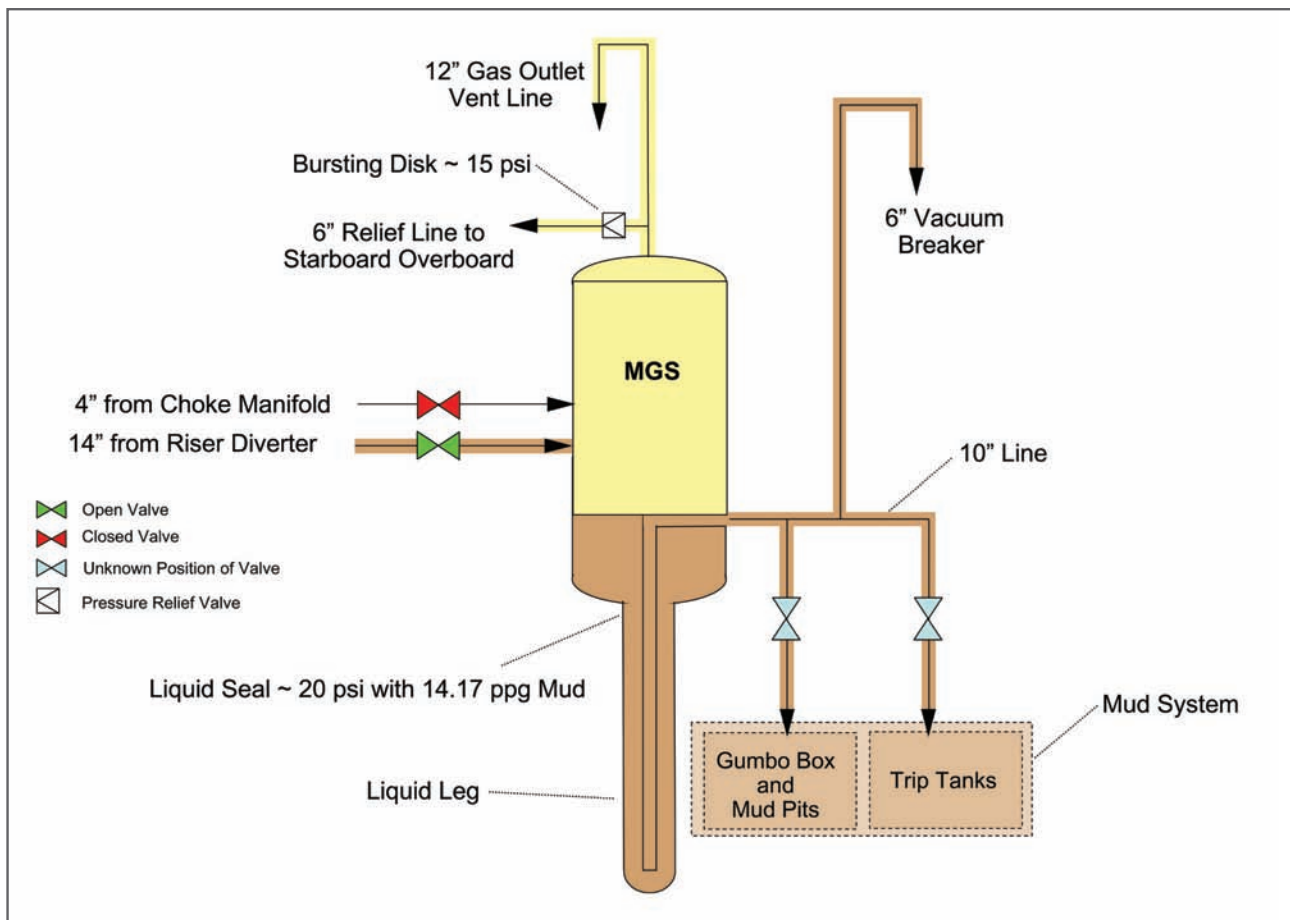
- 14 in. inlet line from the riser diverter.
- 4 in. inlet line from the choke manifold.
- 12 in. outlet vent line terminating at the top of the derrick.
- 10 in. liquid outlet that could be lined up to either the gumbo box or the trip tanks.
- 6 in. relief line flowing overboard to the starboard side.
- 6 in. vacuum breaker terminating approximately one-third of the way up the derrick.

**Figure 3.** Simplified Drawing of the MGS.

Because the 12 in. MGS outlet vent and the 6 in. vacuum breaker vent were goosenecked, they would have diverted flow back down toward the rig.

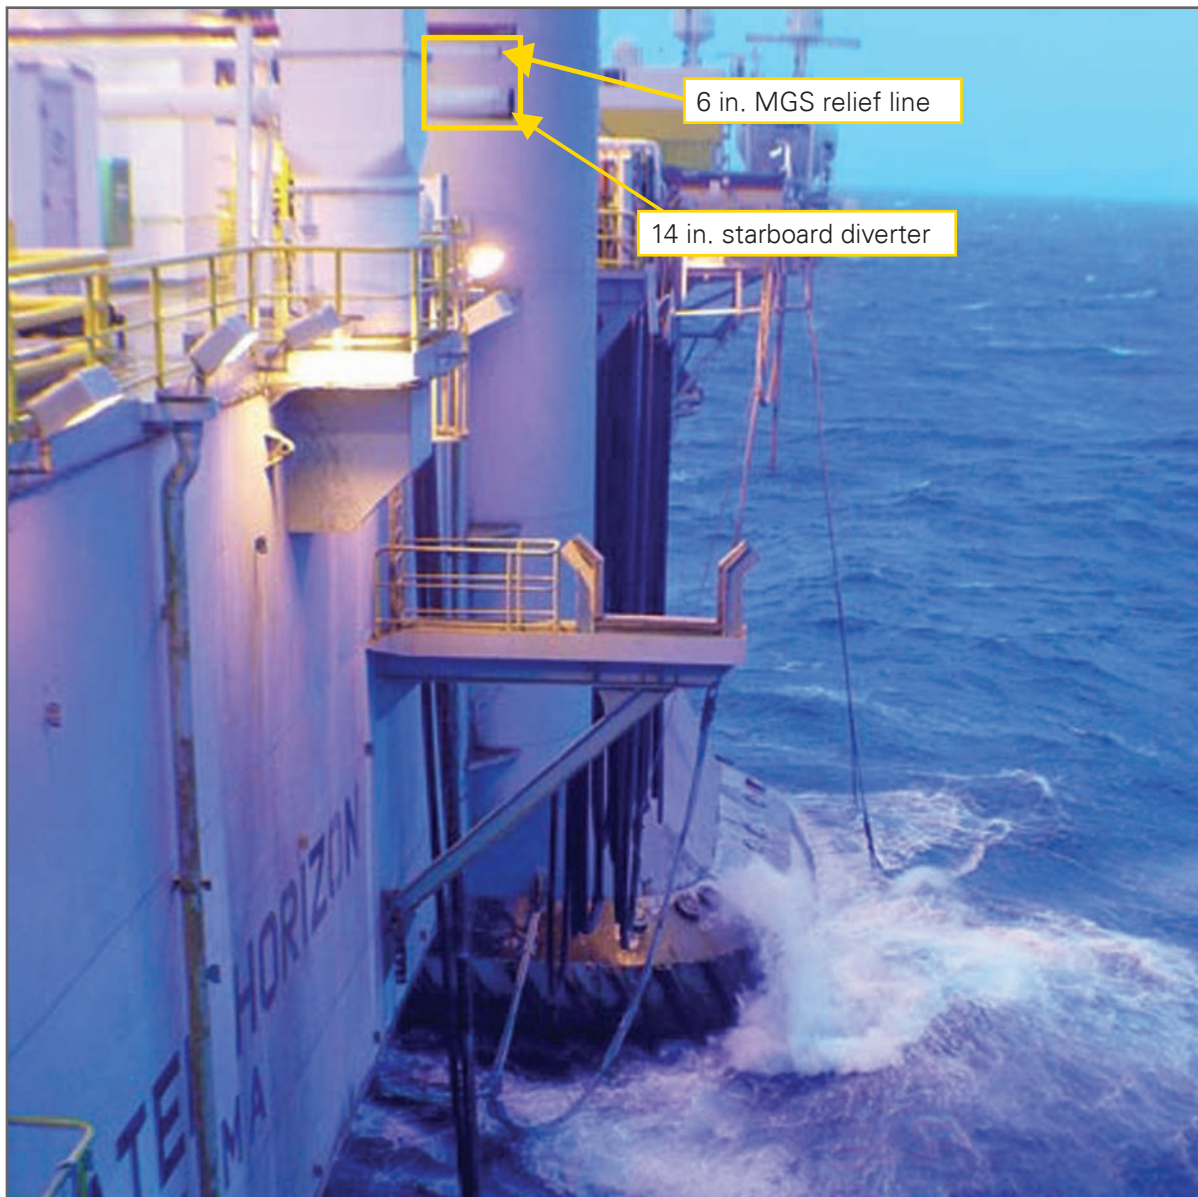
The photograph in *Figure 6* shows that the 6 in. MGS relief line was routed along the same path as the main 14 in. starboard diverter and terminated at the same location on the starboard side of the rig.

**Figure 6.** Photograph of Starboard Overboard Lines.

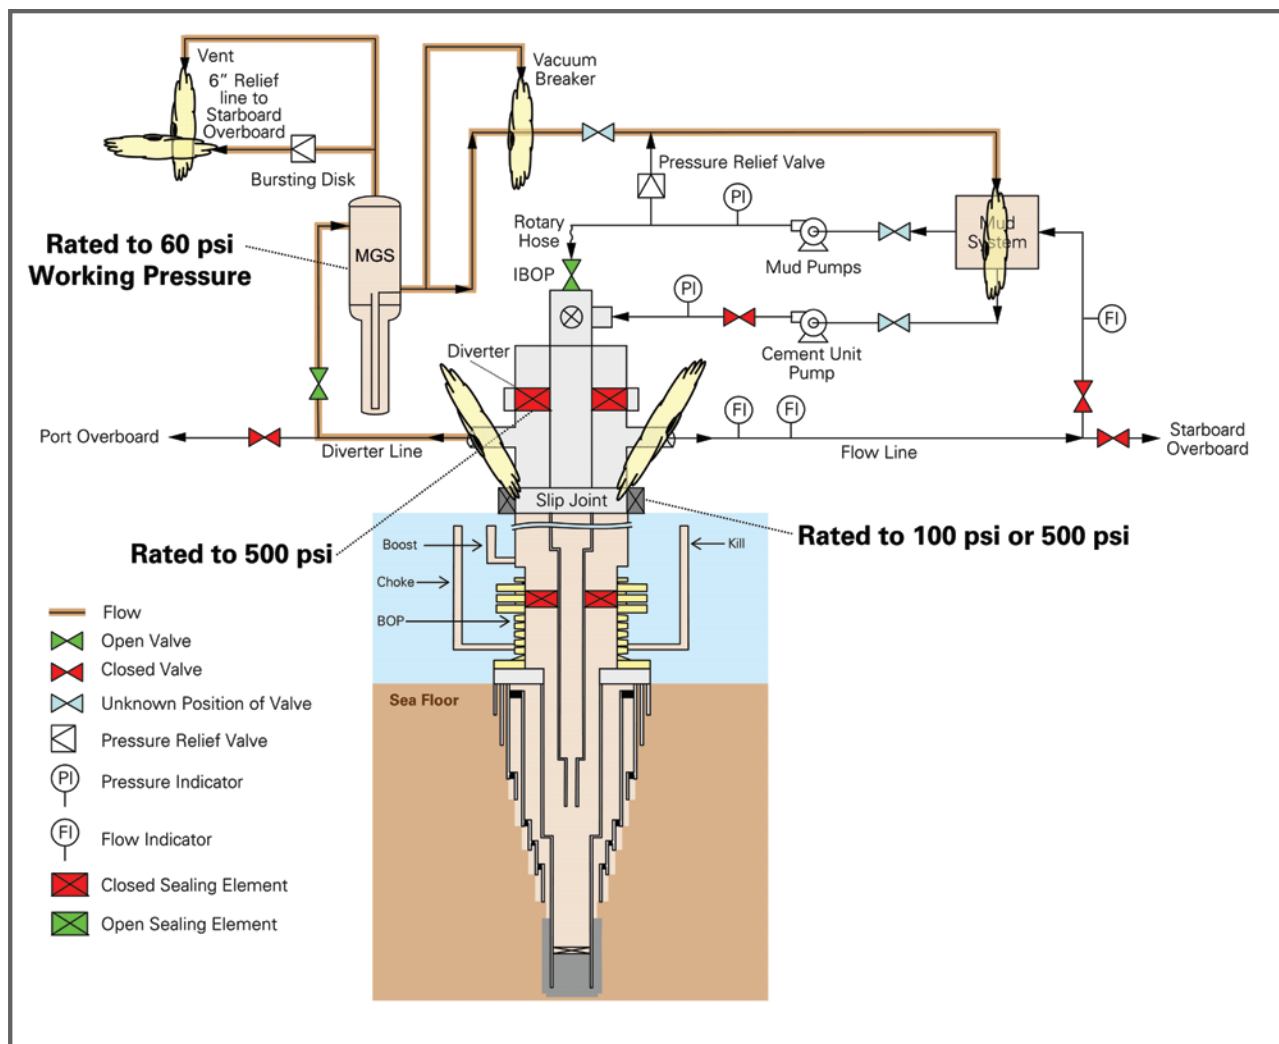
In addition to the MGS 12 in. vent, gas may also have vented onto the rig (Refer to Figure 8.) from the following places:

The case presented in this analysis assumes that the 12 in. MGS vent and the 10 in. MGS liquid outlet to the gumbo box, the riser slip joint seal, the MGS 6 in. bursting disk and the 6 in. MGS vacuum breaker vent were all open flow paths. *Figure 8* is a simplified illustration of these open flow paths.

Other scenarios, such as a closed MGS liquid outlet and no equipment failures (all fluid flowing out of the 12 in. MGS vent) or a catastrophic failure of the MGS vessel were possible, but the investigation team believes that these other scenarios would not substantially alter the net effect of the initial gas release.

**Figure 8.** Schematic of Postulated Hydrocarbon Release Locations.

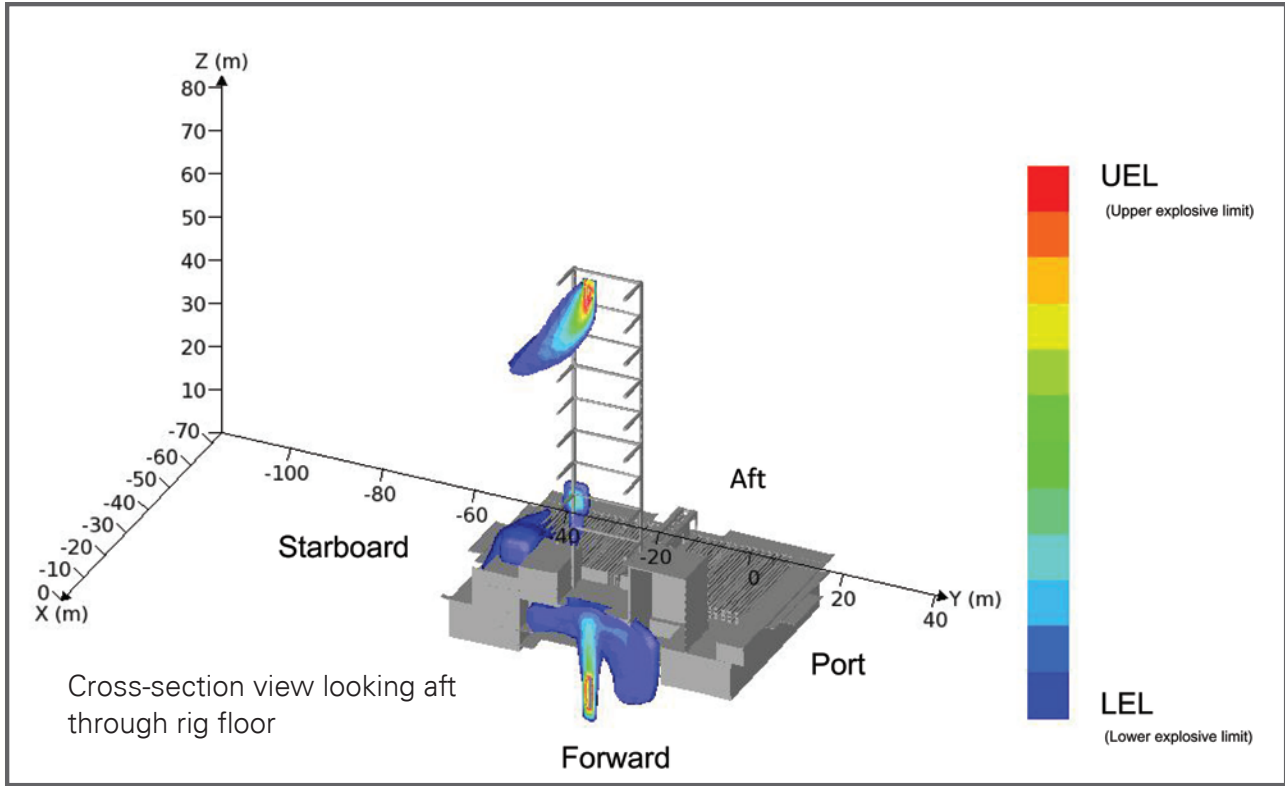
The graphics in *Figure 9* and *Figure 10* show the modeled outcomes of gas rapidly dispersing across the drilling rig. Gas could have also migrated into enclosed spaces under the deck through the mud system or through the HVAC supply fans for the engine rooms.

Figure 9. Vapor Dispersion at 100 Seconds.

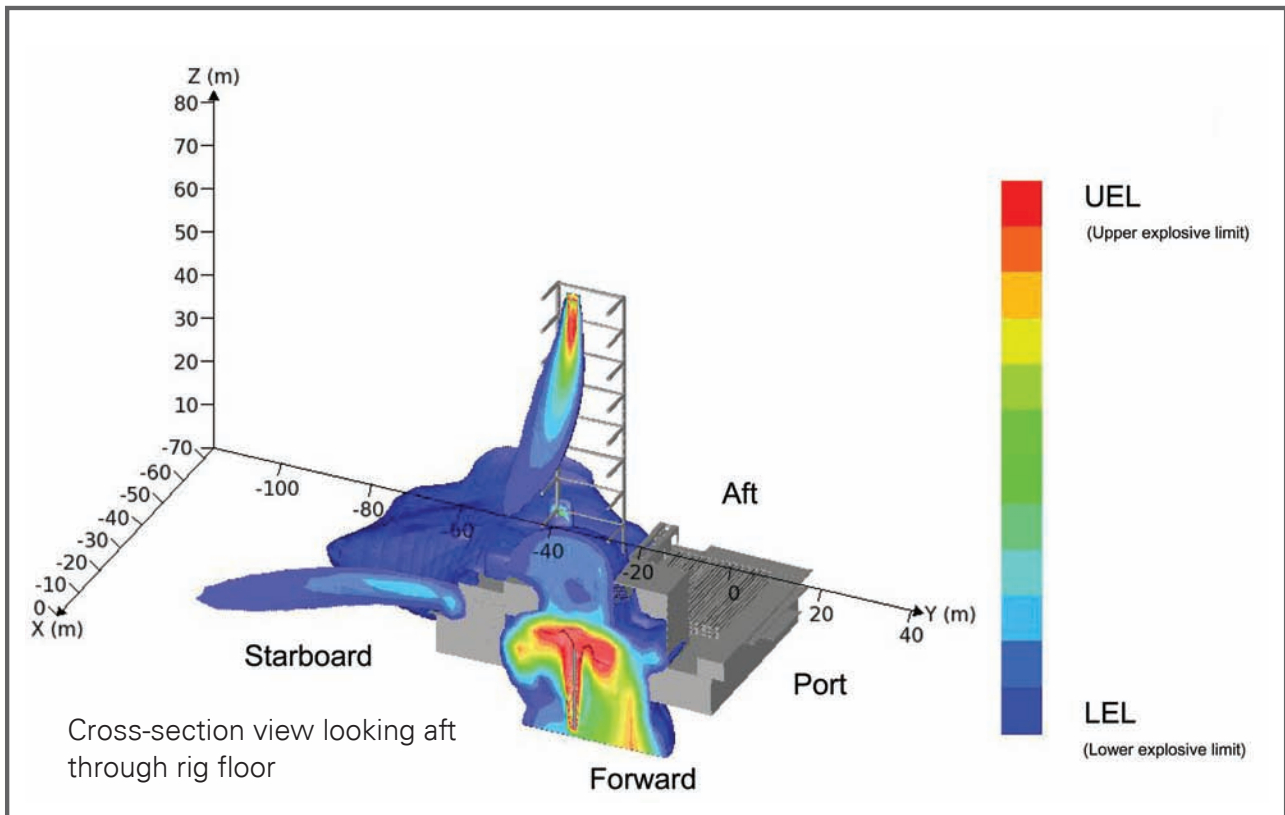
Figure 10. Vapor Dispersion at 240 Seconds.

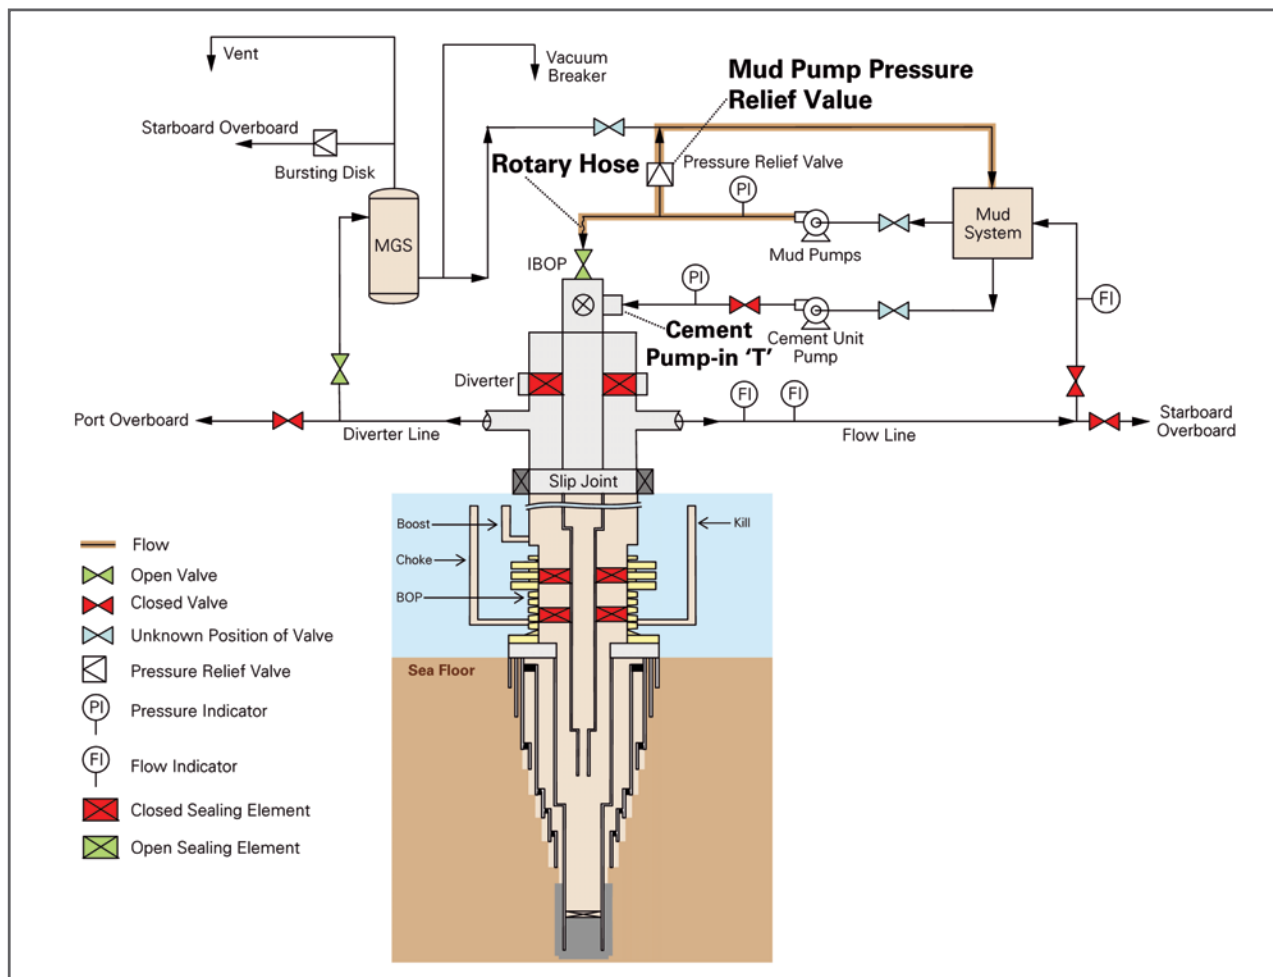
It was important to clarify the position of the internal blowout preventer (IBOP) valve, as this determines the number of potential flow paths to the surface if the BOP had closed and sealed. The simplified process flow diagram in *Figure 11* shows that there were two pressure indicators (PIs), each of which was recorded via the real-time data system. One PI measured drill pipe pressure from upstream of the IBOP, and one measured drill pipe pressure from downstream of the IBOP.

**Figure 11.** Relevant Surface Equipment Downstream of the IBOP at ~21:47.

With the IBOP open, there were a number of potential failure modes that may have created flow paths that sustained the fire following the initial hydrocarbon release from the riser (Refer to Figure 11):

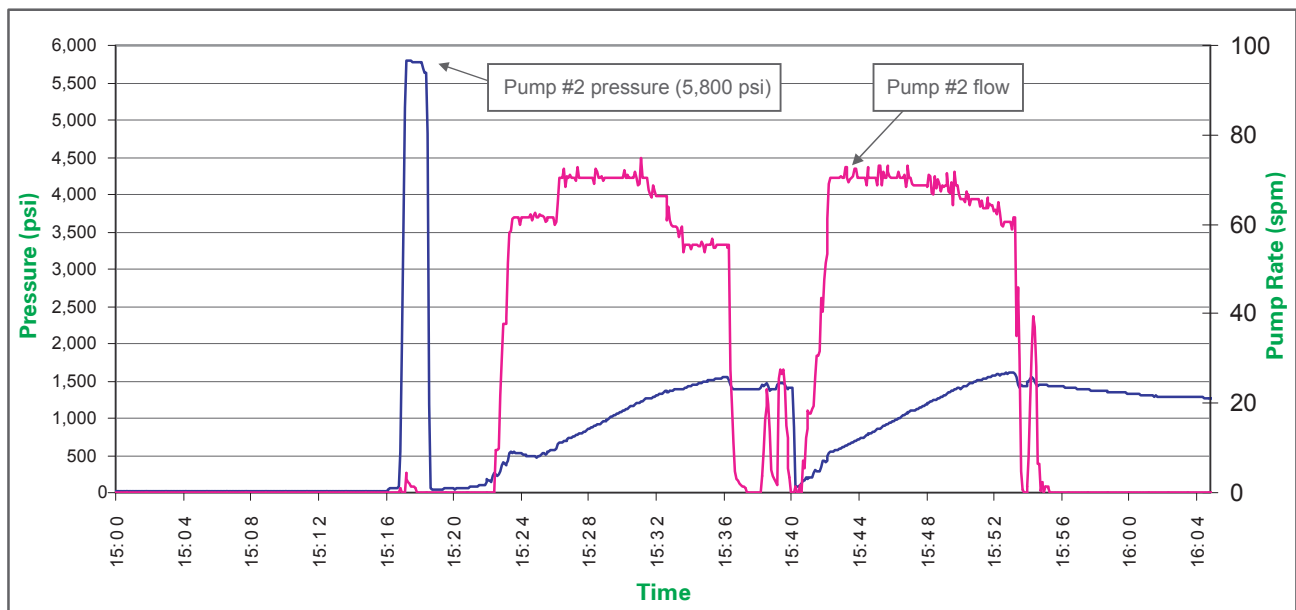
Regarding the last of these potential failure modes, analysis of the mud pump PRVs was conducted to determine their likely set pressure (the investigation team was unable to obtain this information directly from Transocean). The investigation team believes that the setpoint for the high-pressure mud pumps' PRVs was approximately 6,000 psi, based on the two reference points from the real-time data pressure readings shown in *Figure 13* and *Figure 14*. These figures show that:

- Mud pump #2 was tested to 5,800 psi during the negative-pressure test procedure at 15:17 hours.
- While trying to start mud pump #2 at 21:17 hours, the pressure increased to 6,000 psi.

**Figure 13.** Mud Pump #2 Pressure Plot Showing Line Test During Negative-pressure Test.

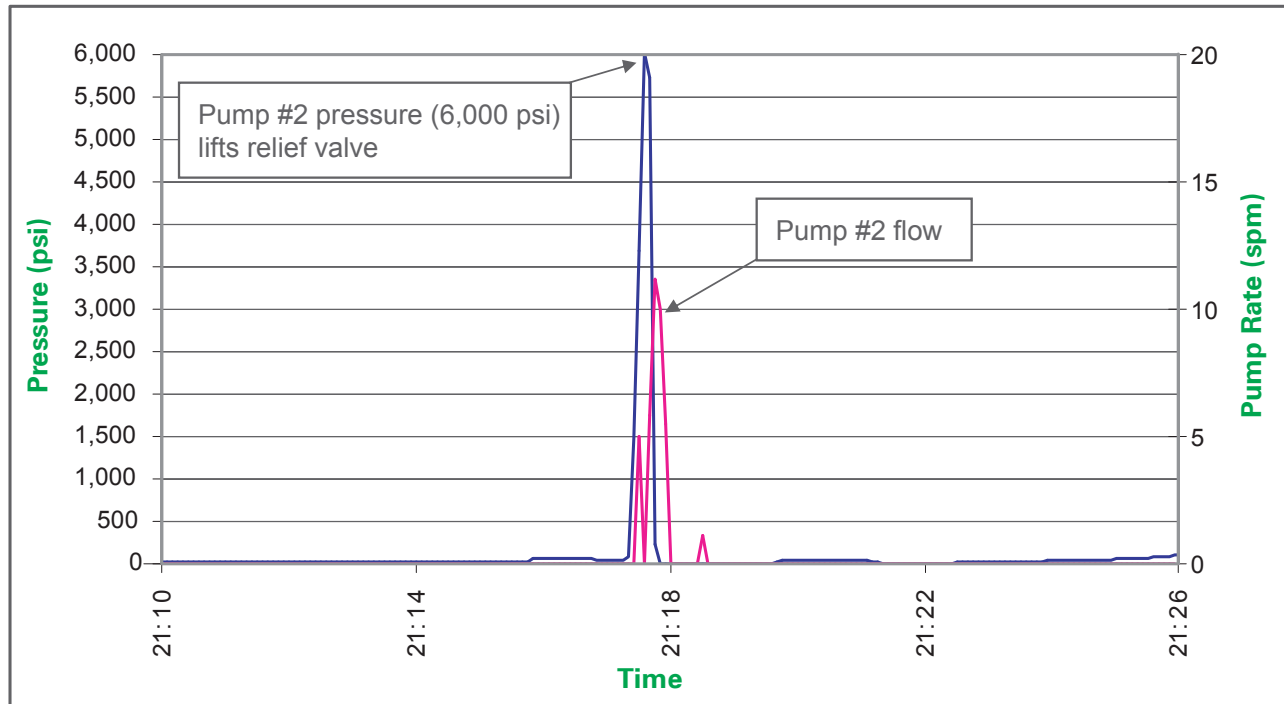
The investigation team believes that mud pump #2 was started against a closed discharge valve at 21:17 hours and the PRV lifted.

**Figure 14.** Mud Pump #2 Pressure Plot Showing Lift Pressure of PRV.

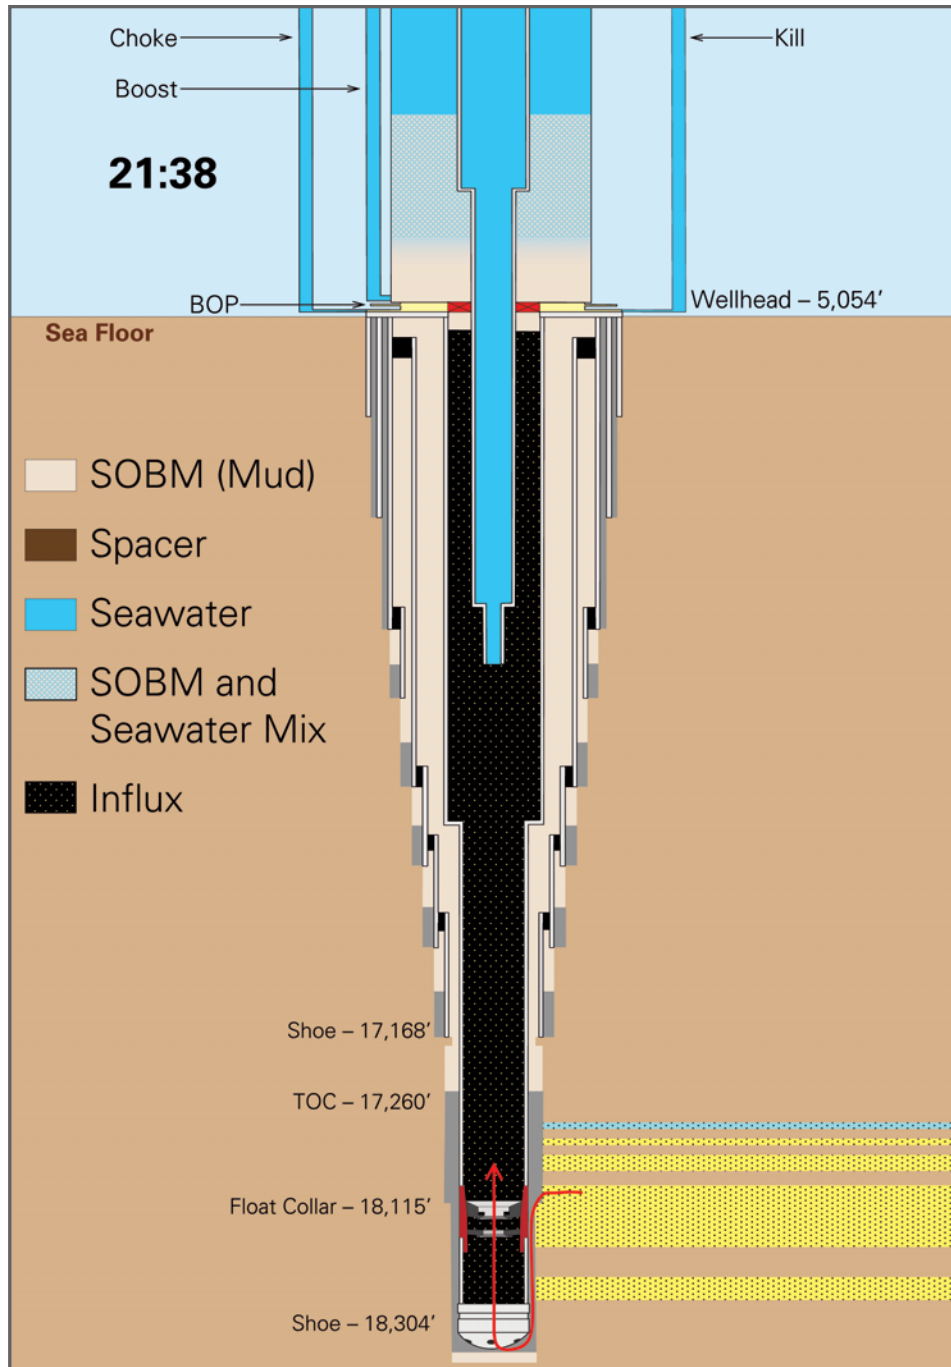
*Figure 15* shows a view of the different fluids across the wellbore at 21:38 hours, if the BOP was closed, and illustrates that hydrocarbons would probably have been located below the BOP at that time. In the figure, a sharp interface among different fluids is shown for simplicity of illustration. In reality, there would have been varying degrees of fluid mixing.

The simulations have been proven to be quite sensitive to the net pay assumption. Therefore, the time of 21:38 hours, when hydrocarbons were assumed to be just below the BOP, could be off by 1 or 2 minutes.

**Figure 15.** Illustration of Wellbore and Position of Hydrocarbons at 21:38 Hours if BOP Was Closed.

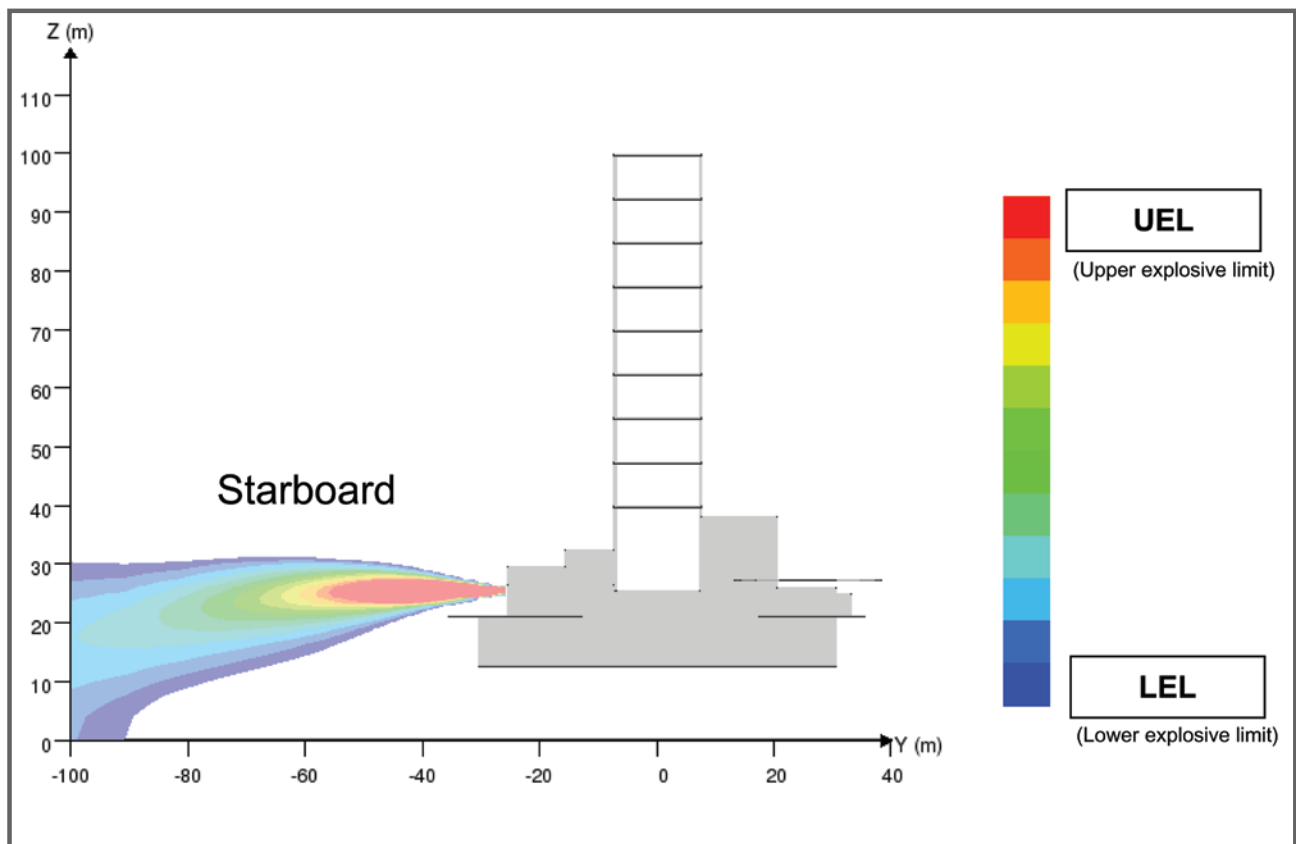
Figure 16. Vapor Dispersion Case for Diverting to the Starboard Diverter.

The investigation team has also concluded that if the well had been lined up to the starboard diverter rather than the MGS, the majority of the gas would have been diverted safely overboard. The pressure increase during the blowout may still have caused a failure of the riser slip joint seals, which would have allowed gas onto the rig floor through the moon pool. However, the majority of the gas would probably have vented through the starboard diverter, reducing the likelihood of hydrocarbons reaching an ignition source and may have reduced the consequences of the event.

Figure 16 shows the likely vapor dispersion pattern based on the orientation of the rig and the prevailing wind conditions on the evening of the accident.

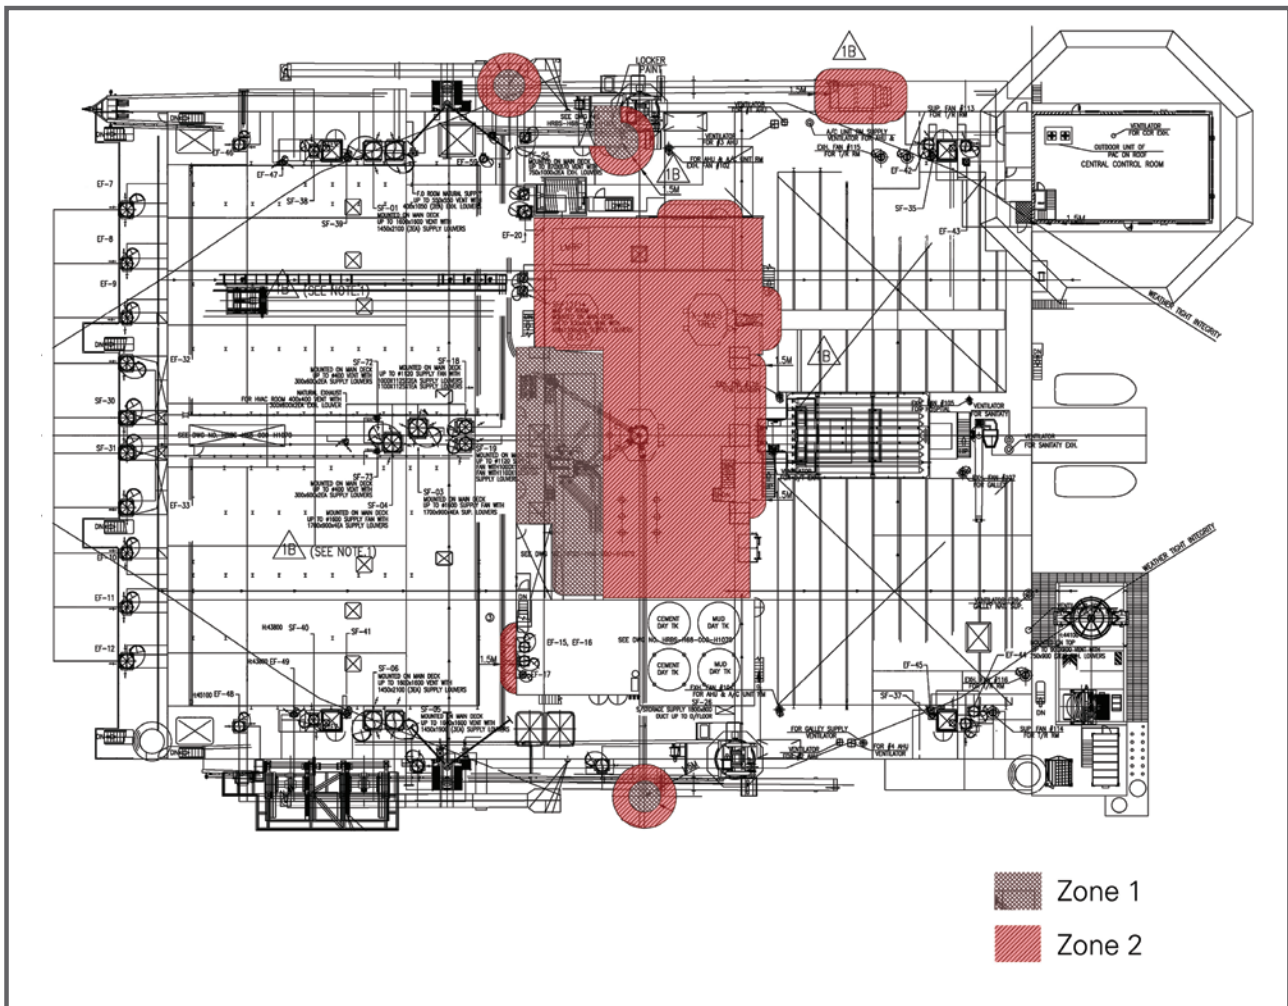
**Figure 17.** Hazardous Area Classification—Main Deck.

The extent of electrically classified areas on *Deepwater Horizon* appeared to be consistent with normal industry practices; however, for gas release events beyond the drill floor, multiple ignition sources could have existed. (Refer to Figure 17.)

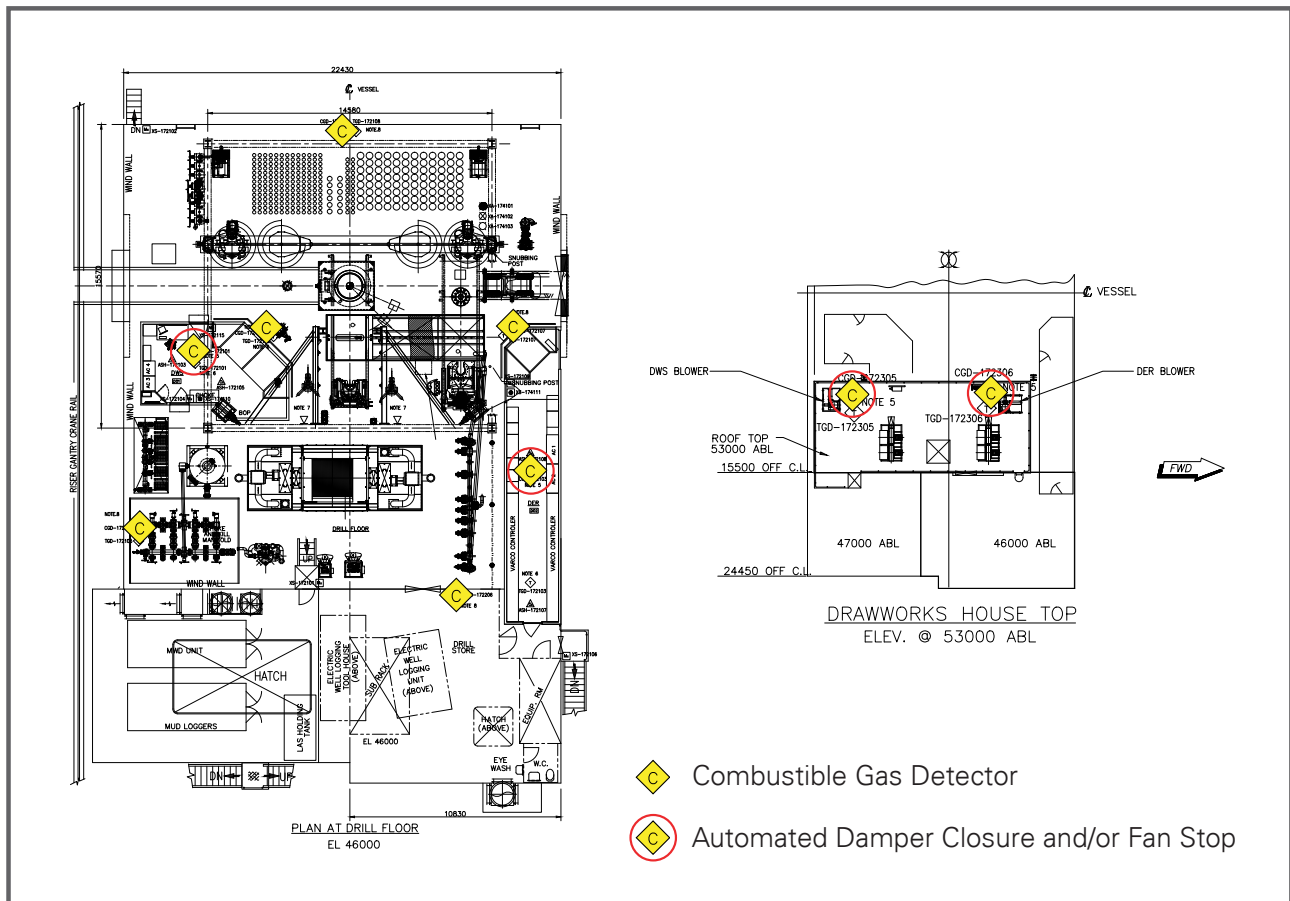
**Figure 18.** CGD Locations—Drill Floor and Above.

The design of the gas detection system was apparently based on a single CGD at each location. Such a system lacks the redundancy levels associated with a high-reliability design. If a single CGD did not work, was inhibited or was out of commission, the protective functions provided by that device would have been lost. Preliminary analysis of available maintenance records and a recent third party condition assessment indicated that gas detectors were adequately tested and maintained.

The physical locations of the CGDs are shown in *Figure 18* (drill floor and above), *Figure 19* (second deck) and *Figure 20* (main deck). These figures show the 13 CGDs that had automated actions and the 14 CGDs that did not.

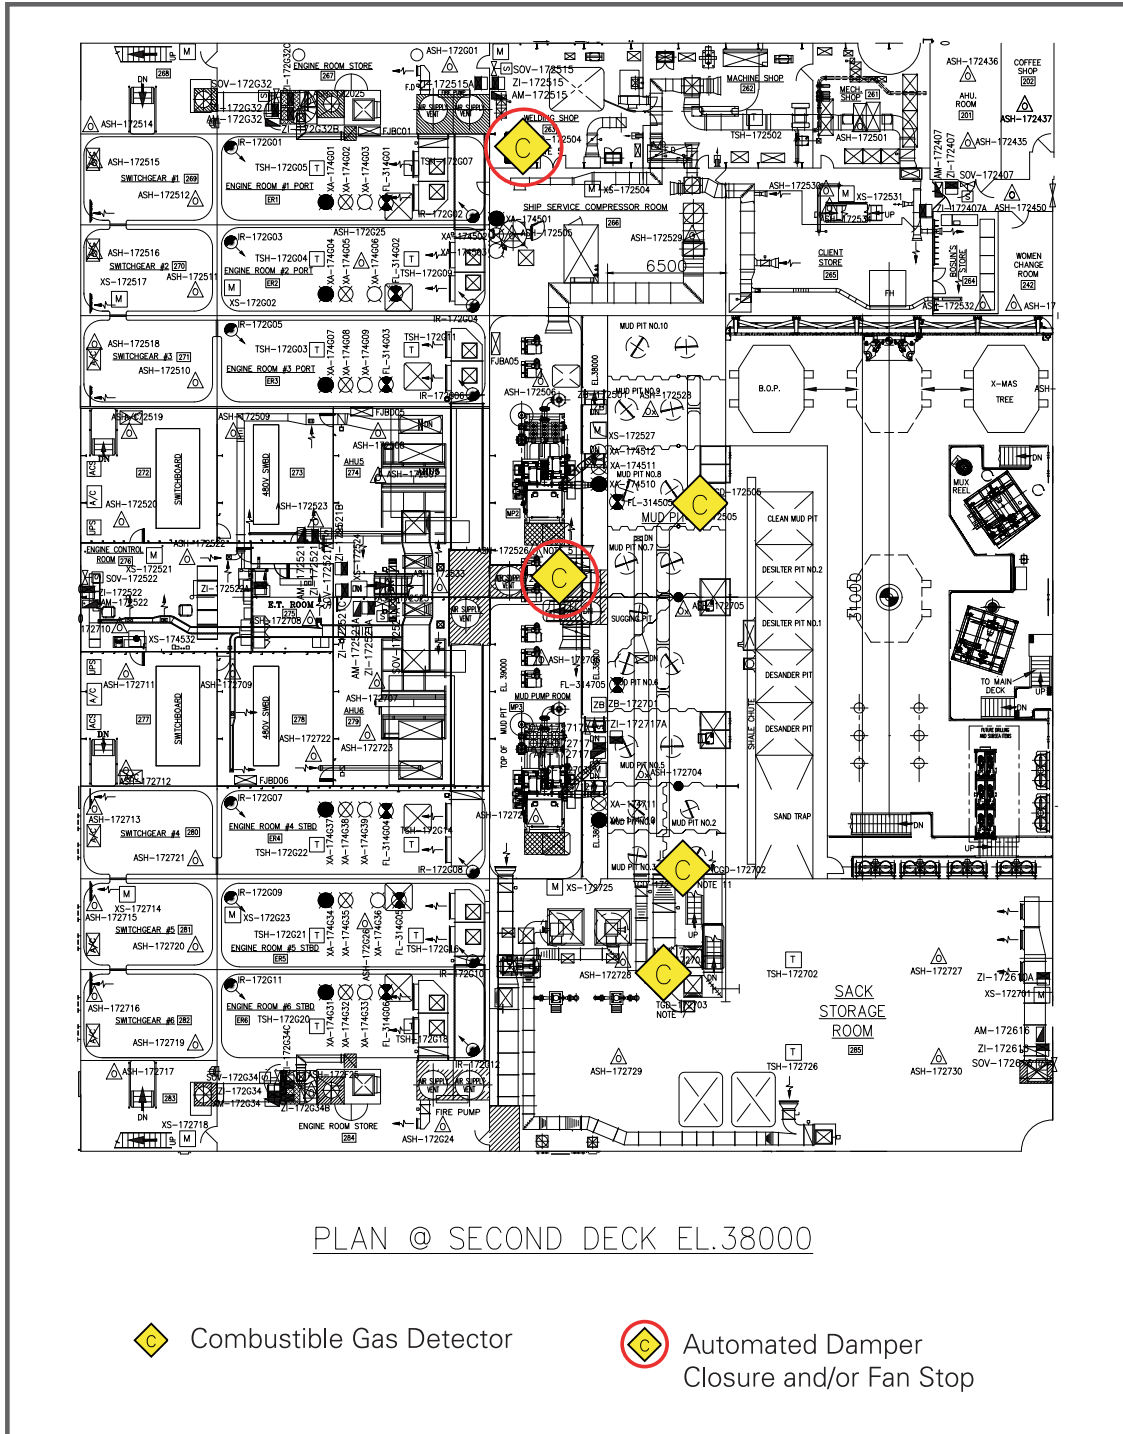
Figure 19. CGD Locations—Second Deck.

The mud pump rooms on the second and third decks were supplied with air from the main deck by two fans located under the aft catwalk. (Refer to Figure 21.) Exhaust was provided by two fans that were also located on the aft deck. (Refer to Figure 21.) According to the C/E matrix in the *MOM*, automated actions should have closed the fire dampers and shut down the ventilation fans to the mud pump rooms upon high-level gas detection. The relevant CGDs were located near the ventilation fan intake on the main deck and in the mud pump room. (Refer to Figure 20 and Figure 19.)

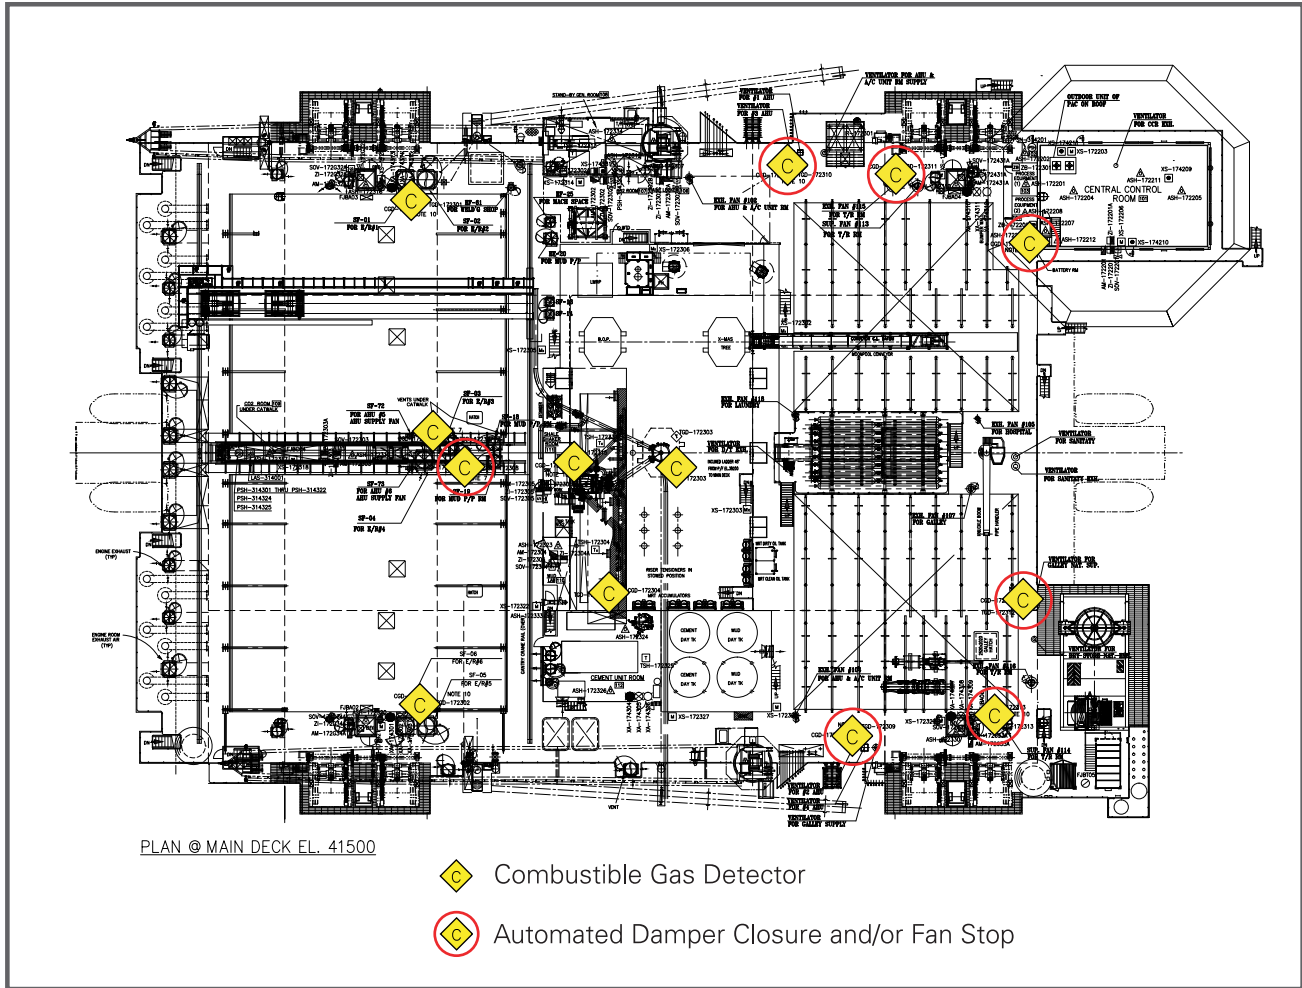
**Figure 20.** CGD Locations—Main Deck.

CGDs were located near the supply intakes for all the engine rooms, but these CGDs did not have associated automated actions to prevent gas ingress to the engine rooms. Therefore, the investigation team concluded that the HVAC system may have transferred gas into the engine room enclosures.

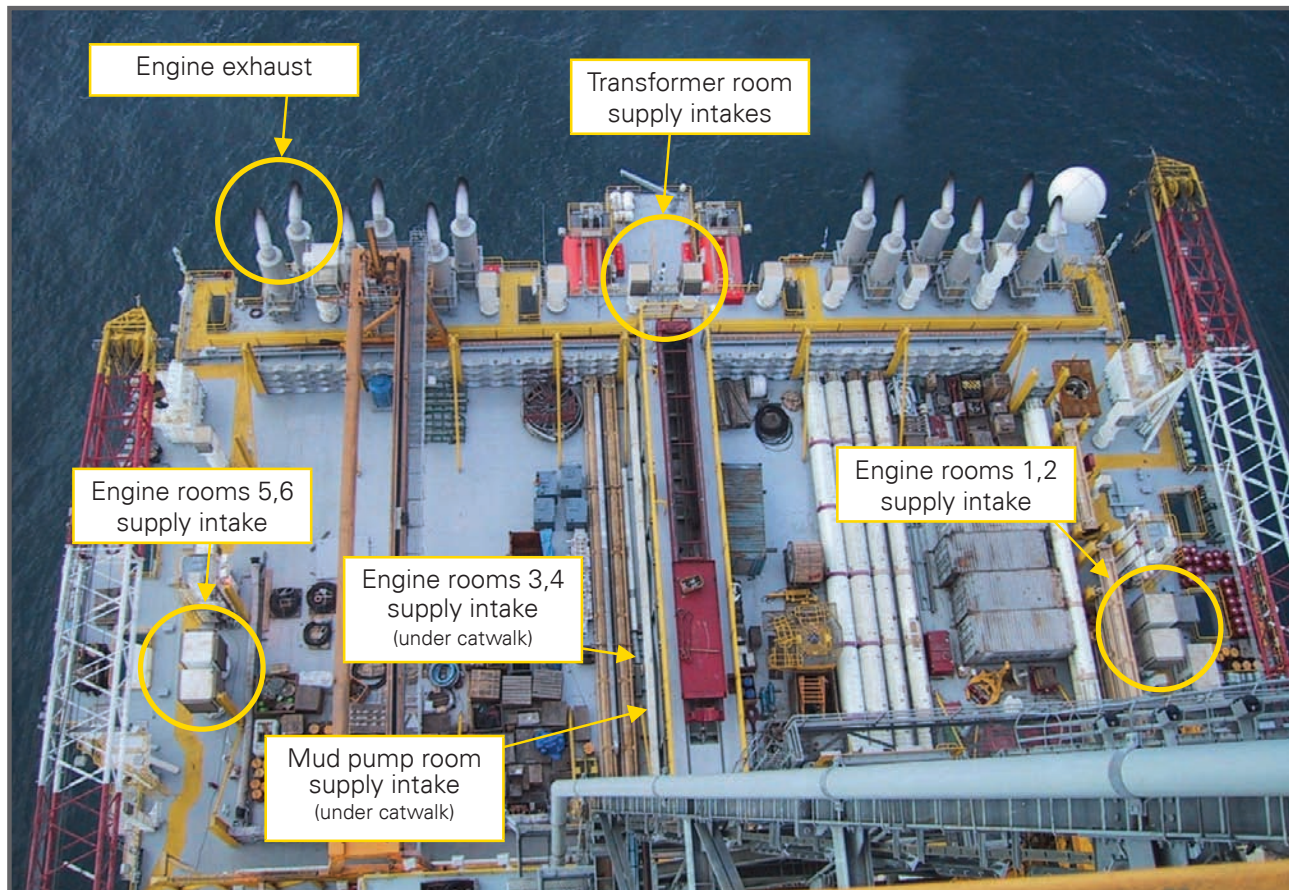
**Figure 21.** Photograph of Aft Deck of *Deepwater Horizon*.

Most air supply and exhaust vents were located on the main deck of *Deepwater Horizon*. Figure 21 shows a layout of key air supply and exhaust vents on the aft main deck and includes intakes to the engine rooms, mud pump room, aft transformer rooms and typical engine combustion exhaust stacks. The heights of the supply intake units above the main deck were approximately 14 ft. for engine room intakes #1, #2, #5 and #6. The heights above the main deck of the engine room intakes for engine rooms #3 and #4 were approximately 9 ft., presumably to fit under the aft catwalk. The radial distance from the center of the rotary table to engine room intake #3 was approximately 70 ft.

According to the *MOM*, each of the engine rooms had a single supply fan and a single exhaust fan. Air supply was drawn from the aft main deck, as shown in Figure 21. The *MOM* also states that the supply fans provided combustion air to the main generators and cooling air to the engine rooms. Backdraft and solenoid-controlled fire dampers were provided on the engine room air intakes, and solenoid-controlled fire dampers were provided for the engine room exhaust vents. Supply and exhaust fans were controlled and monitored by the integrated automation and control system.

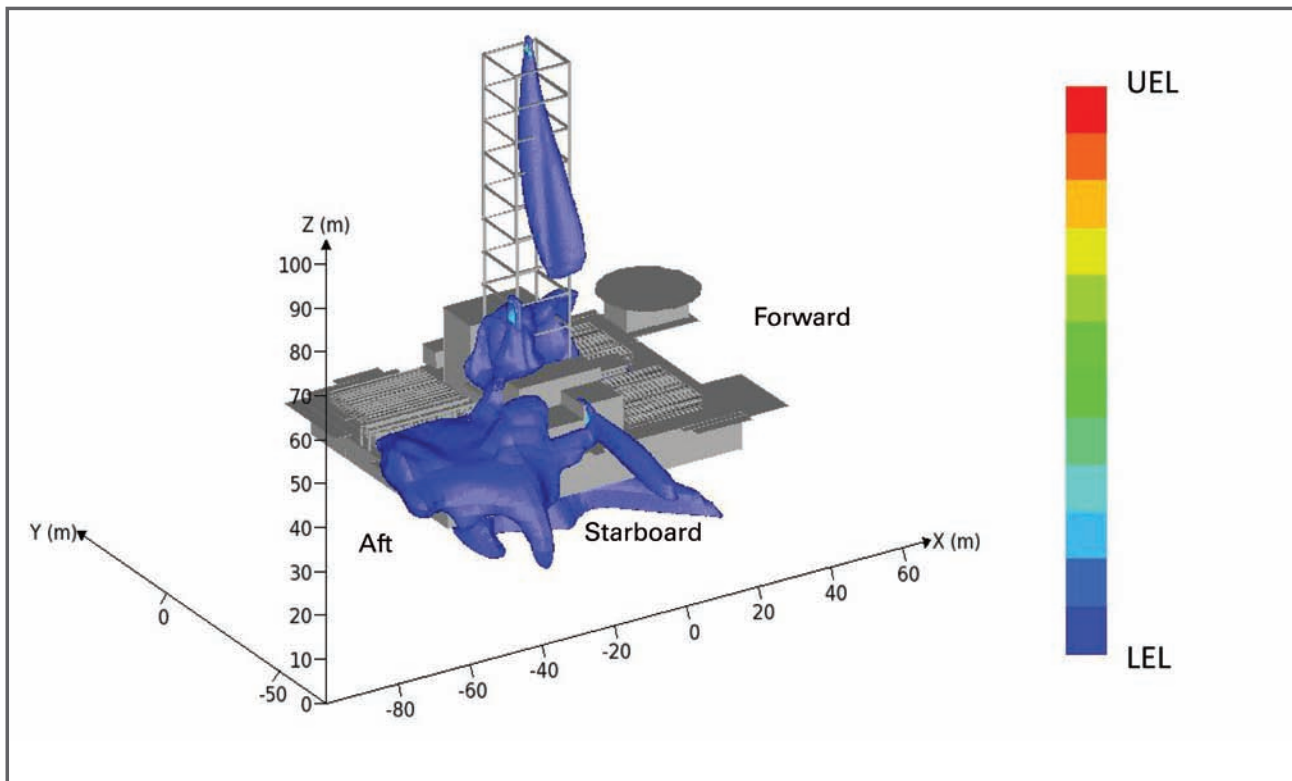
**Figure 22.** Vapor Dispersion Aft Deck—190 Seconds.

Although the F&G system visual and audible alarms were automatically triggered upon gas detection, there were no automated actions to close the fire dampers or shut down the engine room ventilation fans. *Figure 22* shows the modeled vapor dispersion cloud across the aft main deck 190 seconds after gas reached the surface. Gas would probably have reached the engine room HVAC fans and been transferred into the enclosures for engine rooms #3, #4, #5 and #6.

A review of personnel injury locations (including fatalities) and facility damage accounts suggested that one likely epicenter of the explosion was in the starboard aft quadrant; this corresponded to the area of the rig containing engine rooms #3 and #6 (the running engines) and the mud pump rooms. The initial vapor release probably reached the HVAC intakes in this area. (Refer to Figure 22.)

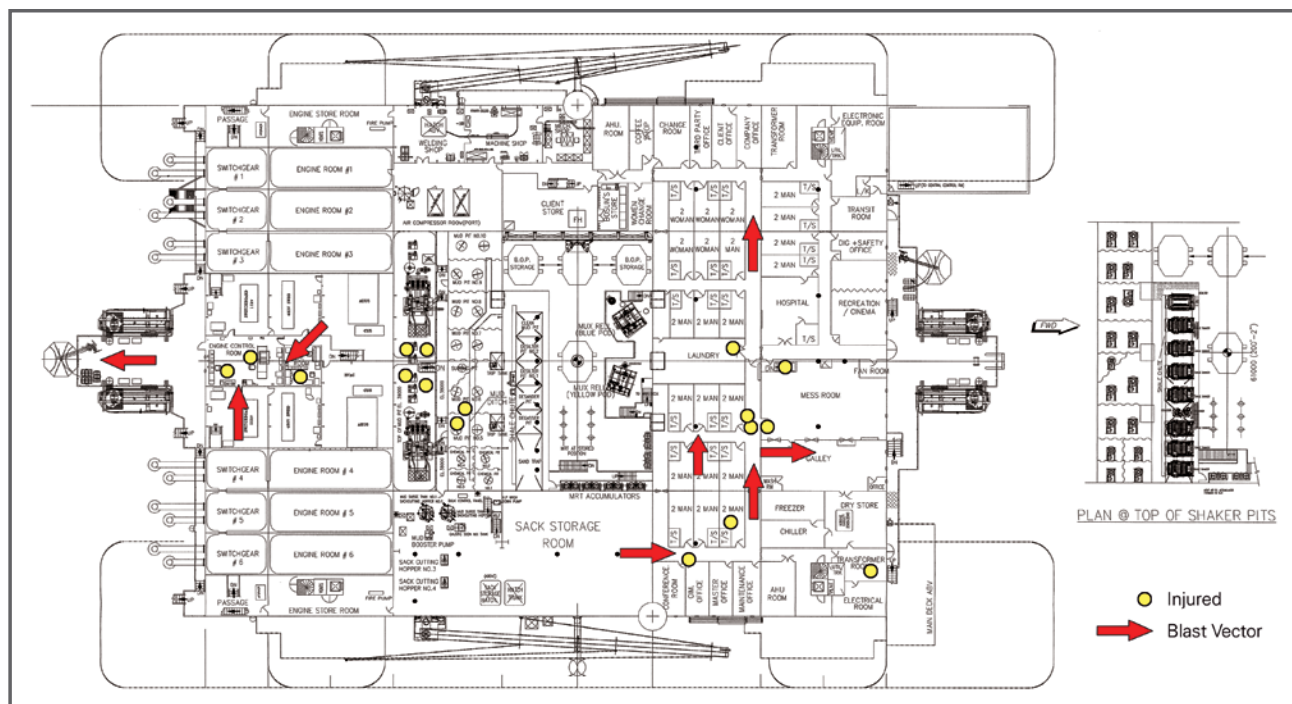
Figure 23. Second Deck Damage Vector Diagram.

The blast over-pressure that occurred at the second deck level created a pressure wave that caused significant damage to the aft starboard side of the accommodations area, where multiple personnel injuries occurred. This pressure wave also caused significant damage to the engine control room on the second deck level at the aft end of the rig. (Refer to Figure 23.)
