# *Deepwater Horizon* Accident Investigation Report

September 8, 2010

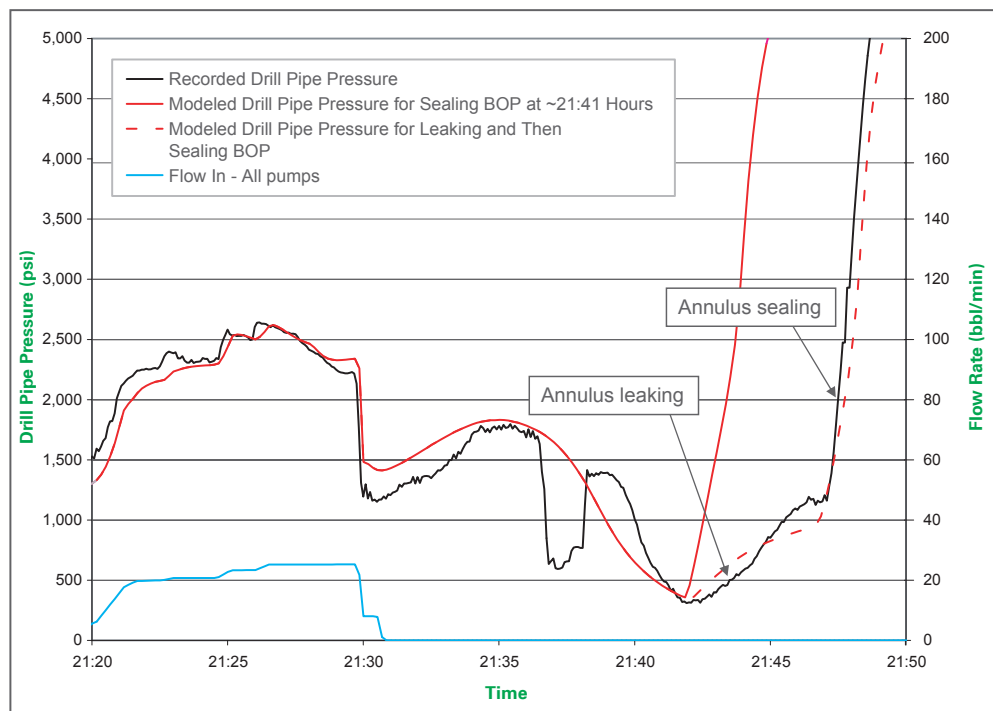
**Figure 1.** Drill Pipe Pressure—OLGA<sup>®</sup> Well Flow Modeling of Drill Pipe Pressure for a Closing BOP Versus Recorded Data.

The recorded surface data, from approximately 21:41 hours to 21:49 hours on April 20 (the time at which Sperry-Sun real-time data stopped transmitting), is critical to understanding the BOP operation prior to the explosions. The data suggests that the normal mode of BOP operation sealed the annulus less than 2 minutes prior to the loss of data transmission just before the explosions. (Refer to 6. *Modes of BOP Operation* of this analysis, which provides a discussion of BOP normal and emergency modes of operation.) The BOP closed, but it was slow to seal. Based on the evidence and analysis to date, it is not certain which BOP components were operated to seal the annulus prior to the explosions. It is likely that a variable bore ram (VBR) eventually sealed the annulus.

As established in *Analysis 5B.*, the rig crew activated the BOP at approximately 21:41 hours. *Figure 1* shows the results from the OLGA<sup>®</sup> well flow modeling of the BOP as activated at 21:41 hours and closing and sealing the annulus in 30 seconds (solid red curve). (Refer to *Appendix W. Report—Dynamic Simulations Deepwater Horizon Incident BP*) However, the recorded drill pipe pressure (solid black curve) indicates that the annulus was sealed approximately 5 minutes later than the OLGA<sup>®</sup> well flow modeling predictions. Further OLGA<sup>®</sup> well flow modeling of the BOP closing in 30 seconds, but allowing leakage past the annular preventer for 5 minutes before fully sealing the annulus, resulted in a drill pipe pressure (dashed red curve) that closely followed the recorded pressure. This analysis indicates that the BOP closed within the expected time, but it did not fully seal for another 5 minutes.

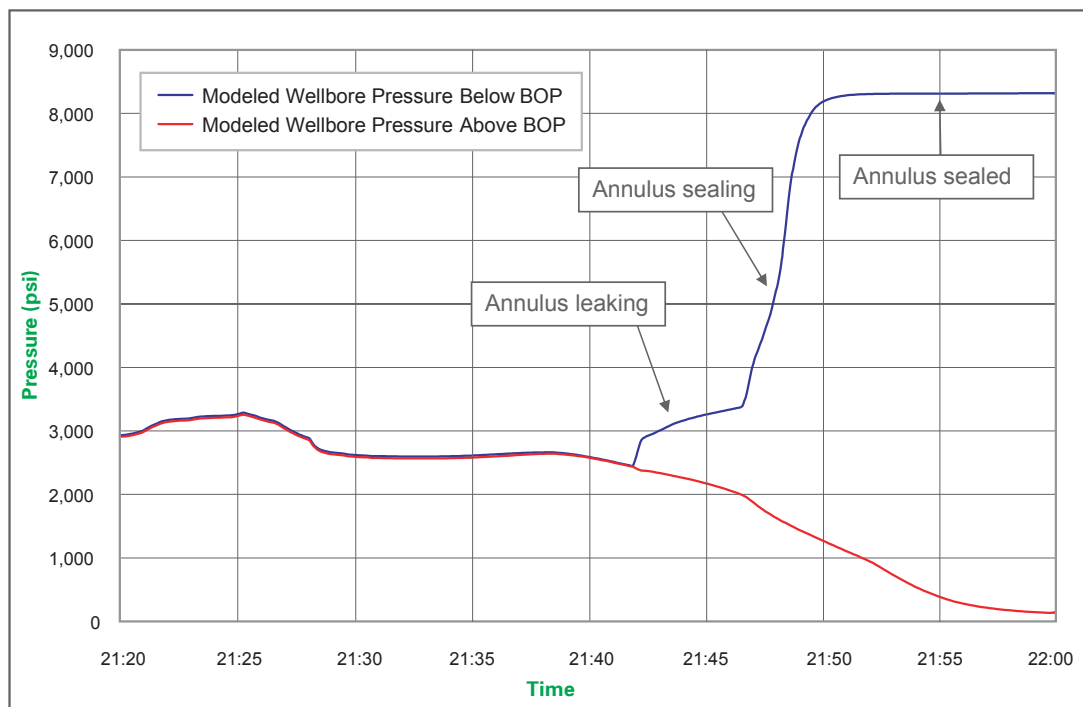
**Figure 2.** OLGA<sup>®</sup> Well Flow Modeling of Wellbore Pressure for a Leaking and Sealing Annular Preventer.

Wellbore pressure simulation using OLGA<sup>®</sup> well flow modeling indicates a differential pressure across the annular preventer of over 8,000 psi after the annulus was sealed. (Refer to Figure 2.) Given that the lower annular preventer was rated at 5,000 psi working pressure, it might not have held a differential pressure of over 8,000 psi. It is therefore less likely that the lower annular preventer would have sealed the annulus.

The annular preventer likely leaked for 5 minutes before the annulus was sealed. Given this finding combined with the evidence suggesting that at least one VBR could have been closed by the rig crew, it is likely that a VBR eventually sealed the annulus. (Refer to 4.1 of this analysis.) However, events subsequent to the explosion and fire could have impaired the integrity of the seal. (Refer to 4.2 *Status of the Drill Pipe Across the BOP After the Explosion* of this analysis.)

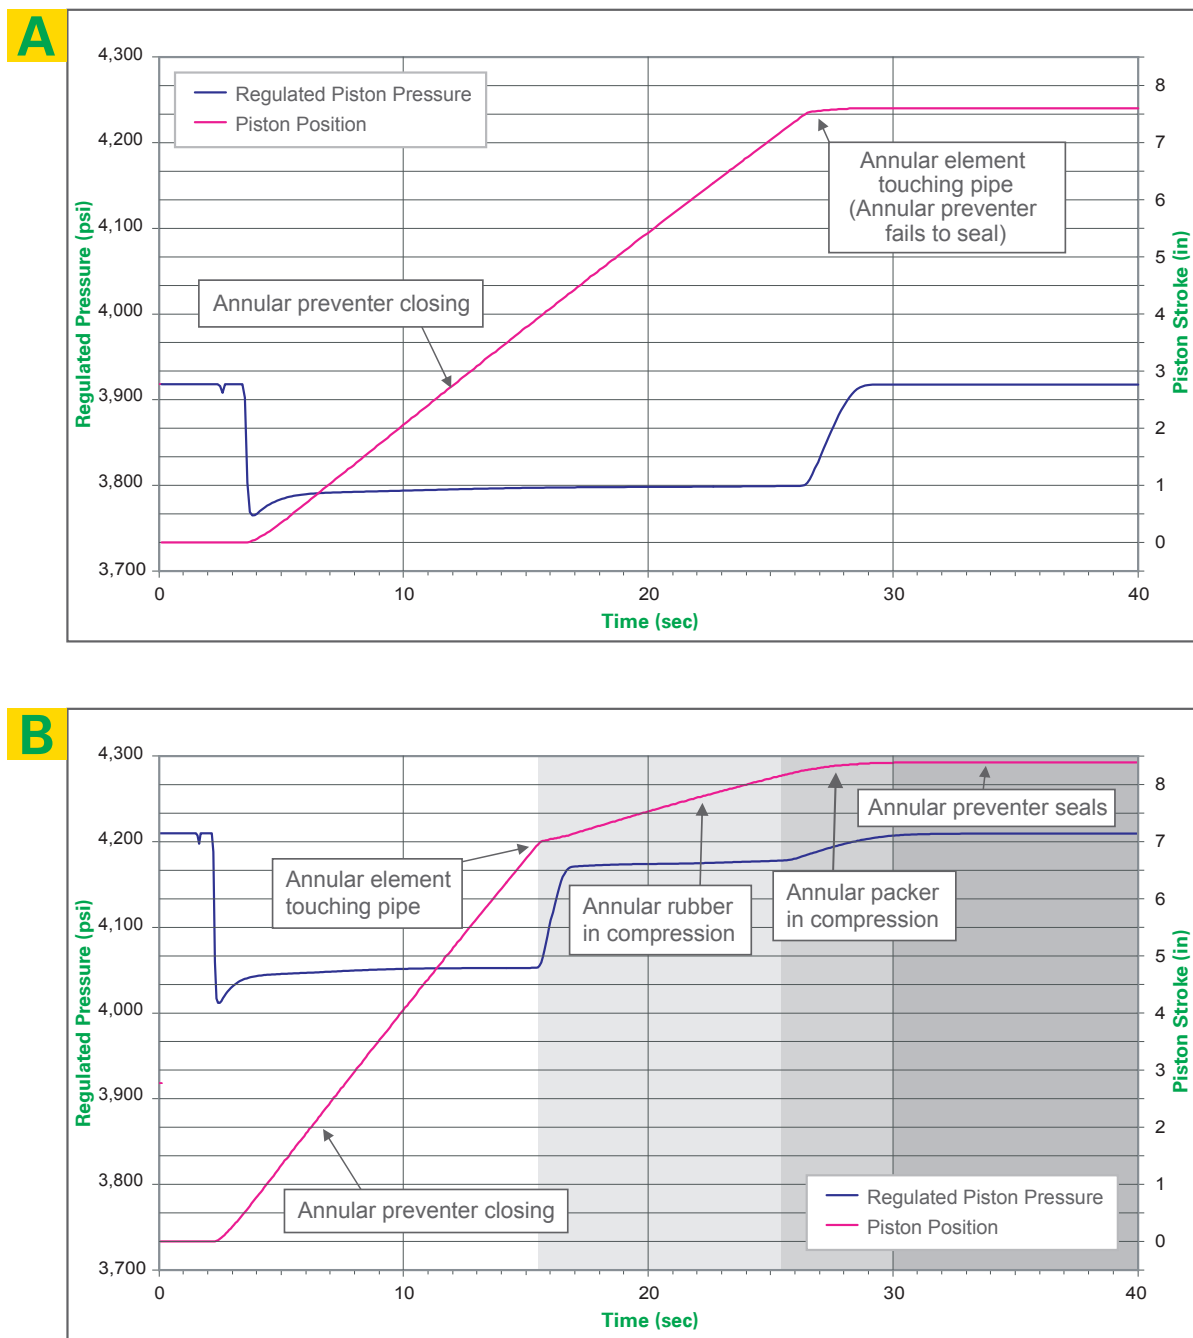
**Figure 5.** Hydraulic Analyses of an Annular Preventer.  
**(A)** Regulated Pressure of 1,700 psi.  
**(B)** Regulated Pressure of 2,000 psi.  
 (All pressures in the figure include hydrostatic head at the seabed.)

*Figure 5* shows the dynamic response of an annular preventer at 5,000 ft. water depth (WD) operating under 1,700 psi and 2,000 psi regulated closing pressures. (Refer to Figure 5.) (Hydraulic pressures in this analysis are quoted in terms of differential pressure, which is the difference between the hydraulic system pressure and the hydrostatic pressure at the sea bed.) The wellbore pressure at the time of the closure of the annular preventer was approximately 2,500 psi. To represent an annular preventer closing in a flowing condition, the simulated pressure in the BOP was increased from 2,500 psi to the shut-in pressure of approximately 8,000 psi as the annular preventer elastomeric element was about to touch the drill pipe.

The dynamic response of the annular preventer operating under 1,700 psi regulated pressure indicated that the annular preventer failed to seal due to rapid increase in wellbore pressure as shown in *Figure 5(A)*. Hydraulic analysis further indicates that an annular preventer would seal around the pipe under a regulated pressure setting of 2,000 psi, as shown in *Figure 5(B)*.

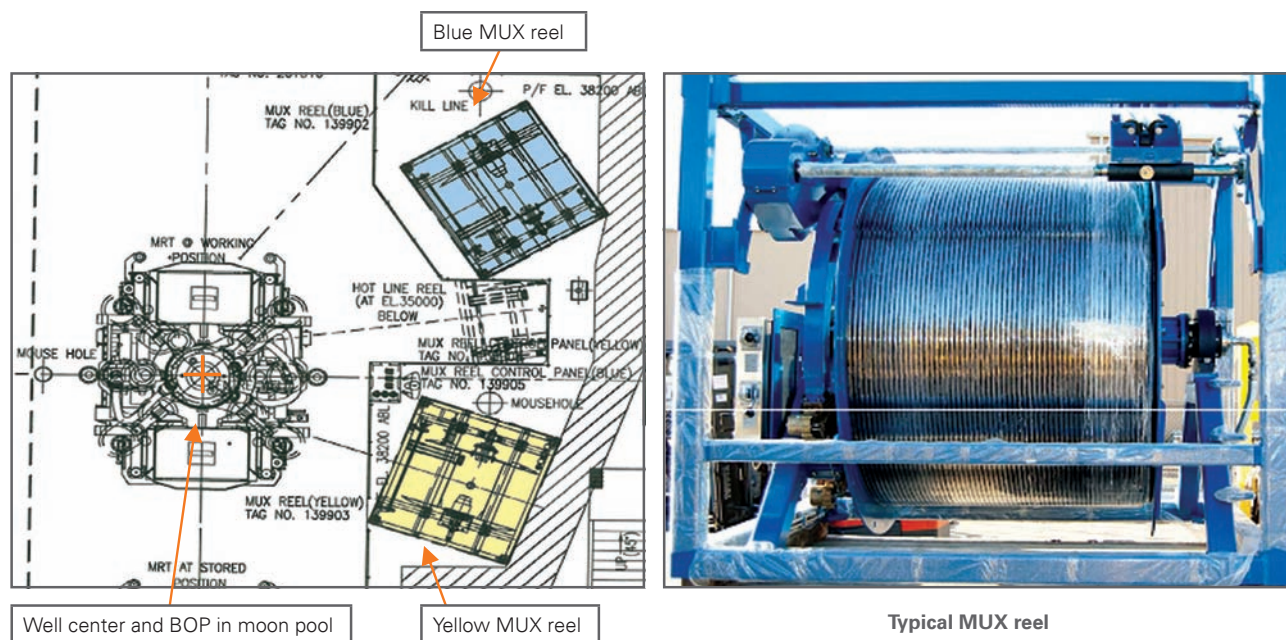
**Figure 6.** Moon Pool Layout Showing the Location of Blue and Yellow MUX Reels.

The subsea supervisor testified during the MBI hearings on May 26–29, 2010, that the TCP had a low accumulator alarm indicating loss of hydraulic power. The witness testified, “I hit the EDS button. Everything in the panel did like it was supposed to at the panel, but it never left the panel. I had no hydraulics.” This account suggests that the EDS did not initiate. Both methods, high-pressure BSR and EDS, would have required communication with the BOP control pod through MUX cables.

The MUX reels were located in the moon pool area within the explosion and fire zone. (Refer to Figure 6.) Since the MUX cables were not protected against explosions or fire, it is very likely that the early explosion and fire damaged the MUX reel slip rings and the cables to the extent that the communication line and electrical power required to initiate the high-pressure BSR and EDS functions were no longer available.

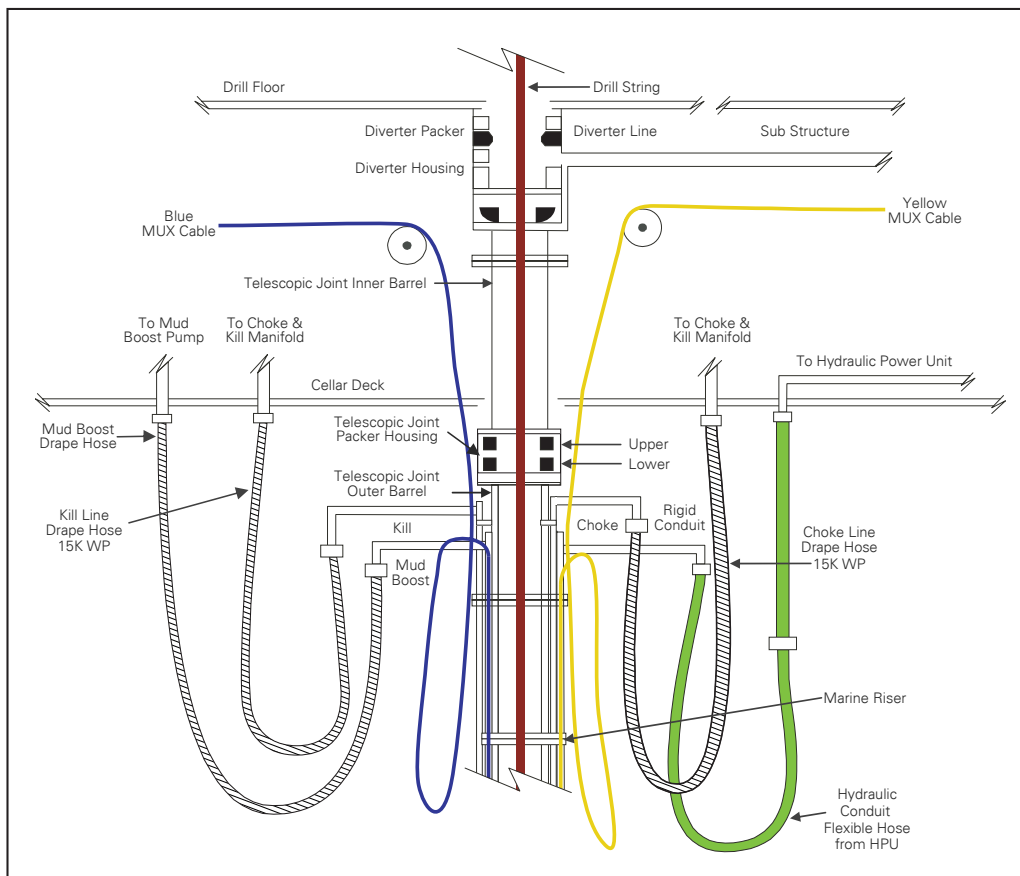
**Figure 7.** Typical Configuration of Flexible Hoses in the Moon Pool.  
 (Hydraulic conduit flexible hose is shown in green).

The AMF sequence is initiated when electrical power, communications and hydraulic pressure are lost to both pods. To initiate an AMF, all three services must fail (i.e., after damage to the MUX reels or cables and to the hydraulic conduit, caused by explosions and fire). As indicated in 3.1 of this analysis, the MUX cables, which carry electrical power and communications, were vulnerable to explosion and fire damage. Though the hydraulic conduit flexible hose was less vulnerable to damage than the MUX cables, it was located close to the MUX cables in the moon pool and could have been damaged by the explosions and fire. (Refer to Figure 7.)

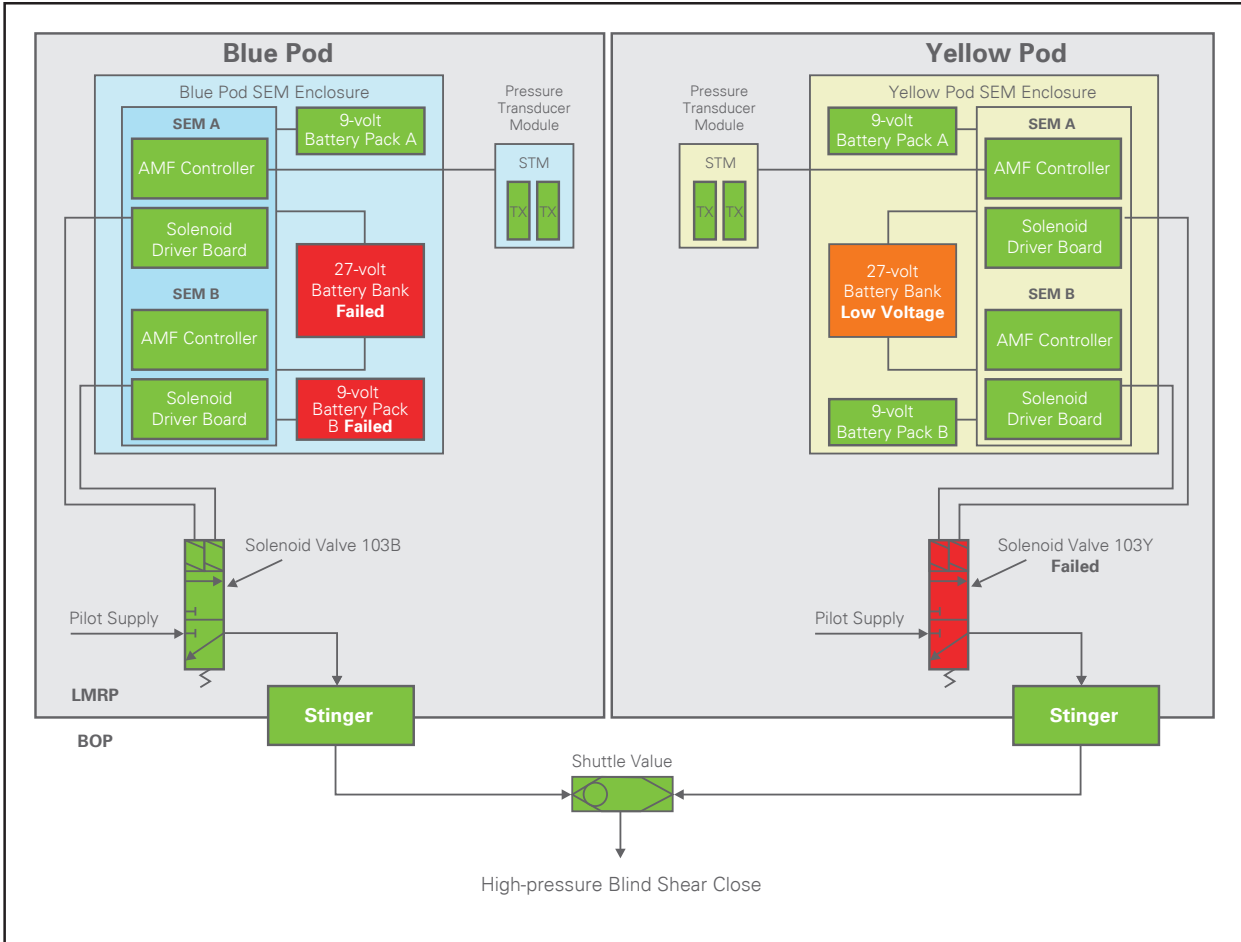
**Figure 8.** Simplified Schematic of the AMF Control System.

During the yellow pod test performed by Transocean and Cameron after the accident, both coils on solenoid valve 103 failed to energize, suggesting electrical coil faults. The investigation team found no evidence that this failure occurred after the accident; rather, the team concluded that this failure condition very likely existed prior to the accident. (Refer to 5.1 *Maintenance* of this analysis.) A faulty solenoid valve 103 would mean that the yellow pod could not have performed the AMF sequence, as no pilot

signal could have been sent to the pilot-operated control valve to activate the high-pressure BSR close function. As described in *5.5 Monitoring and Diagnostic Capability* of this analysis, the rig's BOP control diagnostic system should have been capable of remotely detecting the faulty solenoid valve and recording it on the system event logger.

*Figure 8* shows a simplified schematic of the AMF system. There were two 9-volt battery packs and a 27-volt battery bank (made up of 3 packs of 9-volt batteries connected in series) in each pod. These batteries were not rechargeable. The 9-volt AMF battery packs were used to power the AMF card processors. When the AMF was enabled, these batteries provided continuous power to the AMF cards. The 27-volt battery bank was used to provide power to the 24-volt rated AMF card relays, the pressure sensors and the solenoid valves that were used in the AMF sequence, including solenoid valve 103.

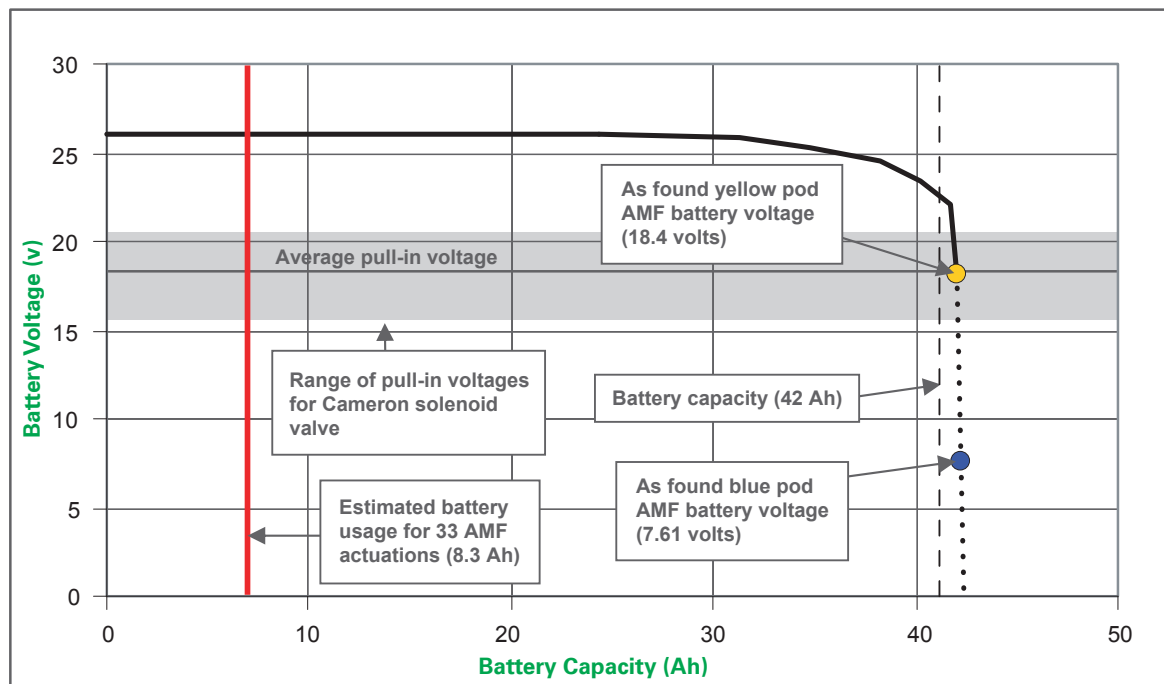
**Figure 9.** Discharge Curve for a 27-volt AMF Battery Bank.

In 2004, Cameron, the BOP manufacturer, issued an engineering bulletin, *EB 891D*, recommending that battery banks be replaced after one year of operation or when the number of actuations exceeds 33 for that year, whichever comes first. The discharge curve for a 27-volt battery bank indicates that after 33 actuations, the battery bank would have expended only 20% of its expected life, as measured in ampere hours (Ah). The measured charge of 7.61 volts on the 27-volt battery bank was past the expected annual usage and was beyond the design life of the battery bank. (Refer to Figure 9 and *Appendix X. Deepwater Horizon Blue Pod AMF System Batteries.*)

The investigation team considers that it is very likely that the charge at the time of the accident would have been insufficient to activate the AMF.

The available maintenance records from 2001 to 2010 indicate that during this period, the AMF batteries were changed at a frequency less than the manufacturer's recommendation. The BOP control diagnostic functionality did not include measuring the charge on the AMF batteries. Transocean maintenance records for AMF batteries are discussed in 5.1 of this analysis.

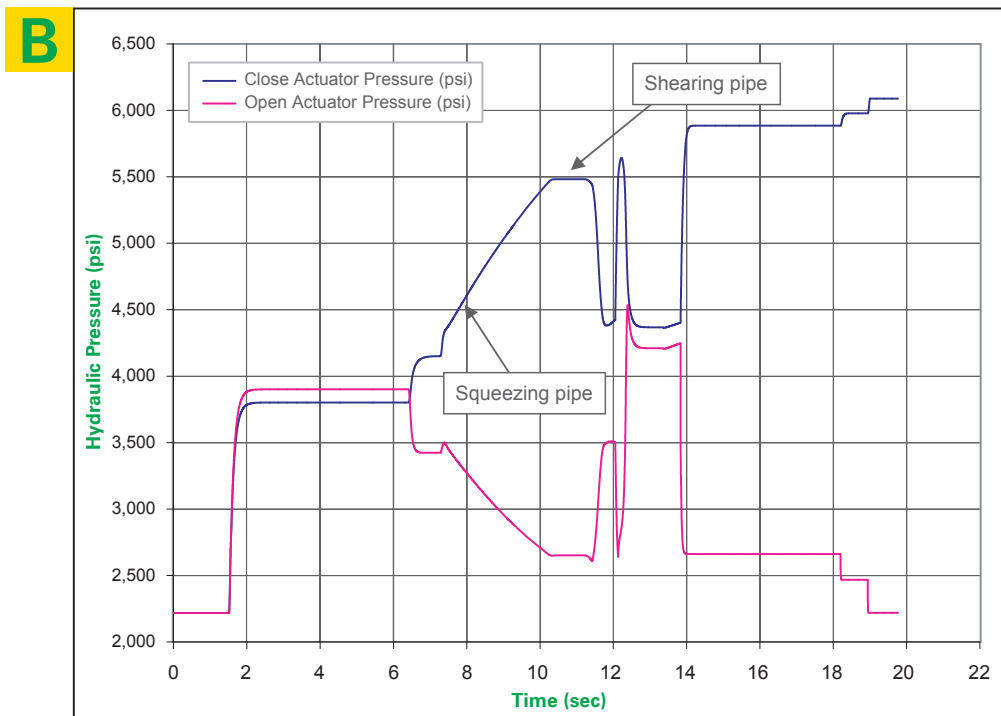
**Figure 11.** Hydraulic Analyses of BSR Closure Response (at a Wellbore Pressure of 3,000 psi and 5,000 ft. WD) **(A)** With and **(B)** Without a Leak in the ST Lock Hydraulic Circuit. (All pressures include hydrostatic head at the sea bed.)

*Figure 11* shows the responses of the BSR with and without a leak in the ST lock hydraulic circuit. The analysis assumes a pipe shearing pressure derived using Cameron's formula for 5 1/2 in., 21.9 ppf, S-135 pipe at a wellbore pressure of 3,000 psi. *Figure 11(B)* illustrates that without a leak, there was sufficient pressure to shear and seal the drill pipe. In comparing *Figure 11(A)* and *Figure 11(B)*, the impact of a leak is seen to increase the time it takes to build up hydraulic pressure in the actuator to be able to shear the pipe (12.5 seconds versus 10.5 seconds). However, even with the presence of the leak, sufficient hydraulic pressure was achieved to complete the shearing operation. With the leak, the overall shearing operation would have taken 17 seconds to complete, whereas without a leak, shearing operations would have finished in 14 seconds.

The impact of the second leak on the BSR ST-lock circuit, potentially within an ST-lock sequence valve, could not be fully investigated without access to the BOP. (Refer to 5.2 of this analysis for further discussion of all leaks of which BP is aware.)

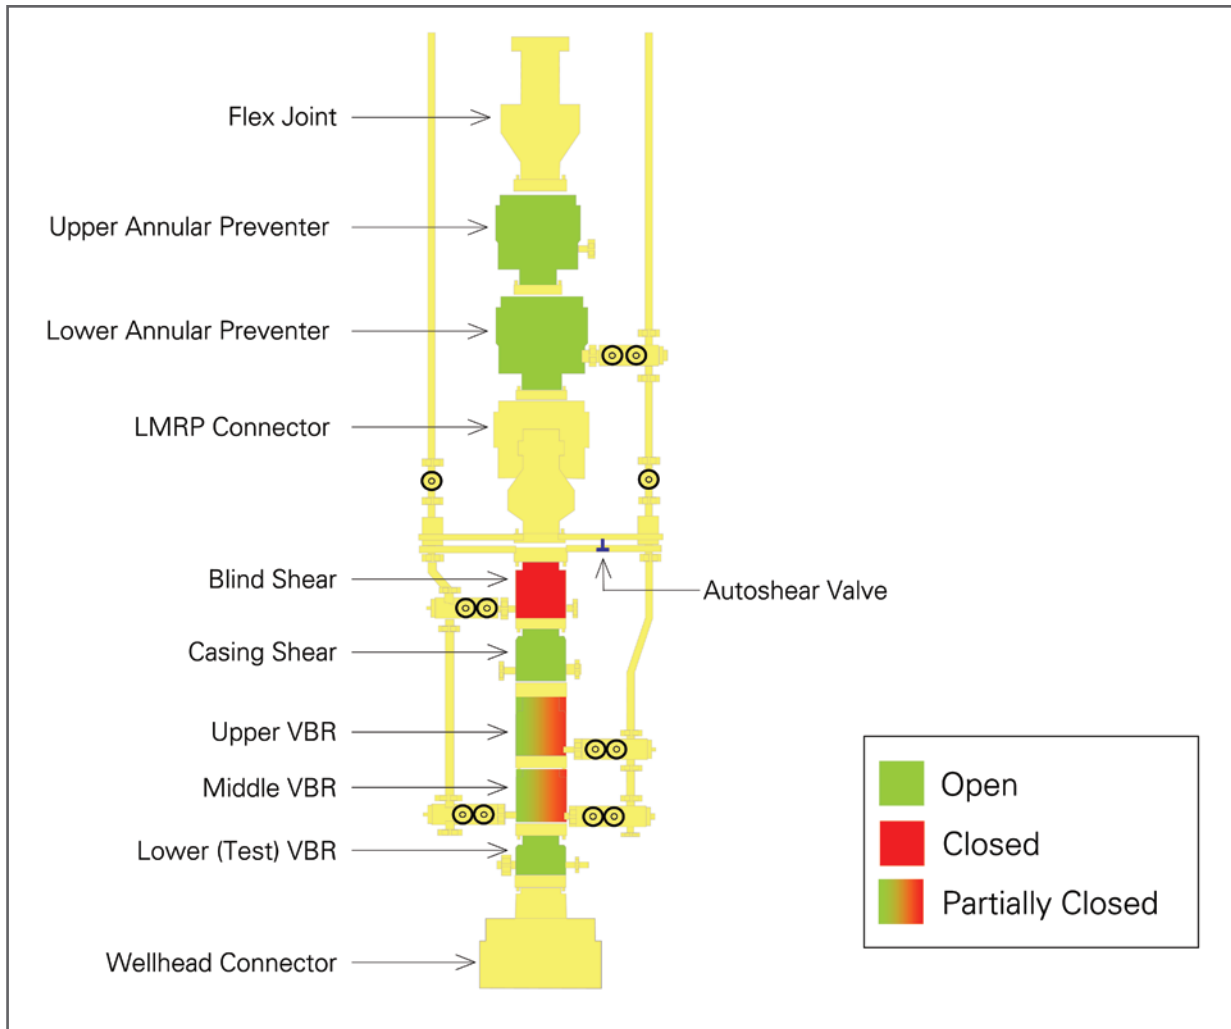
**Figure 13.** Likely Status of BOP Rams Immediately After Autoshear Initiation.

Based on these findings, the investigation team concluded that the upper, and possibly the middle, VBRs were likely closed by the rig crew.

*Figure 13* shows the likely status of the BOP rams immediately after the initiation of autoshear.

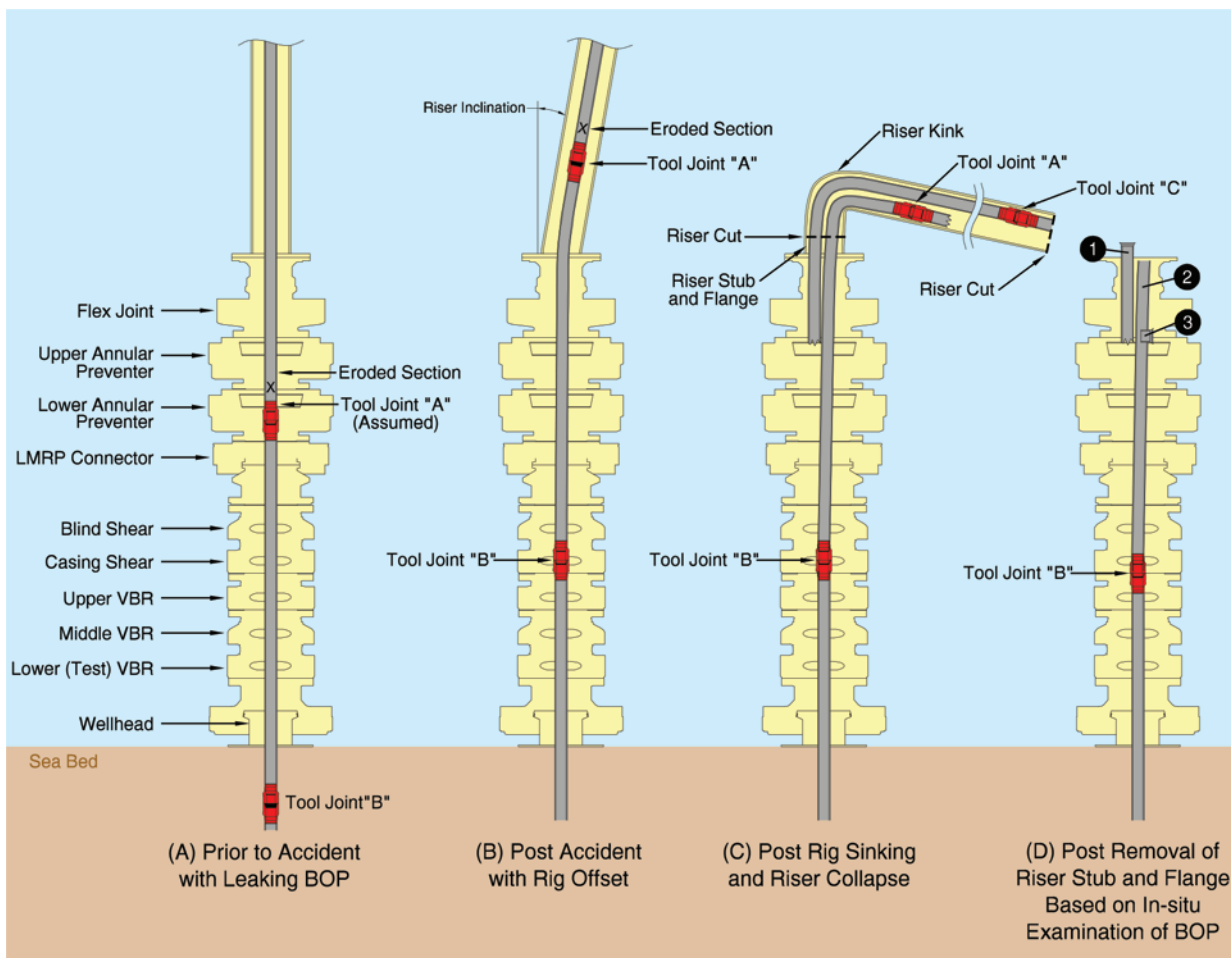
**Figure 15.** A Schematic of Drill Pipe Configuration Across the BOP Over Time.

The right-hand pipe section had a jagged, broken end with extensive wall thickness reduction. This appeared to have been caused by localized erosion on the outer drill pipe wall, which was not present on the adjacent inner wall of the riser.

The investigation team determined that this erosion may have occurred when the section of pipe was in the BOP, where it experienced extremely high flow velocities during the leaking of a ram or annular preventer, indicating that this section of drill pipe was continuous through the BOP. The approximately 22 in. long erosion zone could suggest that the erosion event took place in an annular preventer.

Assuming the erosion took place at the lower annular preventer, the right-hand pipe must have moved by approximately 25 ft. This could have happened as the rig drifted off location after power was lost. (Refer to time period [B] in Figure 15.) The metocean records indicate that the current velocity at sea level at the time of the accident could have been above 0.69 ft./sec. The investigation team did not have access to the vessel's hydrodynamic characteristics in order to perform a drift-off analysis of the rig. However, it is likely that a current of this magnitude would have caused the vessel to drift off after the power was lost at approximately 21:49 hours.

For the drill pipe to have moved upward by 25 ft., the next tool joint down the drill string (Tool Joint "B" in Figure 15 with an outside diameter of 7 in.), would have had to pass through the middle and upper VBRs. This could indicate that the ST locks were not operated when the rig crew likely attempted to close the VBRs, and the rams allowed the pipe to move upward through the BOP.

The drill pipe likely broke off at the eroded section while moving upward through the BOP. There are eyewitness accounts stating that the top drive fell onto the rig floor (by approximately 26 ft.), possibly due to the failure of the draw works during rig evacuation. The drill pipe likely had already failed at the eroded section by this time, as it was being pulled upwards due to increasing vessel offset. It is therefore inconclusive whether downward movement of the top drive would have imposed any load on the closed VBR.

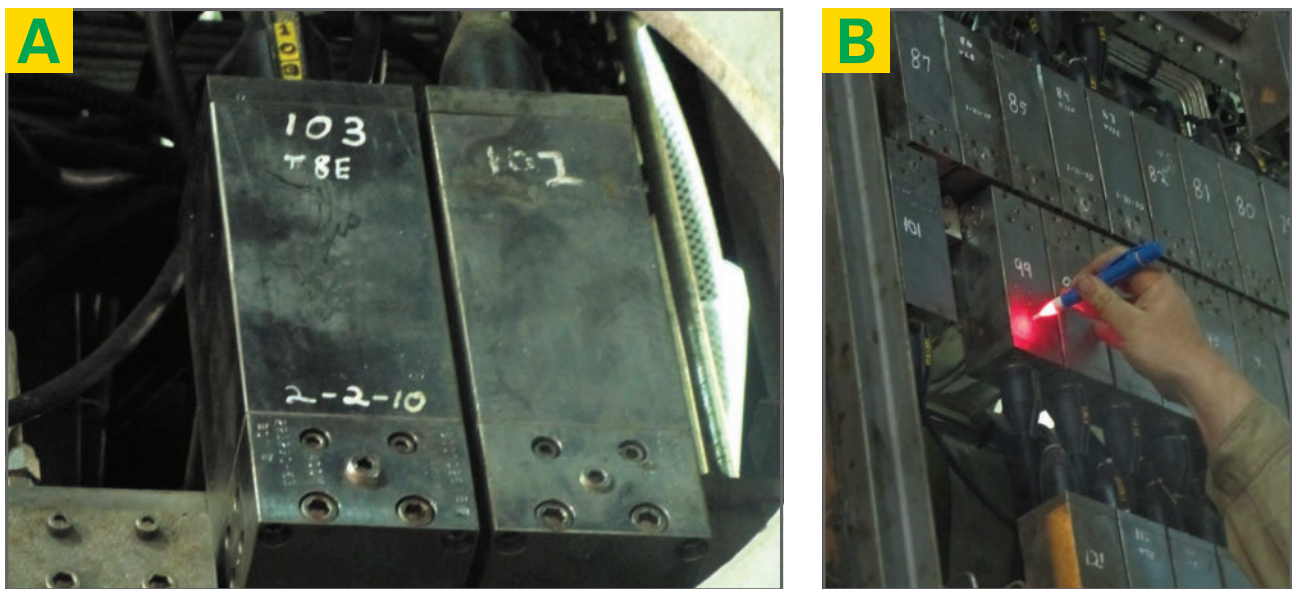
**Figure 16. (A)** Photograph of Solenoid Valve 103 in the Yellow Pod. **(B)** Testing of Solenoid Coils.

- Solenoid valve 103 in the yellow pod, which was required to operate the high-pressure BSR close function, was found to be defective. (Refer to Figure 16.) This solenoid valve also had a non-OEM electrical connector installed.
- Solenoid valve 3A in the yellow pod, which was required to increase the upper annular preventer regulator pressure, was also found to be defective.

- The investigation team considers that even if the yellow pod batteries had sufficient charge, the status of the solenoid valve 103 would have prohibited the closure of the BSR from the yellow pod.

The control system was capable of identifying the coil defects in solenoid valves 103 and 3A in the yellow pod and logging them in the event logger. A failure mode effects and criticality analysis (FMECA) performed as part of a BOP assurance analysis of *Deepwater Horizon* BOP stack identified this failure mode. As stated in the FMECA report, when this failure is detected, the mitigation is "Switch to alternate pod, secure well and pull LMRP."

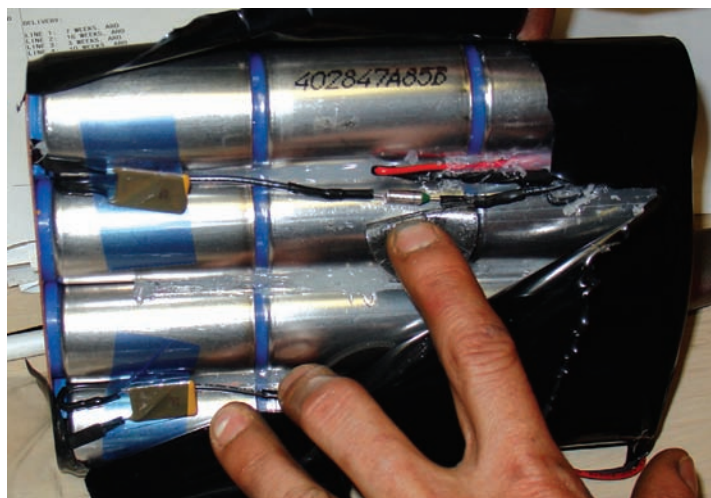
**Figure 17.** Photograph of a 9-volt AMF Battery Pack.  
(Not from *Deepwater Horizon* BOP pod.)

- The 27-volt AMF battery bank in the yellow pod (made up of three packs of 9-volt batteries), which was required to operate the AMF, had a charge of 18.41 volts. (Refer to Figure 17.) The battery bank discharge curve indicates that the battery bank voltage was already in rapid decline. (Refer to Figure 9.) While this charge was low, it was sufficient to complete the AMF sequence multiple times during tests conducted at the surface. During the August 23-27, 2010, MBI hearings, a subsea superintendent stated that the battery bank voltages were measured incorrectly (i.e., the 18.41-volt measurement) and that, prior to re-installing the yellow pod after it was retrieved, the voltages were rechecked and a battery bank voltage of 27 volts was measured.

The charge level of the batteries for the AMF sequence could not have been monitored on the surface while the BOP was deployed subsea. If the battery voltage was not checked on the surface prior to the BOP deployment, there would have been no means of determining the charge on the batteries once the BOP was deployed.

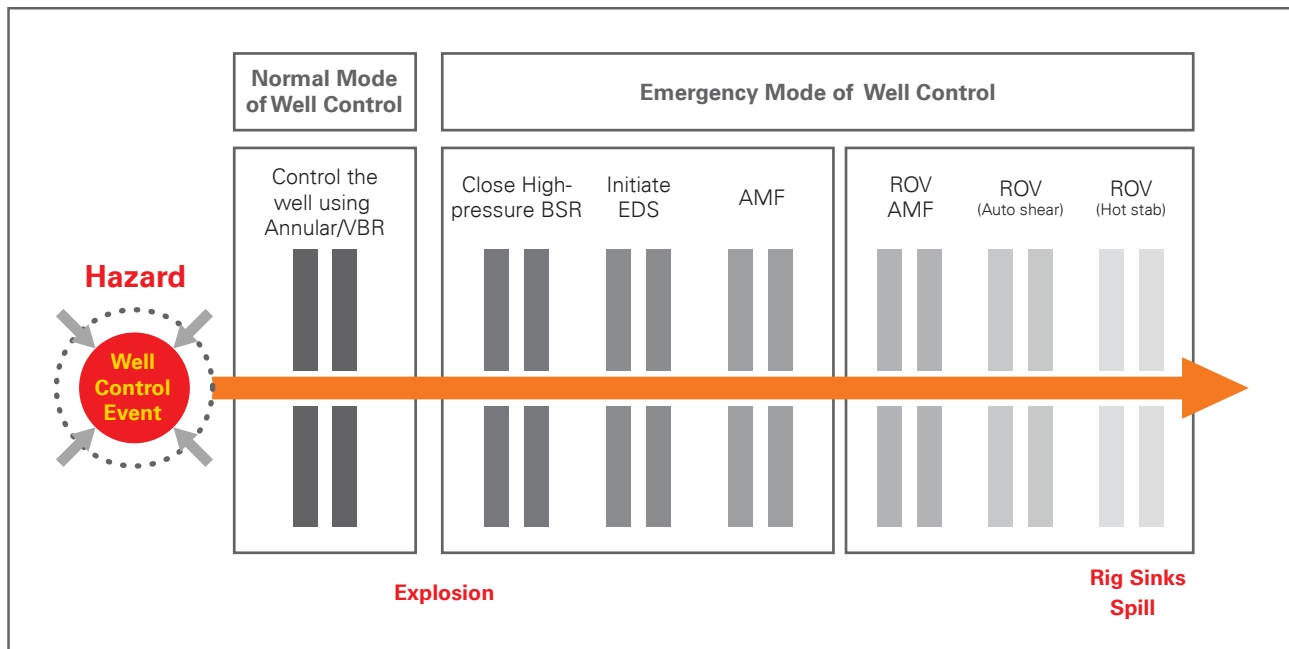
Figure 20. BOP Well Control Modes of Operation.

There were six possible methods of closing the BSR in emergency mode that pertain to this accident (refer to Figure 20):

- **AMF:** an automatic means of closing the high-pressure BSR when electrical power, electronic communication and hydraulic pressure are all lost. AMF is designed to mitigate the risk caused as a result of catastrophic failure of the riser with the resultant reduction of hydrostatic head of mud in the riser to seawater hydrostatic head. This function had to be manually armed by rig personnel from the BOP control panel and required at least one operational control pod. The accumulators on the BOP stack were the only source of hydraulic power for this function. The investigation team concluded that the AMF very likely did not function due to the condition of critical components in the control pods.

- **ROV-initiated AMF:** a simulation of AMF conditions to close the high-pressure BSR by using an ROV to cut power/communication and hydraulic lines at the LMRP. This was attempted hours before the rig sank, but the investigation team concluded that the AMF very likely did not function due to the condition of critical components in the control pods.

The rig crew attempted the normal mode of BOP system operation (using an annular preventer and possibly a VBR) prior to the accident. The emergency mode of well control shown in *Figure 20* relates to the period after the accident, but only the ROV hot stab intervention continued after the rig sank.
