QUALITY SYSTEM COMPLIANCE VENDOR / SUPPLIER AUDIT REPORT

Qantas Airways Limited

**Contracted Maintenance – SIAEC Singapore "D" Check on
Qantas Aircraft VH-OJO V/C: T7105**

AQD Audit ID: 06/SPT/10

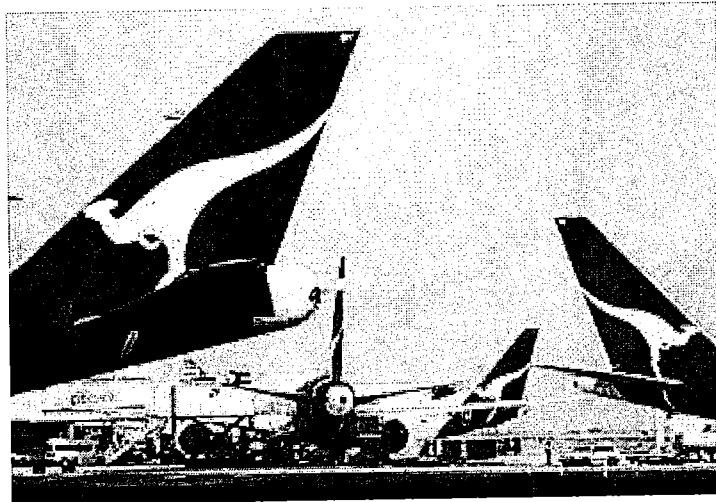
Deadly ... an overseas maintenance crew sealed off a Qantas jet's back-up oxygen supply. Source: No credit

A leaked maintenance report on the Airbus seen by the Herald Sun and dated March 11 says: "On investergation (sic) found crew oxy bottle shutoff valve in the closed position and lockwired."

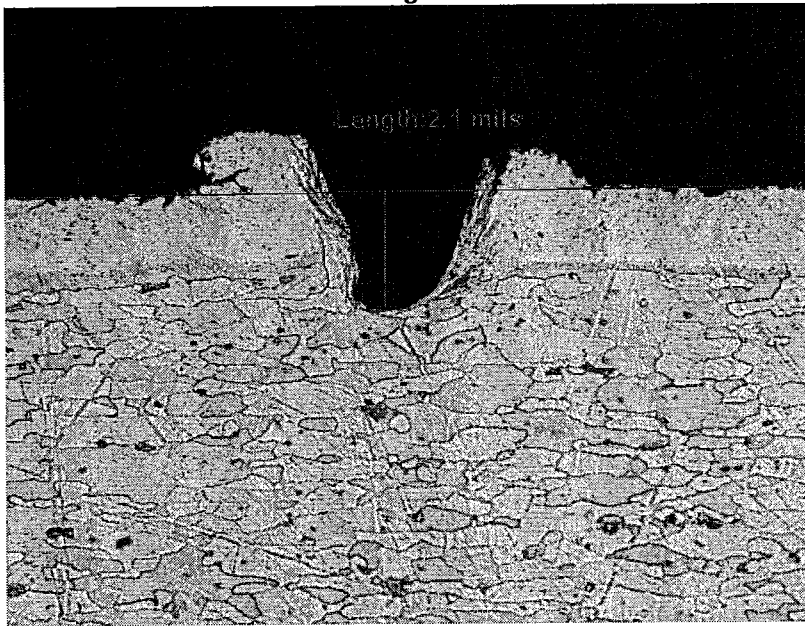
Image 1

The above is a cross sectioned Scribe Line, showing the damage below the surface. Note this scribe goes below the Protective Cladding and down into the pure Aluminum. Boeing requires the depth of the Scribe BELOW THE UNDAMAGED SURFACE. Hence in the above image a "Base Line" has been drawn. This was a flat sheet of Aluminum. Easy! In practice on an Aircraft nearly all surfaces have a curvature! This must be allowed for.

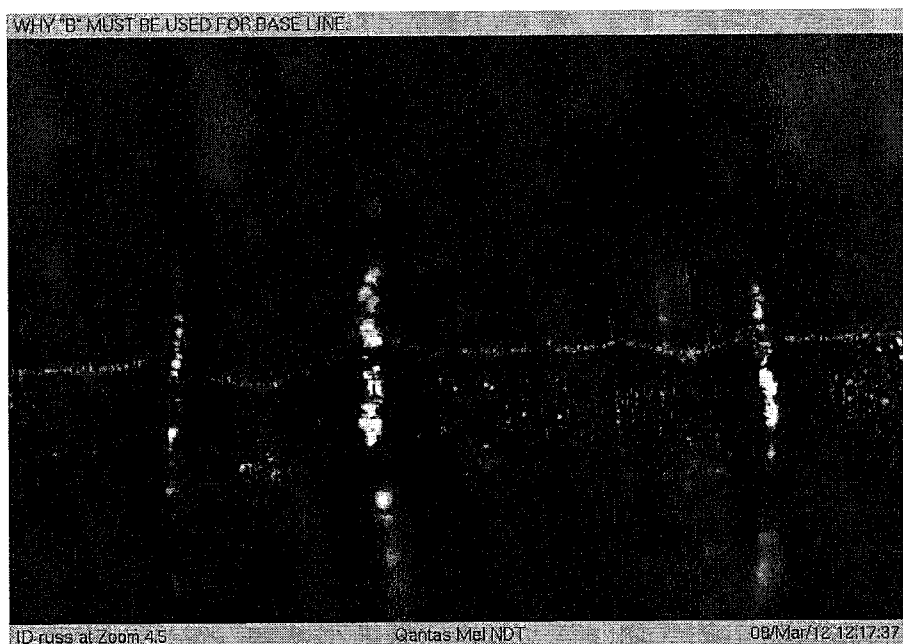
Image 2

Above is the RAW captured Image, shows 3 "Lands with damage between them". The Base line is required to join undamaged surfaces. Hence we draw the Base Line as shown below.

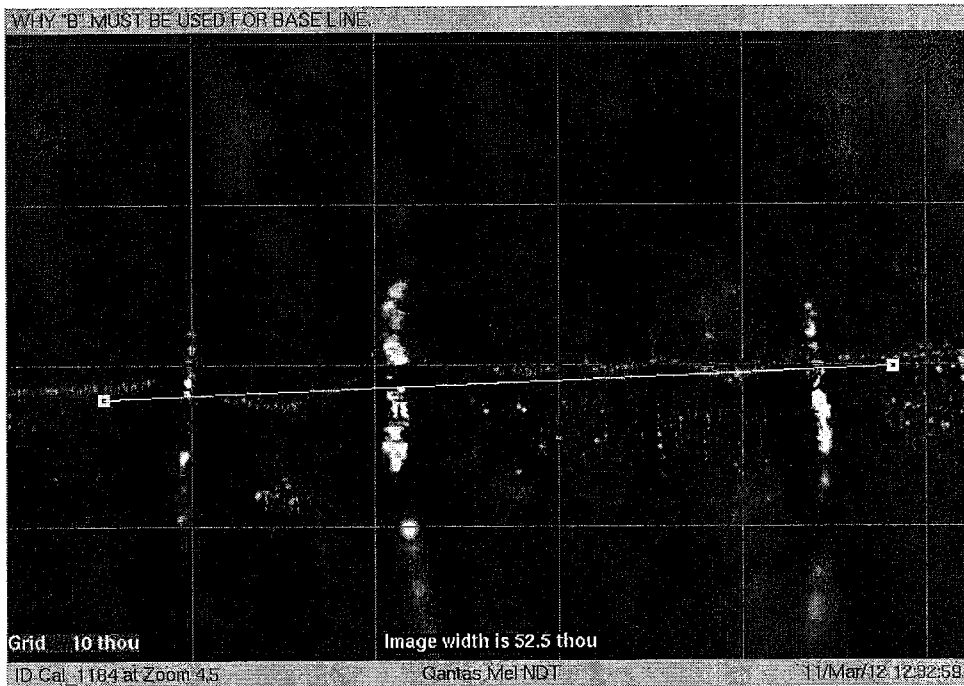
Image 3

The damage that is of concern is always BELOW this Line!

Note that this line is NOT drawn as a vector, but as a "stair case approximation".

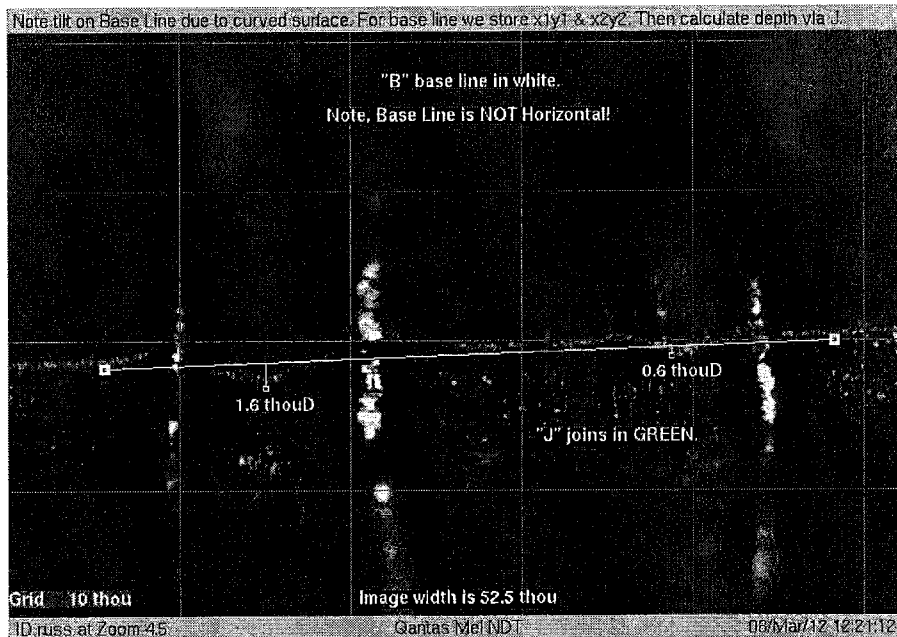
Image 4

Note that a "J" line just touches the base line, no small square is shown.

2) Boeing requires the use of a Base Line for all Scribe Line Measurements.

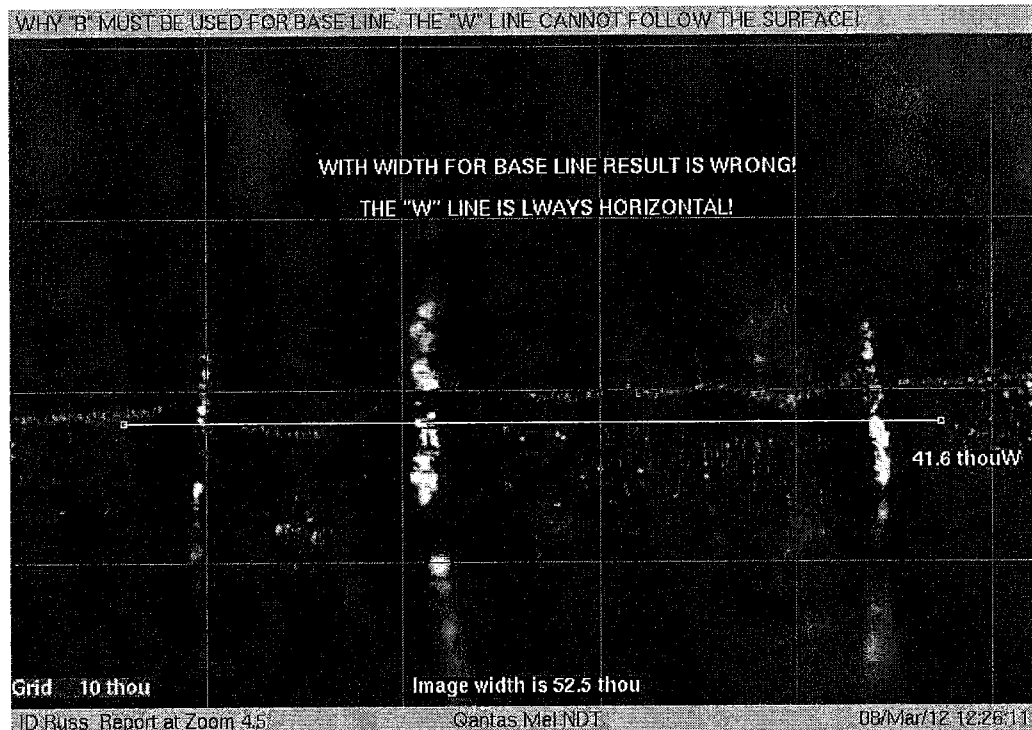
Image 5

This line cannot be used to reference the damage of the Scribe Line!

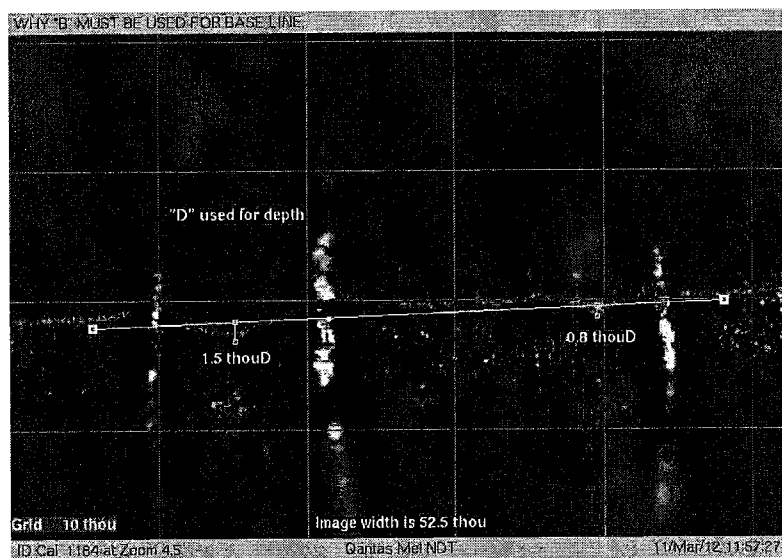
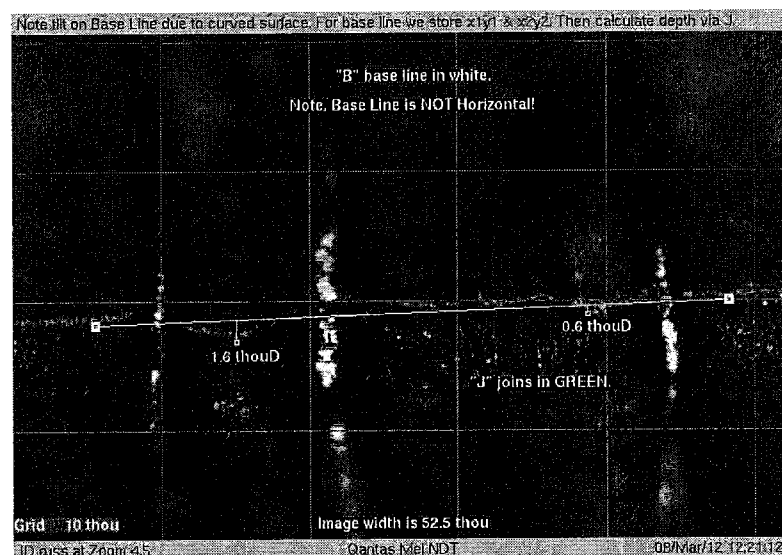
As can be seen from the above two samples, the top one with "D", the lower with "J", only a small difference. But "J" is more accurate!

To clear the confusion we always train to use "J".
