QUALITY SYSTEM COMPLIANCE VENDOR / SUPPLIER AUDIT REPORT

Qantas Airways Limited

**Contracted Maintenance – SIAEC Singapore "D" Check on
Qantas Aircraft VH-OJO V/C: T7105**

AQD Audit ID: 06/SPT/10

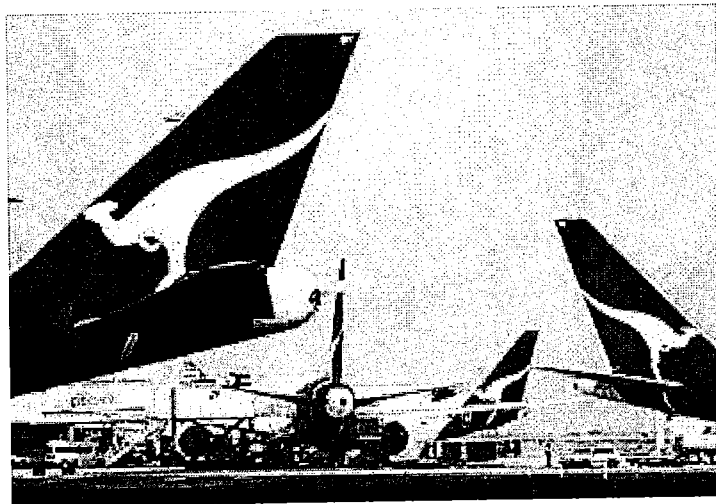
Deadly ... an overseas maintenance crew sealed off a Qantas jet's back-up oxygen supply. Source: No credit

A leaked maintenance report on the Airbus seen by the Herald Sun and dated March 11 says: "On investigation (sic) found crew oxy bottle shutoff valve in the closed position and lockwired."

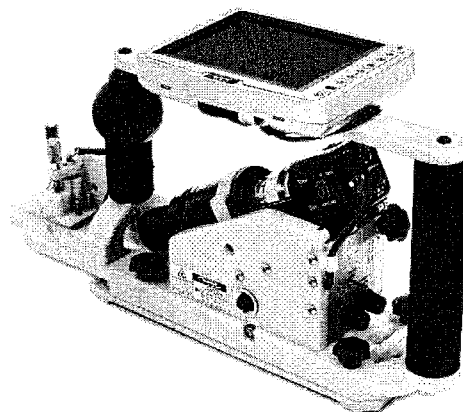
The major difficulty in using the LMM is the depth of field at full zoom which gives an image magnification of approximately $M=170$.

The width of the viewed section of metal when at full Zoom (4.5) is about 52.5 thou. Or about 1.3mm. The depth of field is only 6 thou, or about 0.15mm. **This is very small.** Therefore the LMM MUST be held STEADY! The weight of the LMM is 1.9kgms. Therefore after 10 to 20 mins a rest is needed. Various techniques are taught in the training class to make the task as easy as possible. One MAJOR recommendation pointed out in training is the use of a TEAM to carry out the Inspection. The recommended team is 3 persons. But always no less than 2! The solution is that the team rotate inspection duties! Highly important is that all team members have all the required knowledge and skills to take any role in the Inspection. Critical is that the team member holding the LMM is supported by at least 1 other team member. The technique being "One Holds the LMM, the Other Adjusts as required." The reason that we suggest 3 team members is operational safety. The third person maintains "Situational Awareness". He watches out for cables around feet, etc. His position is recommended always to be close to the InspectCam to assist with pressing the store key! It has been observed that most users have adopted a 3 team approach.

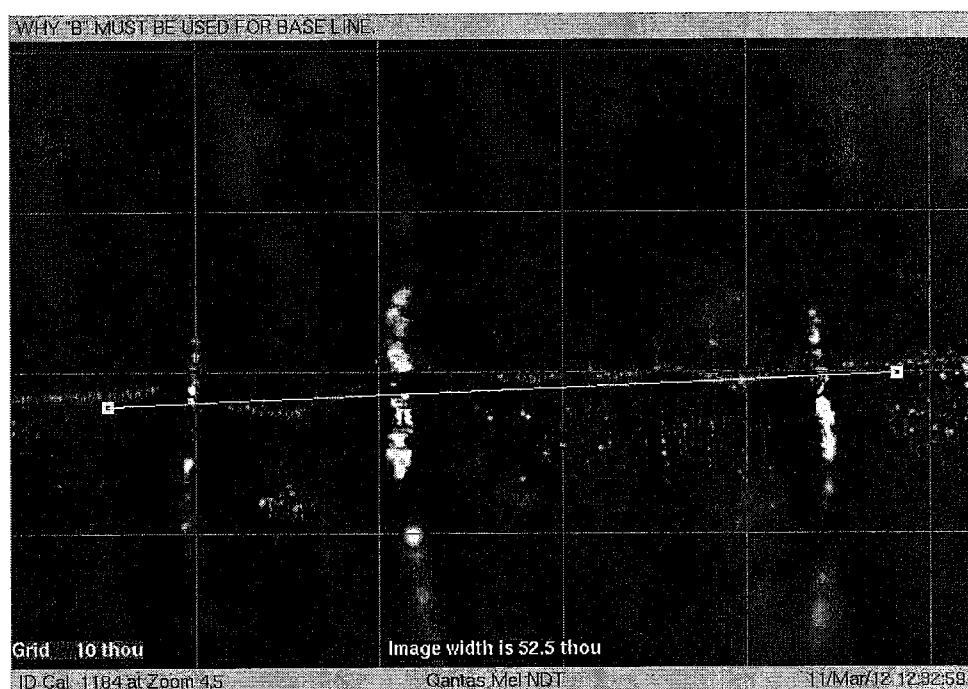
Image 3

Above is the RAW captured Image, shows 3 "Lands with damage between them". The Base line is required to join undamaged surfaces. Hence we draw the Base Line as shown below.

The damage that is of concern is always BELOW this Line!

Note that this line is NOT drawn as a vector, but as a "stair case approximation".

The recommended procedure now is to use "J" to join up to the base line.

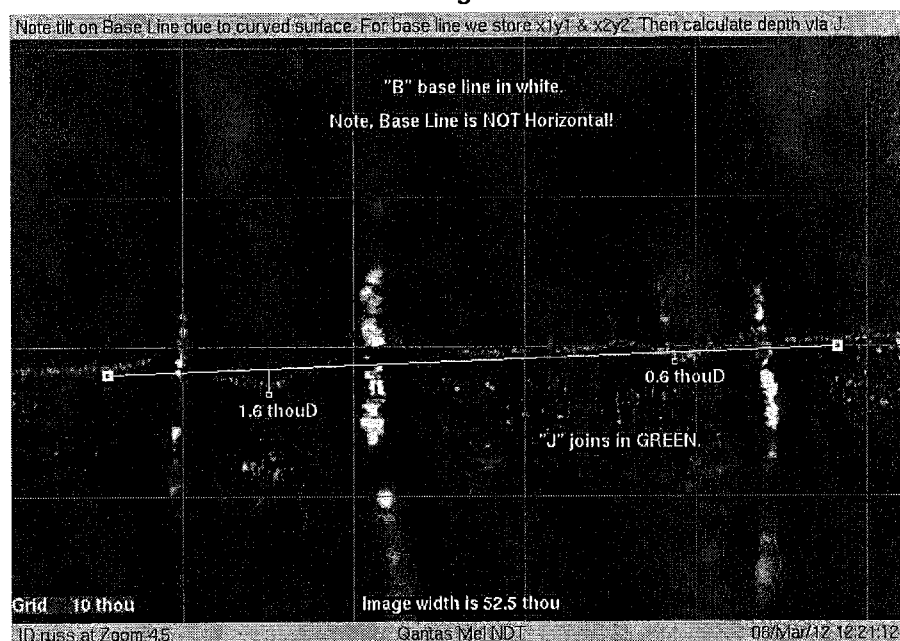
Image 4

Note that a "J" line just touches the base line, no small square is shown.

2) Boeing requires the use of a Base Line for all Scribe Line Measurements.

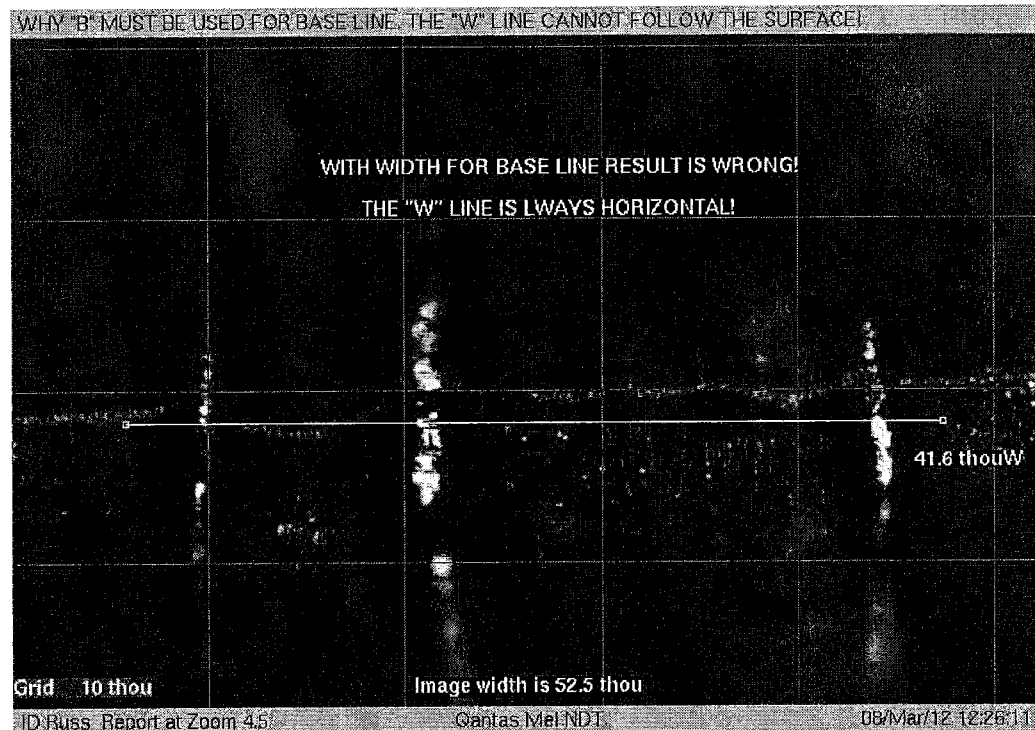
Image 5

Using a "W" as a base line would result in the following!

This line cannot be used to reference the damage of the Scribe Line!

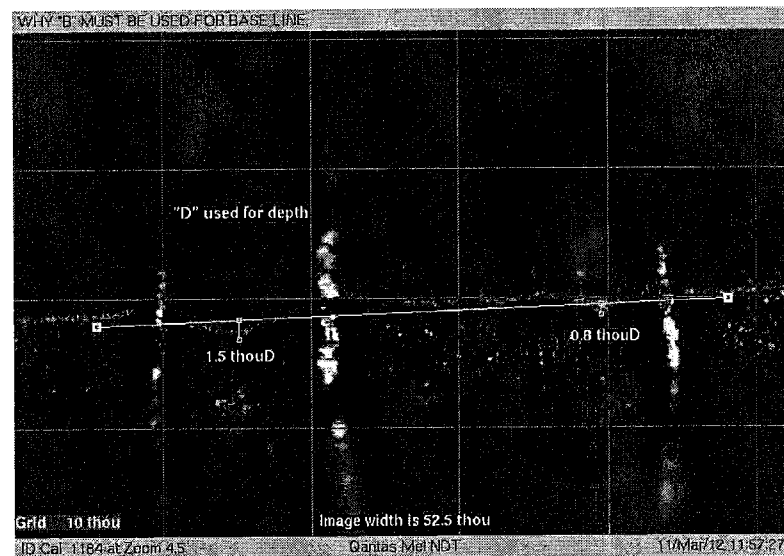
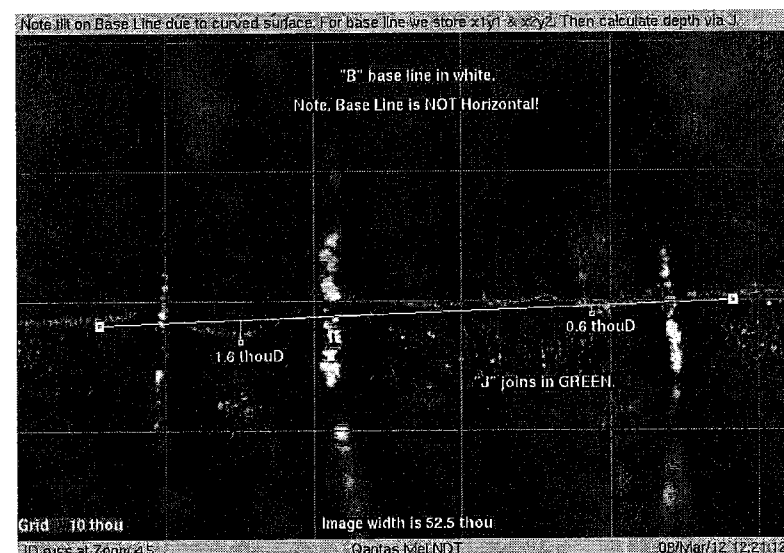
As can be seen from the above two samples, the top one with "D", the lower with "J", only a small difference. But "J" is more accurate!

To clear the confusion we always train to use "J".
