# 2008 DISTRIBUTION WOOD POLE AUDIT REVIEW

## A Review of Western Power's Response to the

## 2006 Regulatory Compliance Assessment of Western Power's

May 2009

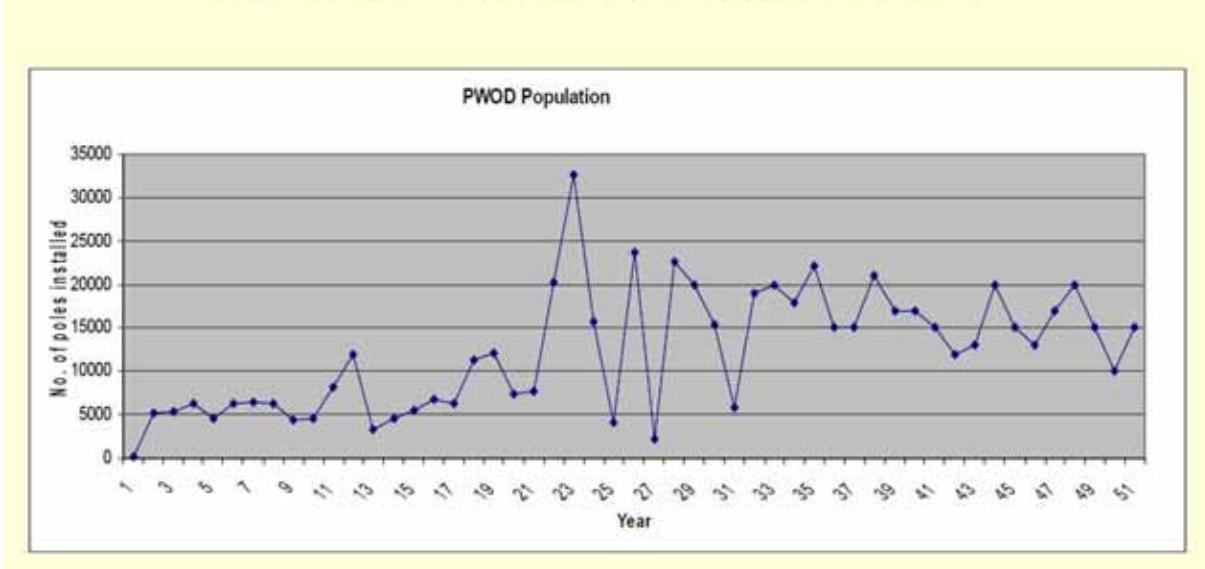
# Age of Distribution Wood Poles

The 'Age of the Distribution Wood Poles' chart presented in the Network Performance Seminar 11 June 2008 is a good example of the data needed to manage wood pole replacement.

Distribution Wood Pole Age Profile - Network Performance Seminar 11 June 2008
