**Cairns Base Hospital**

Cyclone Resilience Study -  
Structural and Building Envelope

CSRR/206509-81/R001

First Issue | 25 September 2012

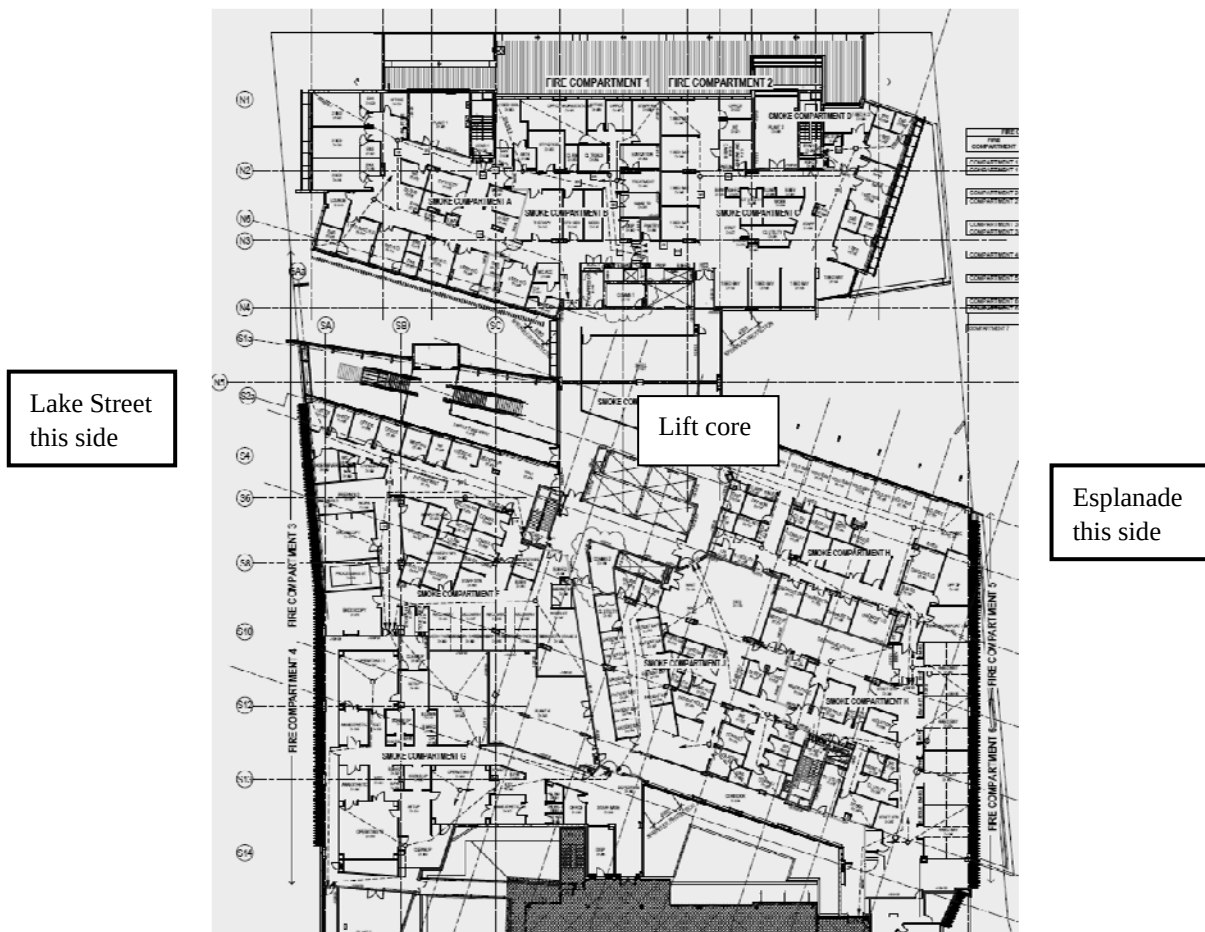
**Figure 4: General layout of Block D at first floor.**

Block D is under construction at the time of writing; due for completion in 2013. It comprises a 3 level podium structure with a further 3 levels of clinical floors plus 2 levels of plant at the top. The layout at Level 1 is shown in Figure 4, below.

All floors, including the ground floor, are suspended decks. The ground floor was built on an earth mound so no sub-floor void exists below this level as it does in other blocks. The ground floor is at a level of 4.05m AHD, to match the other existing blocks.

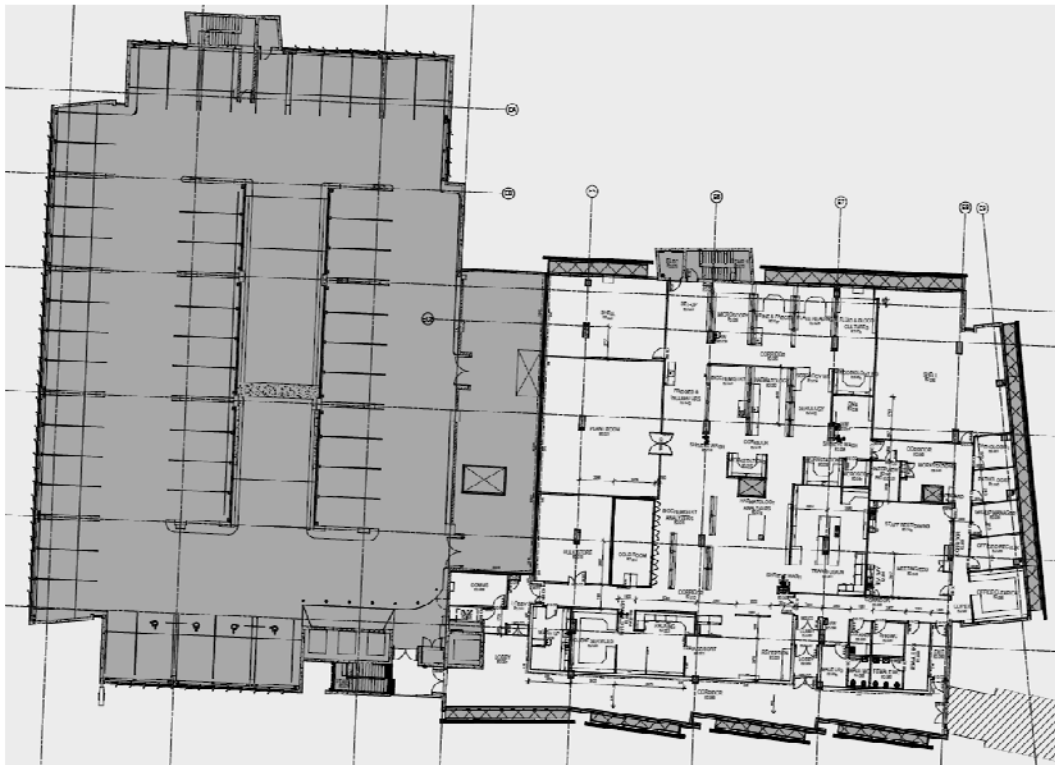
**Figure 5: General layout of Block E at second floor.**

Block E was completed in 2011. It comprises 8 levels of car park with clinical and support services on ground floor, first and second. The ground floor includes three radiation oncology bunkers, which are massive concrete shells with walls up to 2.5m thick in some places.

The main structure is a reinforced concrete frame with a lift core and several stair cores sapped around the floor plate. The building envelope comprises a combination of lightweight cladding including glazing, reinforced concrete walls and open louvres in the car park decks. Many of the glazed areas have external sunshading. The roof to the top car park level is an open-sided Aramax sheet. The full car park decks are entirely naturally ventilated with the louvres allowing air flow while minimising rain penetration under normal conditions.

The ground floor of Block E is lower than the other blocks by approximately 700mm. The general layout of Block E at Level 2 is shown in Figure 5, below.
