# IGNIS ADVISORY NOTE

Evaluation No.IGNS-5216-01 Issue 01 Revision 00 [2017]

## 1 Introduction

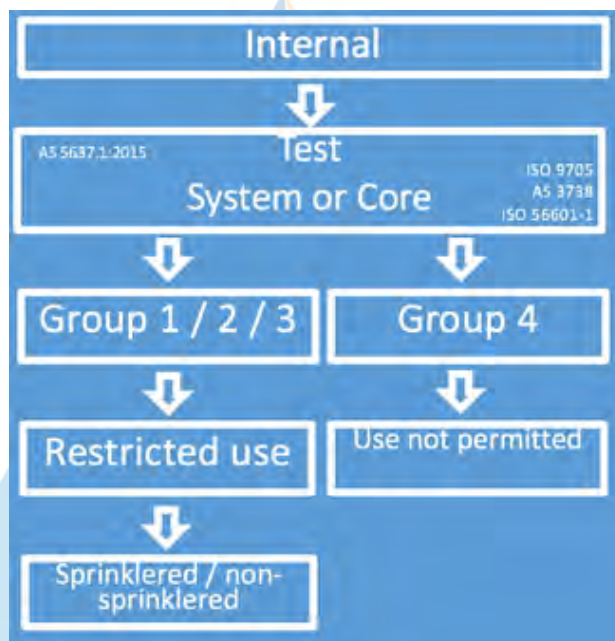
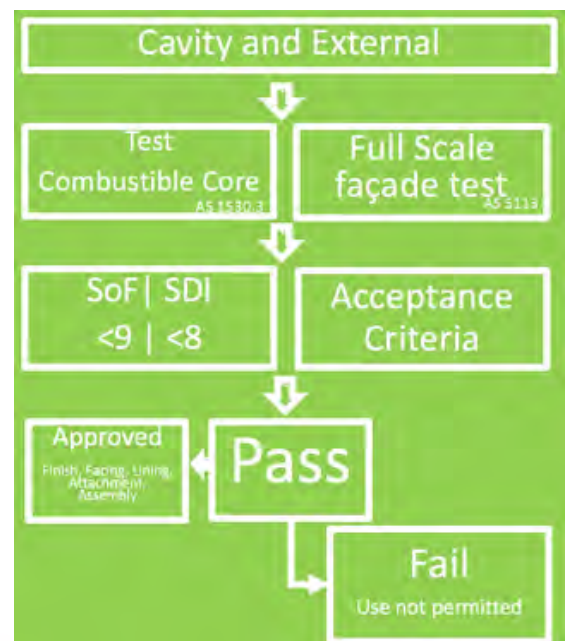
Ignis Solutions has generated the following general flow charts which is then explained in further training documents. With the cavity and external use chart, details on the interaction with full scale testing as well as BCA Specification C1.1 Clause 2.4 are required to be explained further. It is expected that the upcoming verification method. Predicted to be CV3, should assist in providing an appropriate means to achieve compliance.
