**AFTS 629/11/14/RPRT-001**

**CRITICAL REVIEW OF THE KALKARA SYSTEM  
SAFETY AND HAZARD ANALYSIS**

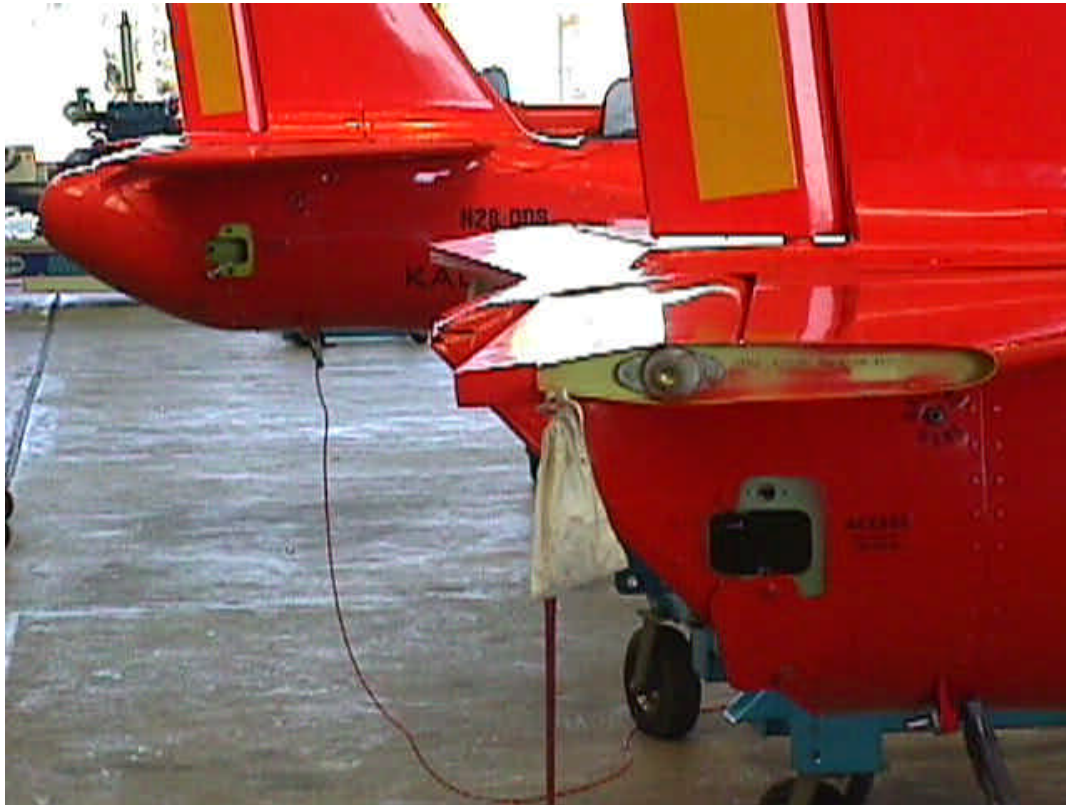
- a. *Water drainage holes:* for example, the left and right halves of the elevator control torque tube are joined centrally by a fabricated universal joint, the attachment bosses of which are inserted and riveted into the torque tubes - therein, they present a step, against which seawater can become trapped, through normal post-recovery flushing and water eradication procedures.
- b. *Corrosion protection:* for example, the elevator torque tube connecting universal joint is fabricated from steel, with no apparent surface treatment finishing. On all aircraft, including those in-store and not yet flown, the universal joints had undergone

corrosion; on aircraft which had flown, the corrosion extent was hastened. With due regard to the water-entrapment probability of the internal steps, it is quite likely that seawater ingress between inner torque tube surfaces and the universal joint boss' surfaces will lead to hastened and marked corrosion, in an area which is very difficult to visually inspect. On this aspect in particular, the critical in-service parameter would not be the number of flights, but the total in-service time since the first flight - as the extent of corrosion deterioration would be likely to increase with time, moreso than with the number of flights (the outboard end of the elevator control torque tube is shown in the following photograph).

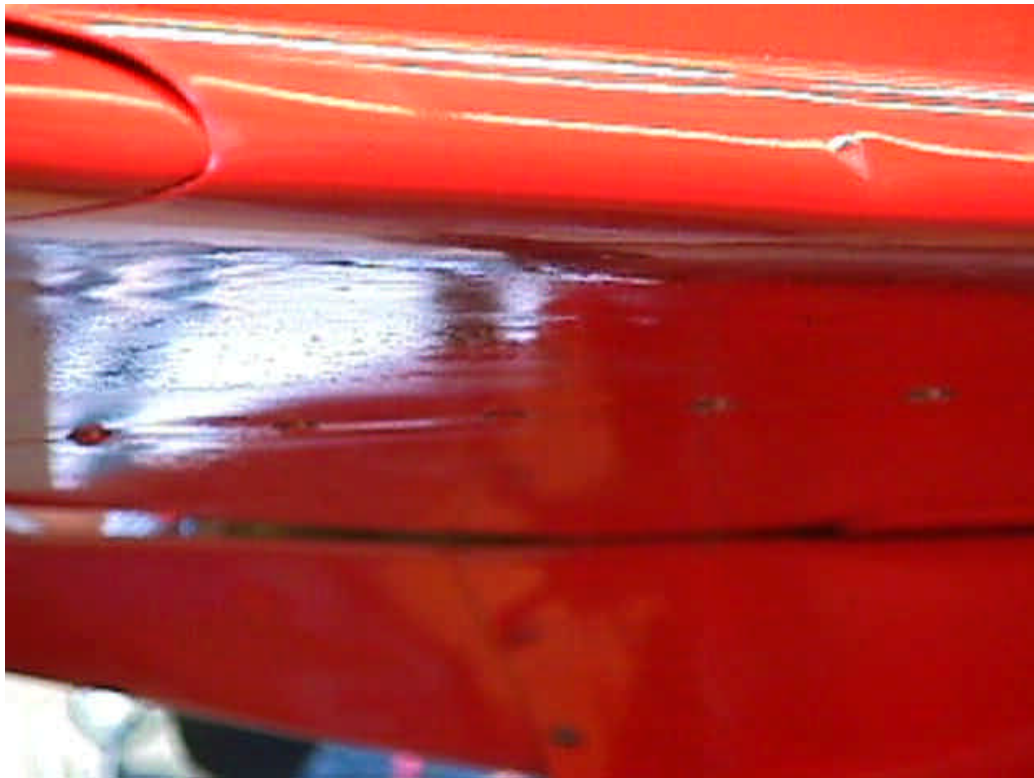
- c. *Damage tolerance and fatigue:* the Kalkara aircraft may presently be without a fatigue qualification, however damage tolerance could be a more critical requirement of airworthiness, especially structural damage that could occur during/post-splashdown or recovery; damage may, and has, occurred due to failure of the parachute to release upon splashdown, and due to the recovery procedure, onto-boat, thence off-boat and onto/off-lorry; corrosion damage tolerance is a further aspect of the structural integrity of the Kalkara airframe, worthy of special consideration in the SSHA; corrosion of the elevator torque tube universal joint, in the first instance, may give rise to hastened wear of the bearing race, in turn increasing the mechanical backlash of the elevators, and hence reducing the damping of some structural vibratory modes - thereby, reducing the flutter margin of the aircraft, in various under-wing target configurations. An example of recovery damage to the airframe is illustrated in the following photograph, of the N28-005 starboard wing - the damage includes a leading edge dent and wing upper surface dimples, both of which have fundamental aerodynamic significance and should be repaired between flights (also observed in the photograph is the wingtip access panel skin joint, which is of variable surface-profile matching, and is therefore, also aerodynamically significant).

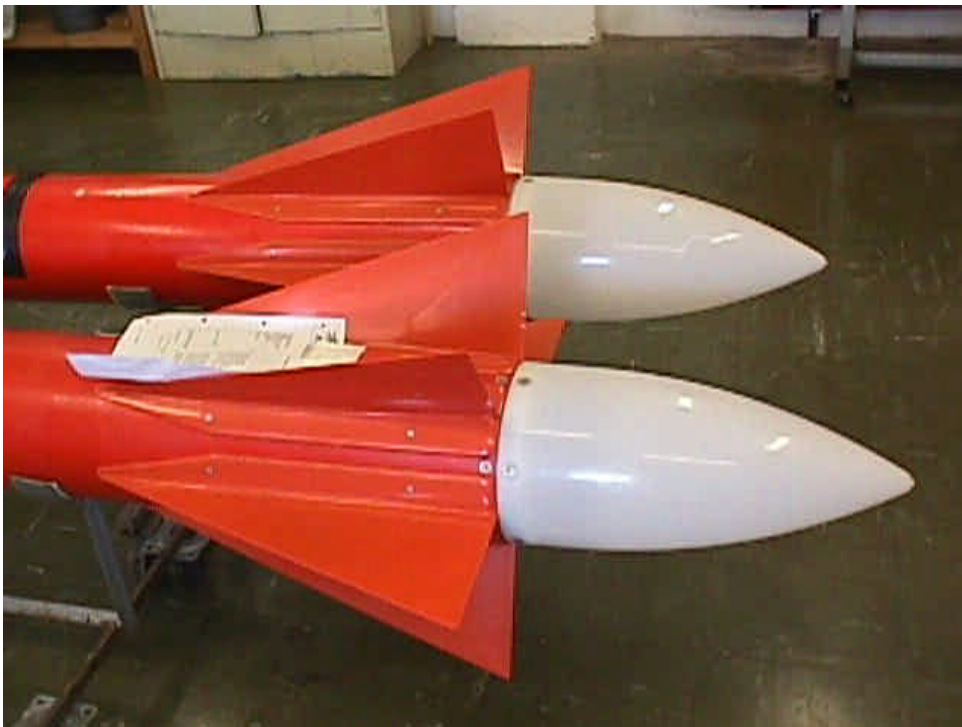
8.5.3 On the matter of the overloads and structural failures, AFTS considers that the tangent-ogive boattails to the RF tows could be contributory to high dynamic loads due to asymmetric harmonically non-steady vortex shedding from the boattails (refer to the following photograph). A truncated boattail, which 'anchors' flow separation and prevents the establishment of harmonically unsteady flow separation, would result in lower dynamic loads.

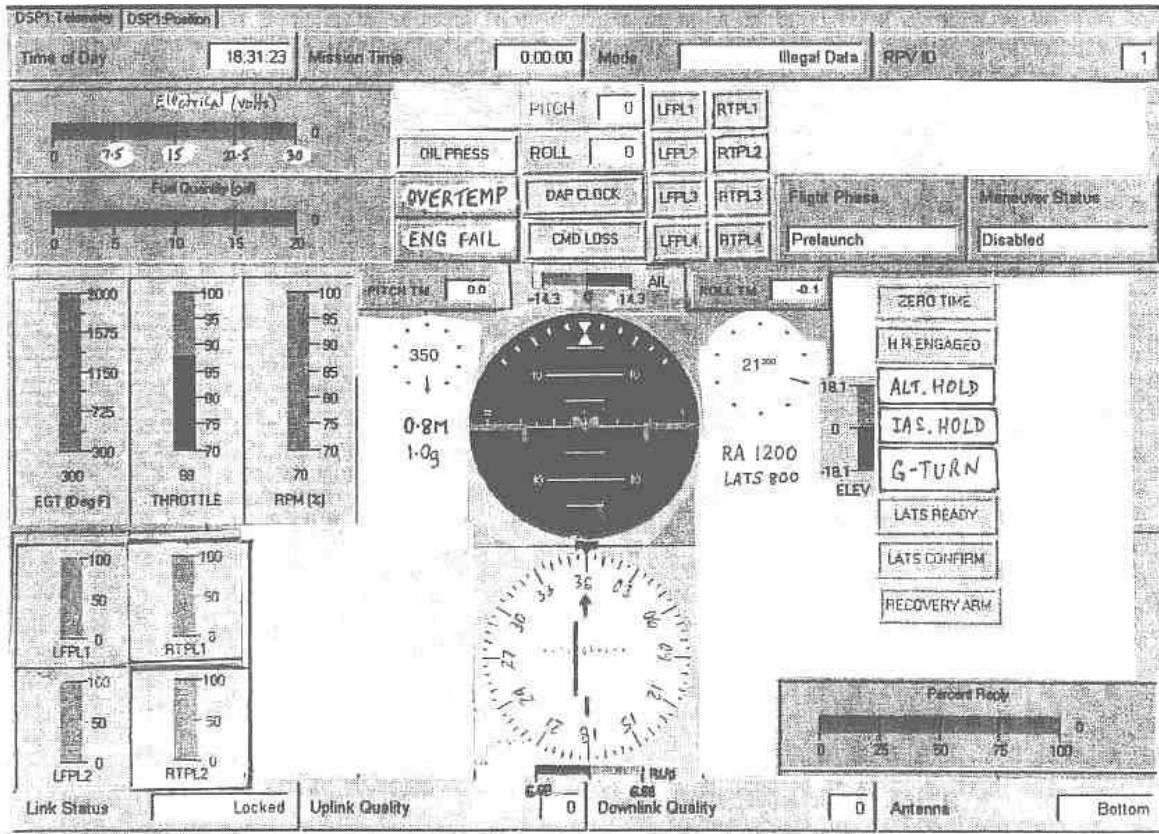
8.10.9 In addition to the Primary Display, the Controller's switch panel is a further Type Design matter, which has a detrimental impact upon System Safety, by inducing Controller errors, in normal and emergency selections. Pertinent features of the panel and improvements, which would reduce the propensity for inducing errors, and hence improve System Safety, include:

- a. Presently, the selector switches are:
  - (1) Closely grouped,
  - (2) Not separated into sections (targets/recover/auto-flight),
  - (3) All similar,

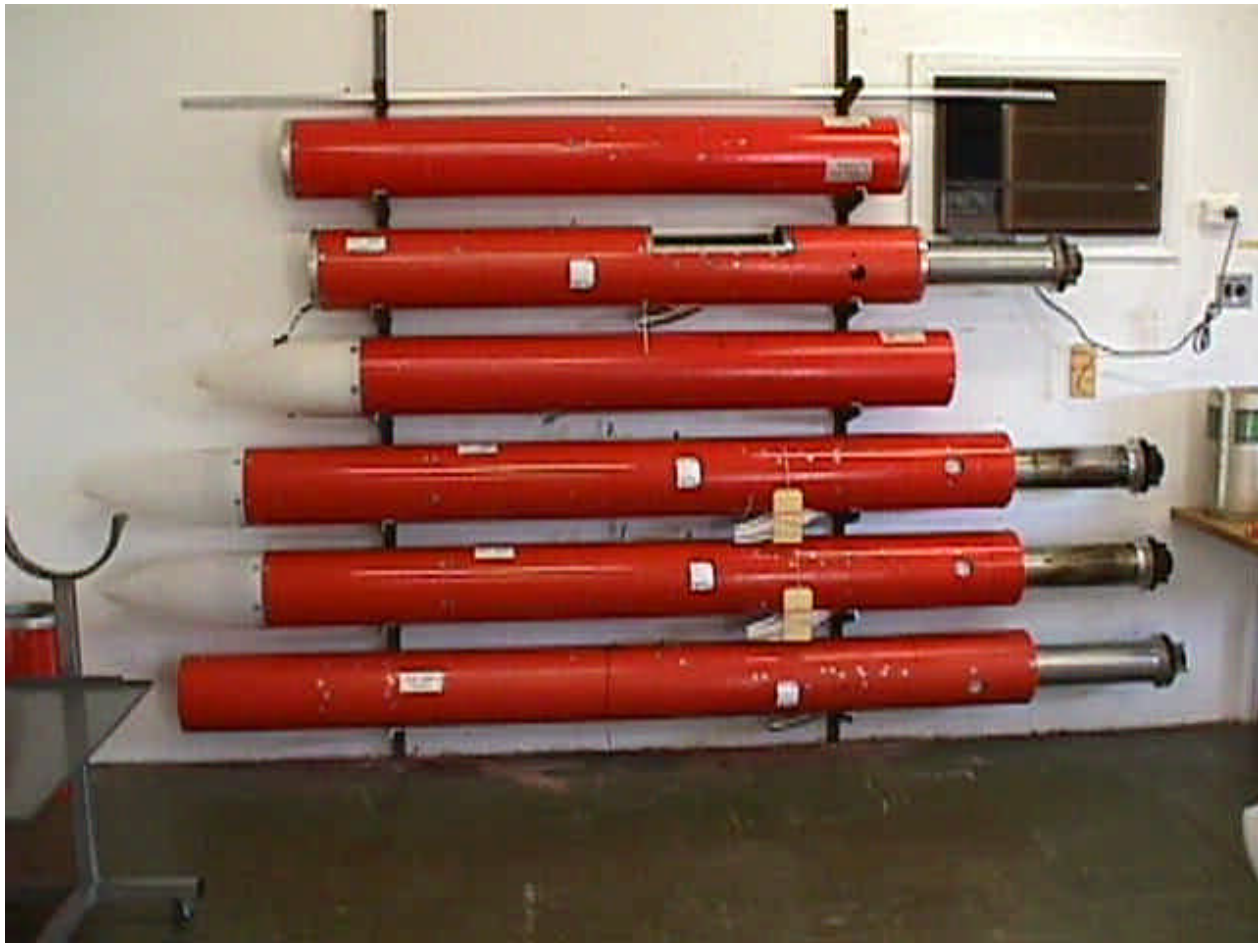
9.4.1 The SSHA does not address the differences in airframe or payloads between the MQM-107E and the Kalkara. A photograph of the Kalkara payloads is shown below. While the description of the differences is included at the upper level of Reference E, there is little in the way of detailed information or any analysis of the actual difference (some analysis of the wing modifications are provided – Reference I) or a reliability analysis of the new equipment and components installed in Kalkara.
