Australian Government
Australian Transport Safety Bureau

Inquiry into Remotely Piloted Aircraft Systems, Unmanned Aerial Systems and associated systems

Appendix C: ATSB consequence analysis of RPAS collisions with other aircraft

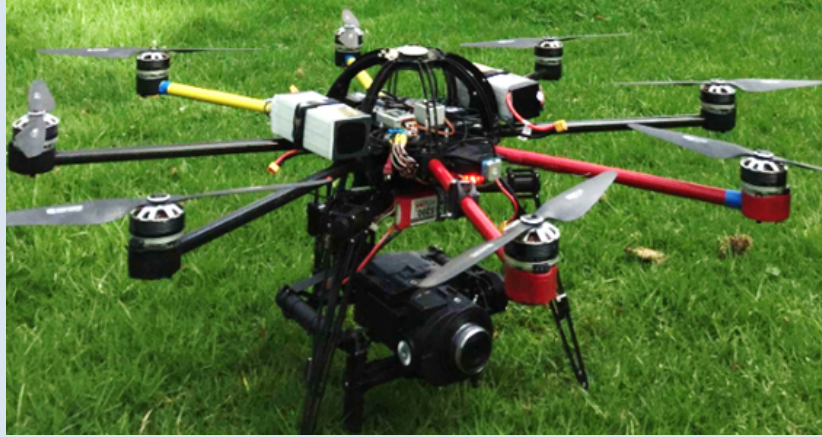
Aeronavics SkyJib 8 remotely piloted aircraft from AO-2015-035. Source: RPA operator

In 2015, an AERONAVICS SKYJIB 8 collided with terrain near Rod Laver Arena, Vic. The RPAS was operating as part of the media coverage of the International Cricket Council World Cup Final, at the Melbourne Cricket Ground. Radio frequency interference was the most likely cause of the accident. The volume of radio frequency traffic at the time of the accident was probably substantial, and perhaps sufficient to override RPA control signals under the prevailing conditions ([ATSB investigation AO-2015-035](#)).
