## **Coal dust in our suburbs: A community-led study of particle pollution in Newcastle and the Lower Hunter coal train corridor**

Prepared by the Coal Terminal Action Group Dust and Health Steering Group

March 2013.

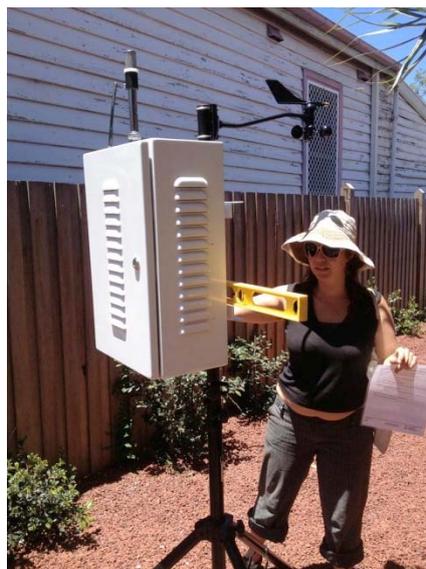
**Picture 1: Representative testing Oris dust monitor**

Three Osiris™ DustTrak portable air quality monitors were used. The monitors simultaneously recorded PM<sub>1</sub>, PM<sub>2.5</sub> and PM<sub>10</sub> at either one minute or 10 minute intervals; as well as wind direction and speed. Each monitor was calibrated before the study began and all three monitors were tested simultaneously at the start of the study. The monitors were used according to the manufacturer's specifications.

Care was taken to ensure that the monitors were positioned to minimise environmental interference such as trees, houses, driveways and so on. The monitors were typically positioned in open lawn areas in the back yards of residences.

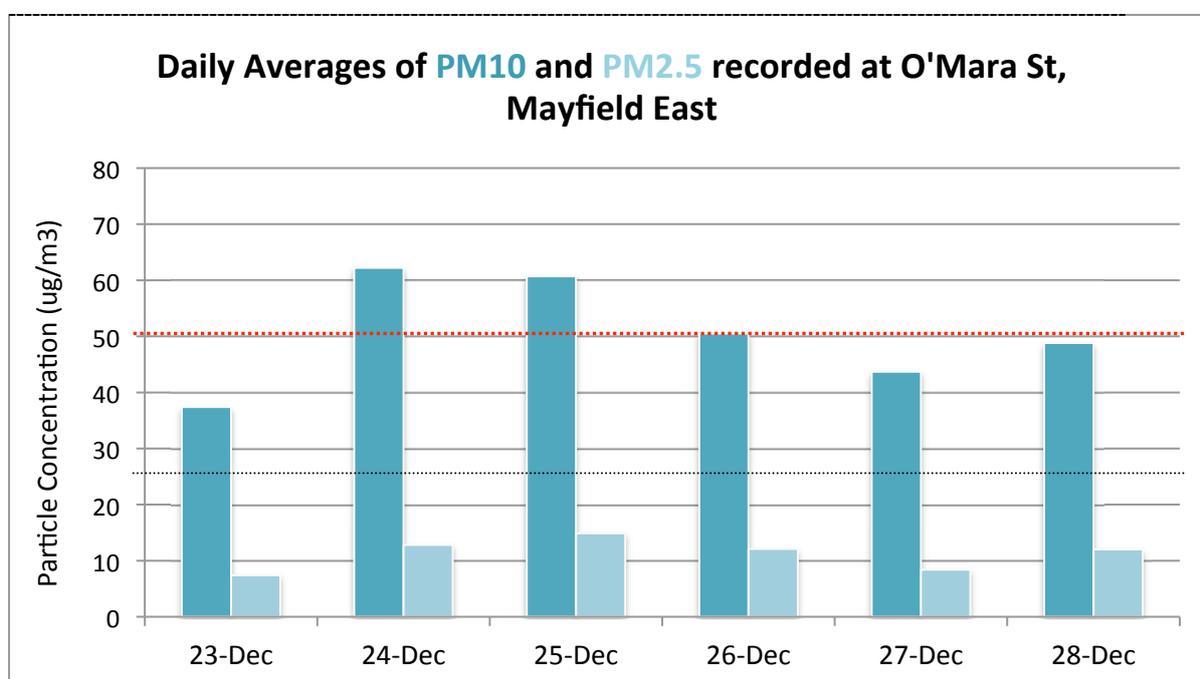
Figure 1: 24-hour averages at O'Mara Street, Mayfield East<sup>2</sup>

O'Mara Street, Mayfield East		
Date	PM <sub>10</sub>	PM <sub>2.5</sub>
23/12/2012	37.4	7.4
24/12/2012	62.2	12.8
25/12/2012	60.7	14.9
26/12/2012	50.5	12.1
27/12/2012	43.7	8.4
28/12/2012	48.8	12

<sup>2</sup> The heavy dashed red line signifies the NEPM PM<sub>10</sub> standard and the light dashed black line indicates the NEPM PM<sub>2.5</sub> guideline.

Figure 1 and Table 1 above show that the PM<sub>10</sub> NEPM standard (50 µgm<sup>-3</sup> average per 24 hours) was exceeded for three of the six days of monitoring and that other days were close to the standard. The highest 24-hour PM<sub>10</sub> average recorded was 62.2µgm<sup>-3</sup>, on 24 Dec.

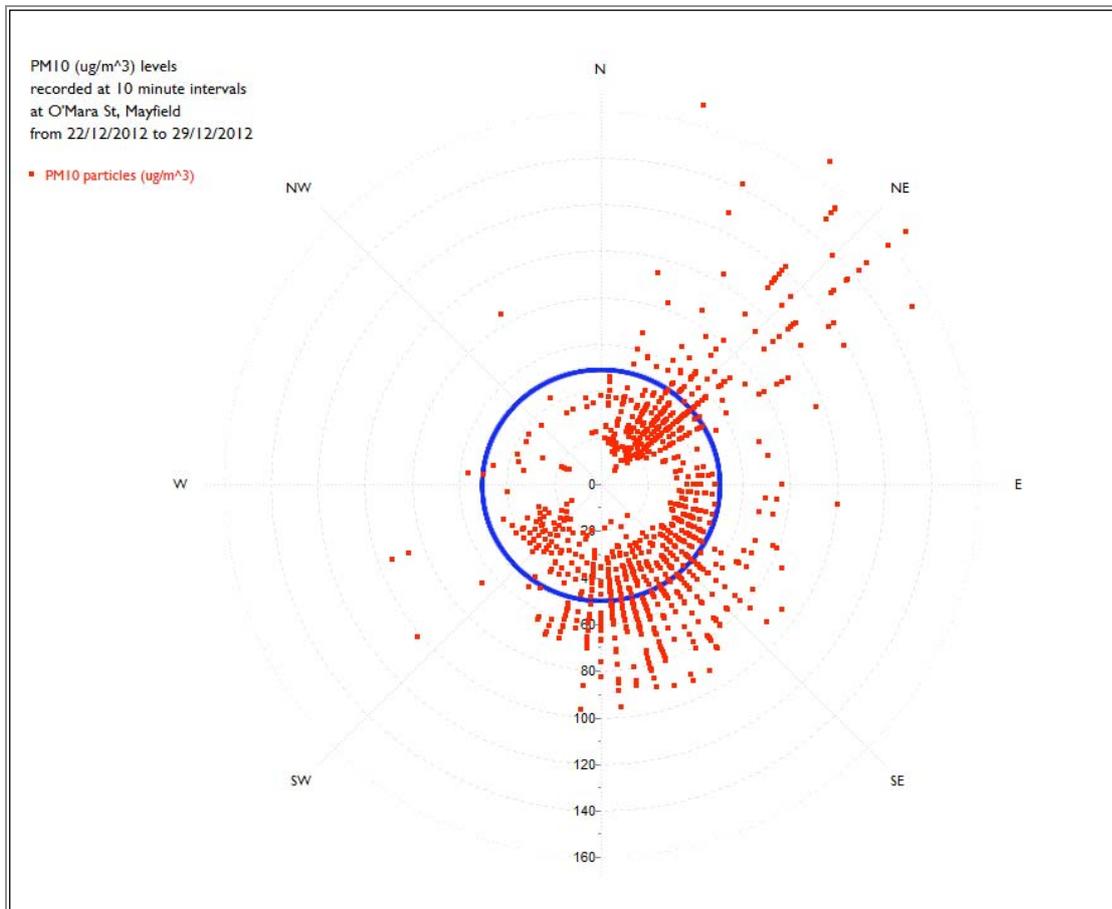
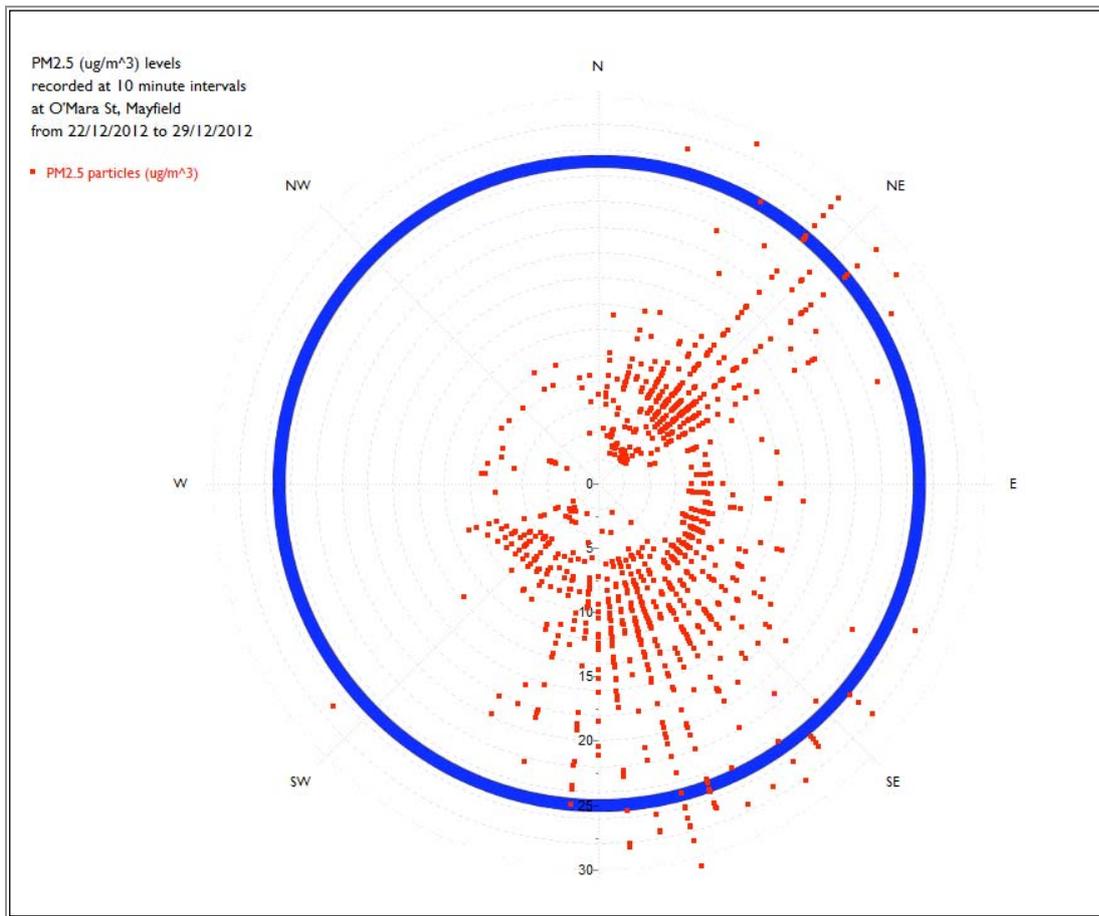
Figure 2: PM<sub>10</sub> concentrations recorded at 10-minute intervals at O'Mara Street, Mayfield

**Figure 3: PM<sub>2.5</sub> concentrations recorded at 10-minute intervals at O'Mara Street, Mayfield**

The above polar graphs indicate that wind was dominated by the north-northeast to southeast directions during this period and that the highest 10-minute average PM<sub>10</sub> concentrations occurred with northeast winds. Airflows would have passed over coal stockpiles and industry to the northeast, which are likely to be significant sources of particles. A second group of higher 10-minute average PM<sub>10</sub> concentrations occurred when winds were from the south-south-east, suggesting the coal rail line in this direction is a likely source. The city of Newcastle to the south-east is also a possible source.

A higher proportion of the PM<sub>2.5</sub> readings occurred from the south-southeast, indicating combustion activities from the city of Newcastle are a significant source of PM<sub>2.5</sub>.

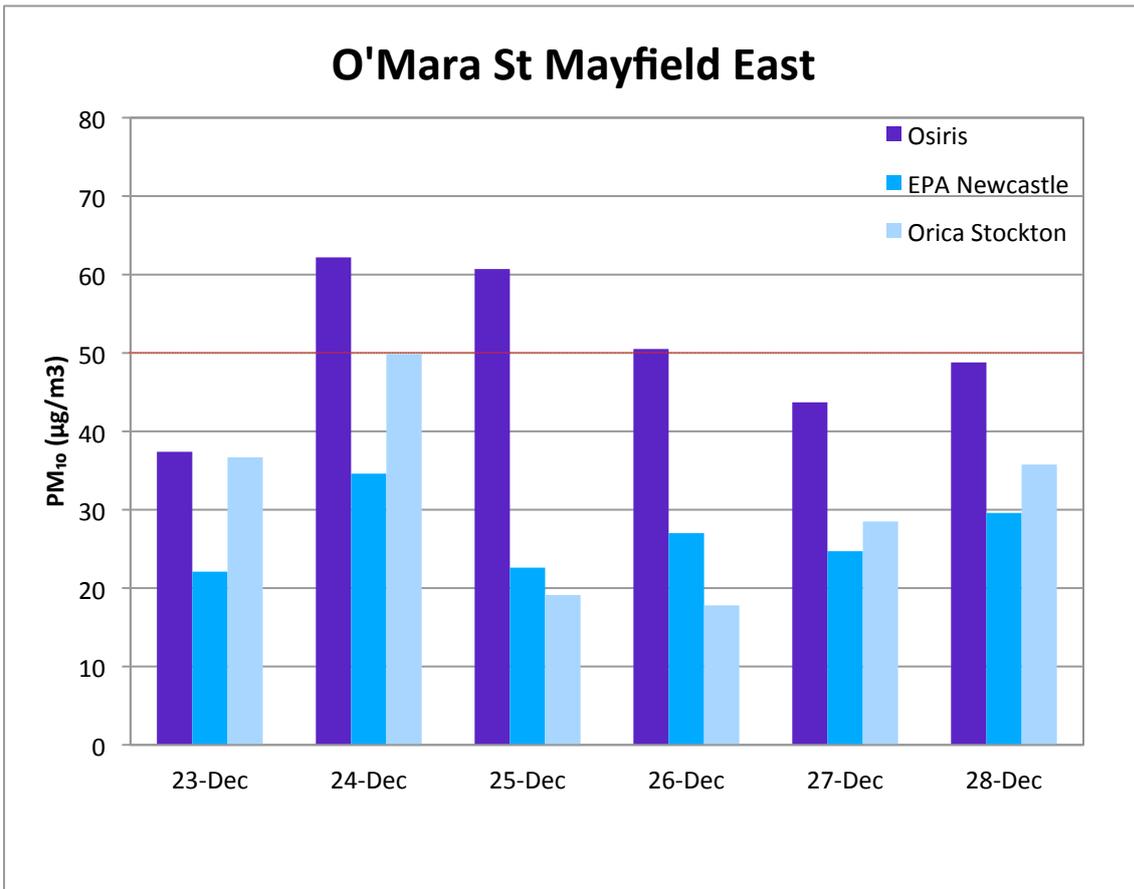
Figure 4: Comparative daily averages of PM<sub>10</sub> for Orisis at O'Mara Street, Mayfield East, EPA at Cooks Hill and Orica at Stockton<sup>3</sup>

Date	Osiris Mayfield East PM <sub>10</sub>	EPA Newcastle PM <sub>10</sub>	Orica Stockton PM <sub>10</sub>
23/12/2012	37.4	22.1	36.7
24/12/2012	62.2	34.6	49.9
25/12/2012	60.7	22.6	19.1
26/12/2012	50.5	27	17.8
27/12/2012	43.7	24.7	28.5
28/12/2012	48.8	29.6	35.8

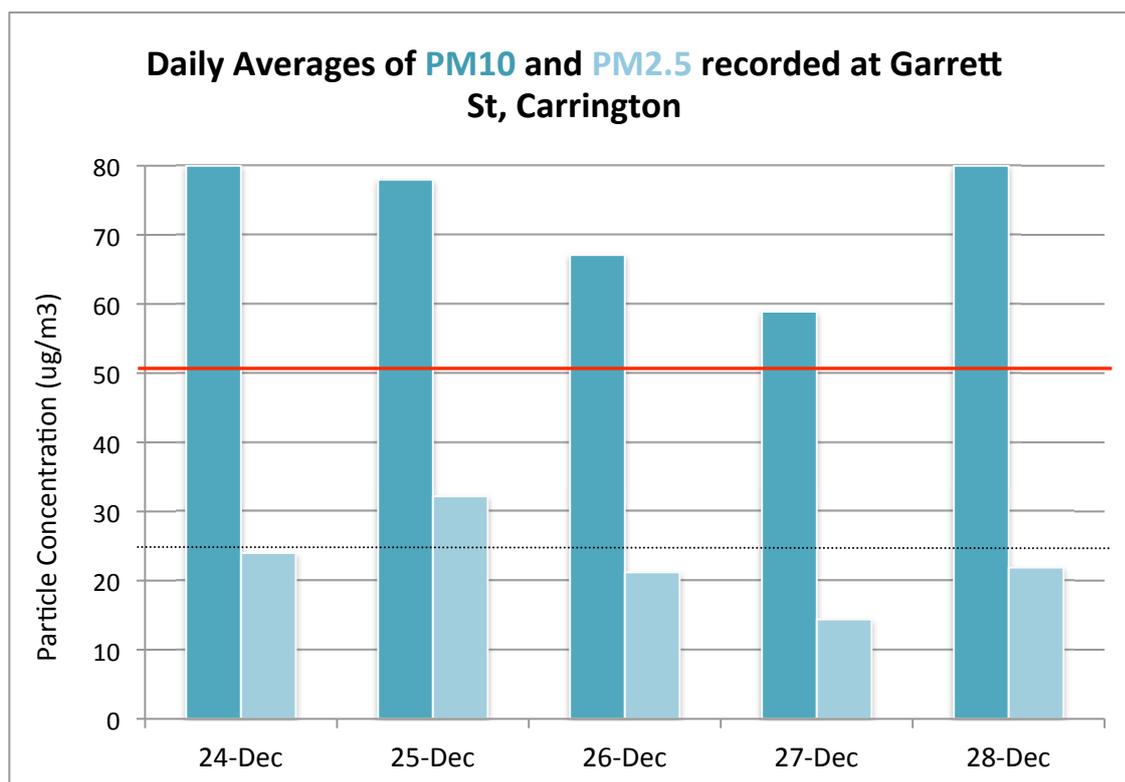
Figure 5: 24-hour averages at Garrett Street, Carrington<sup>4</sup>

Garrett St, Carrington		
Date	PM <sub>10</sub>	PM <sub>2.5</sub>
24/12/2012	80	24
25/12/2012	78	32.2
26/12/2012	67.1	21.2
27/12/2012	58.9	14.4
28/12/2012	80	21.9

These results are the highest daily  $\text{PM}_{10}$  and  $\text{PM}_{2.5}$  averages recorded in any of the 11 sites monitored during the study period, suggesting that Carrington residential areas have a substantial air quality problem.

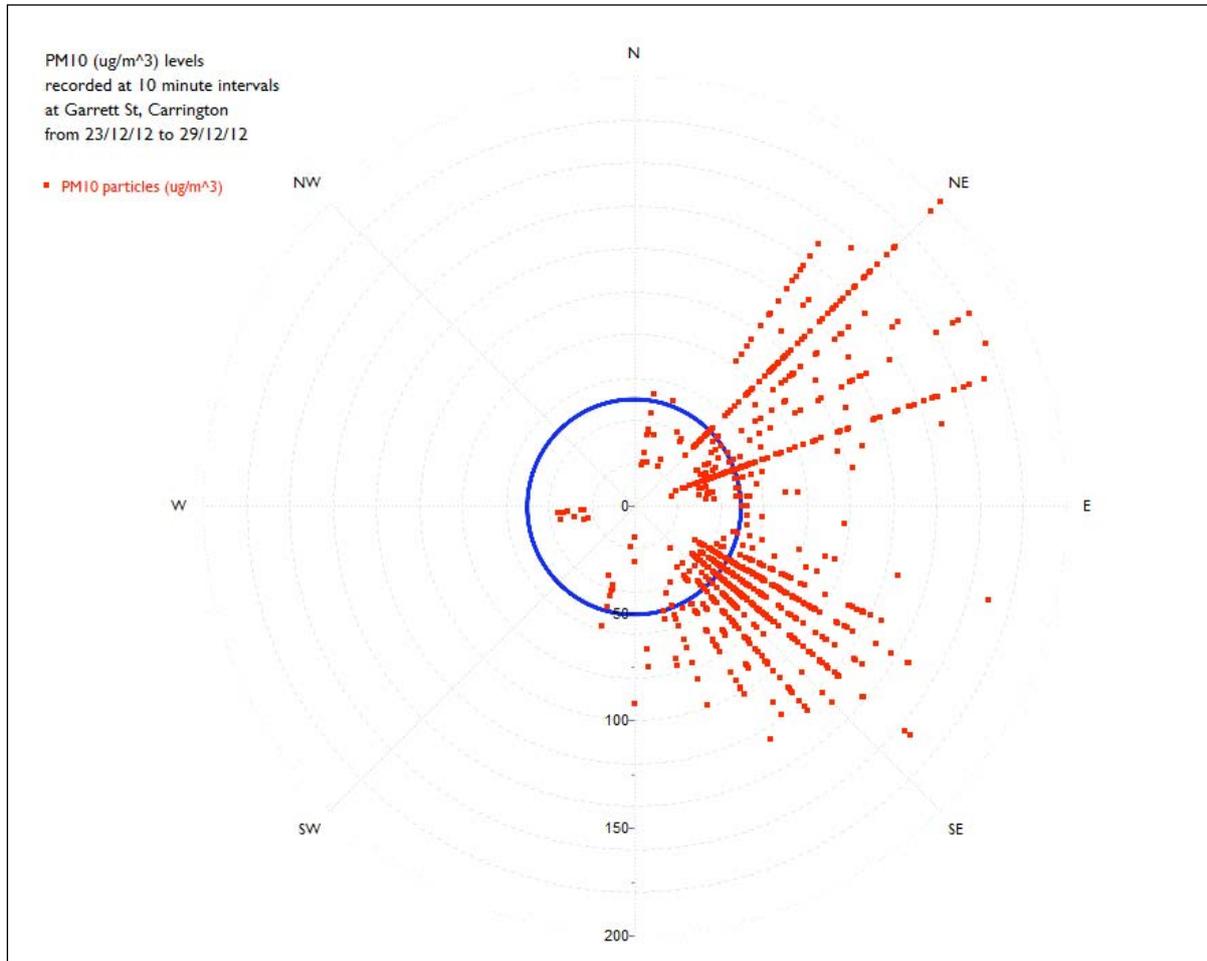
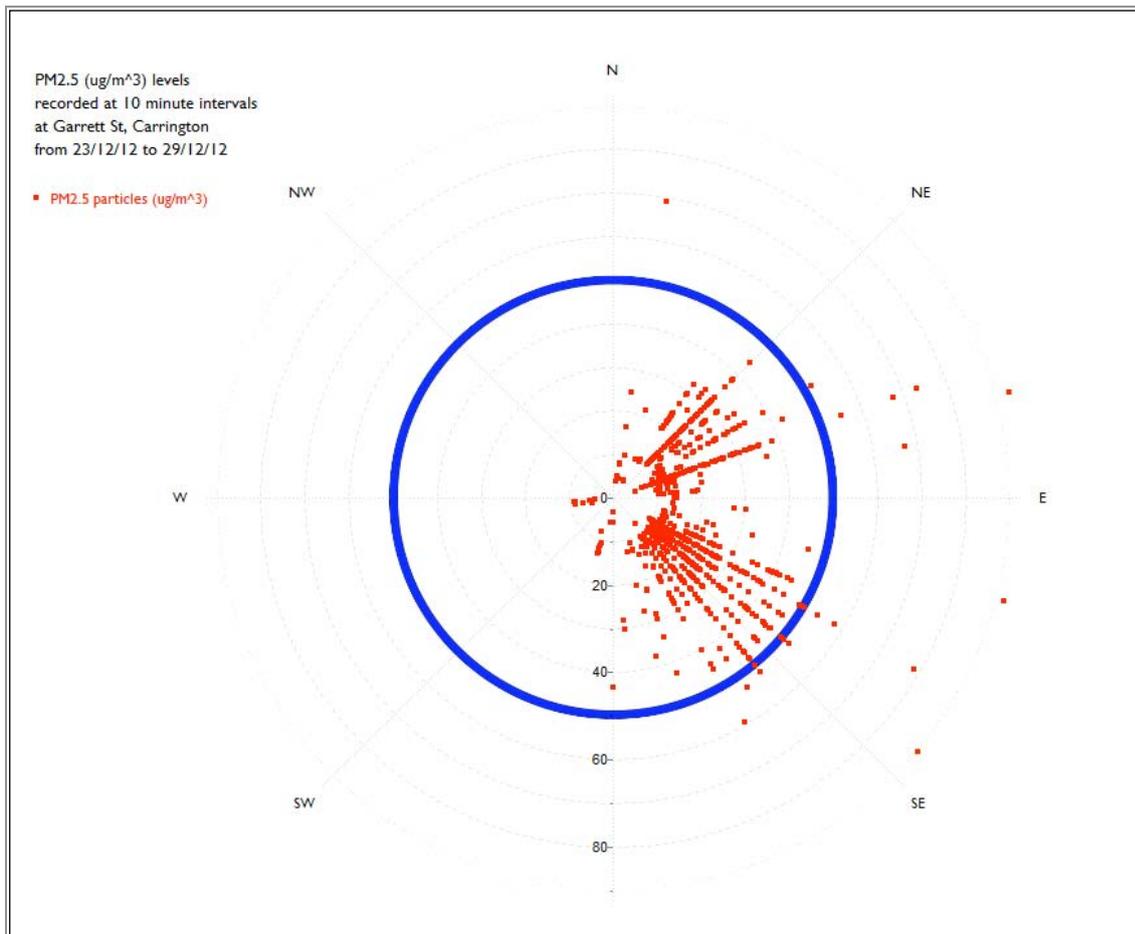
Figure 6:  $\text{PM}_{10}$  concentrations recorded at 10-minute intervals at Garrett Street, Carrington

**Figure 7: PM<sub>2.5</sub> concentrations recorded at 10-minute intervals at Garrett Street, Carrington**

The polar graphs in Figures 6 and 7 above show the breakdown of PM<sub>10</sub> and PM<sub>2.5</sub> concentration in relation to wind direction and speed. These graphs show that winds came almost exclusively from the east-northeast and east-southeast during this period. The recorded wind speed data showed that higher wind speeds occurred from the east-southeast.

The polar graphs show that PM<sub>10</sub> and PM<sub>2.5</sub> 10-minute concentrations are highest in air from the dominant wind directions, which are blowing over the port and other industrial infrastructure from the east-northeast and east-southeast (including parts of the Carrington Coal Terminal). The relatively higher concentrations of PM<sub>2.5</sub> occur in southeasterly winds, suggesting that combustion activities from this broad direction were a significant source of PM<sub>2.5</sub> during the monitoring period.

The PM<sub>10</sub> graph shows that the majority of 10 minute average readings are well above 50µgm<sup>-3</sup>, which translates into very high short-term peaks of PM<sub>10</sub> within each 24 hour period.

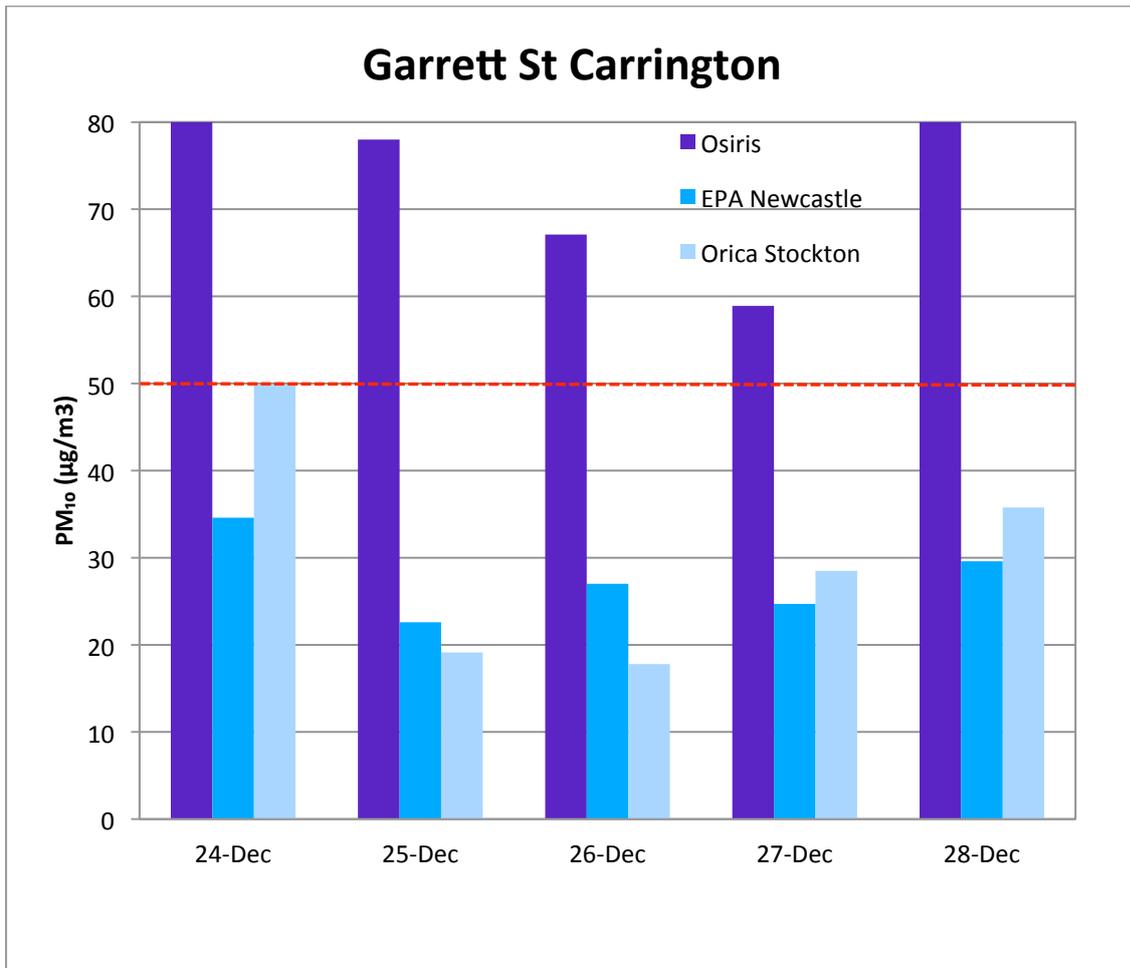
Figure 8: Comparative 24-hour averages of PM<sub>10</sub> for Garrett Street, Carrington, EPA Cooks Hill and Orica Stockton<sup>5</sup>

Date	Osiris Carrington PM <sub>10</sub>	EPA Newcastle PM <sub>10</sub>	Orica Stockton PM <sub>10</sub>
24/12/2012	80	34.6	49.9
25/12/2012	78	22.6	19.1
26/12/2012	67.1	27	17.8
27/12/2012	58.9	24.7	28.5
28/12/2012	80	29.6	35.8

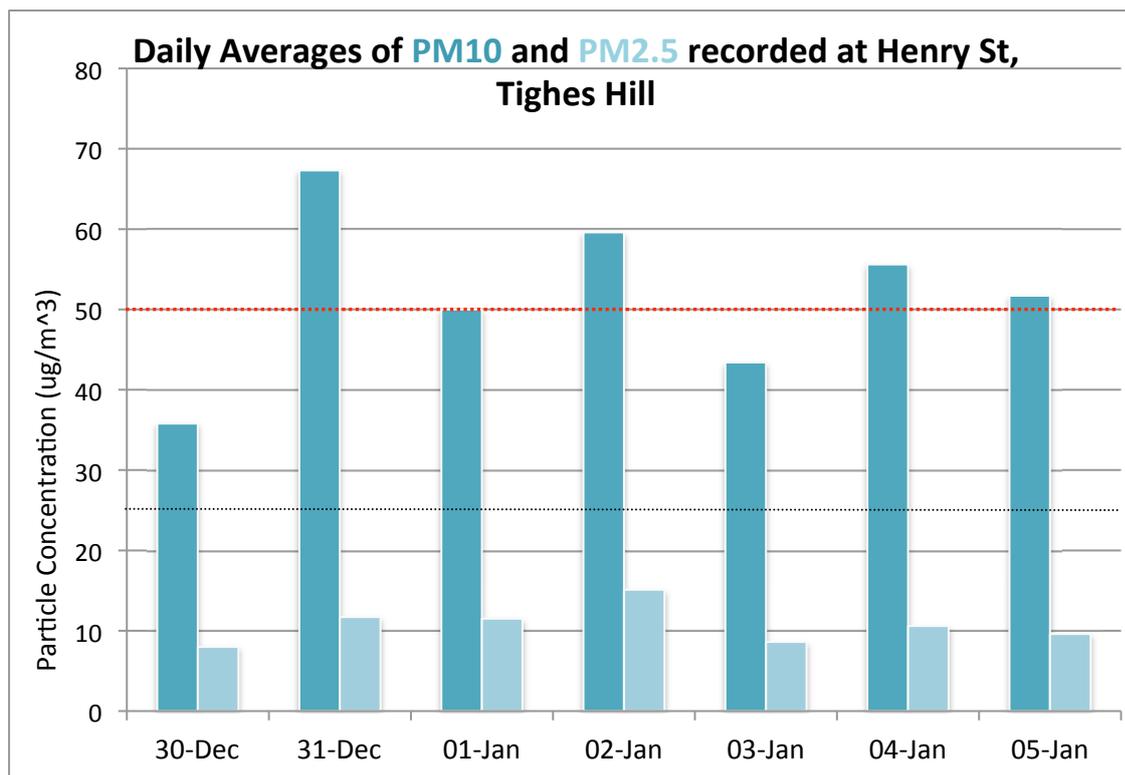
Figure 9: 24-hour averages at Henry Street, Tighes Hill<sup>6</sup>

Henry Street, Tighes Hill		
Date	PM <sub>10</sub>	PM <sub>2.5</sub>
30/12/2012	35.8	8
31/12/2012	67.3	11.7
1/01/2013	50	11.5
2/01/2013	59.6	15.1
3/01/2013	43.4	8.6
4/01/2013	55.6	10.6
5/01/2013	51.7	9.6

<sup>6</sup> The heavy dashed red line signifies the NEPM PM<sub>10</sub> standard and the light dashed black line indicates the NEPM PM<sub>2.5</sub> guideline.

are the second highest daily PM<sub>10</sub> averages recorded in any of the 12 sites monitored during the study period, suggesting that Tighes Hill residential areas have a substantial air quality problem.

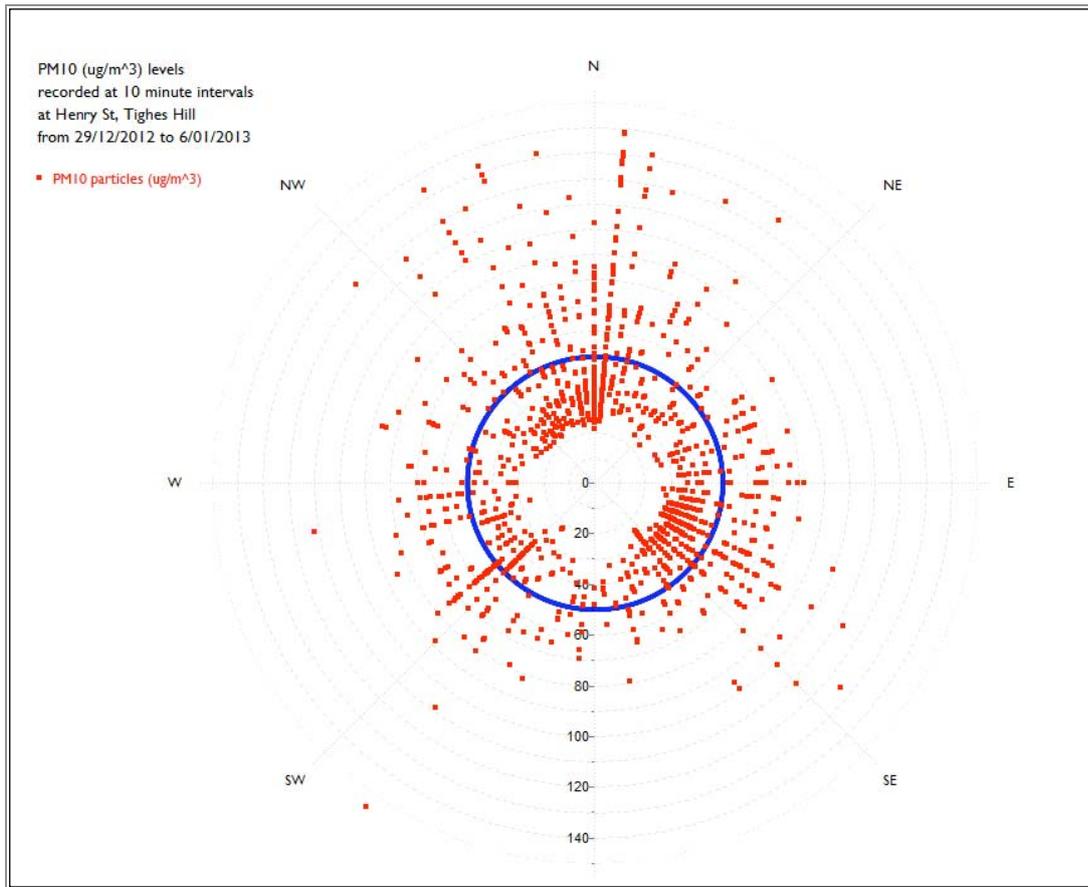
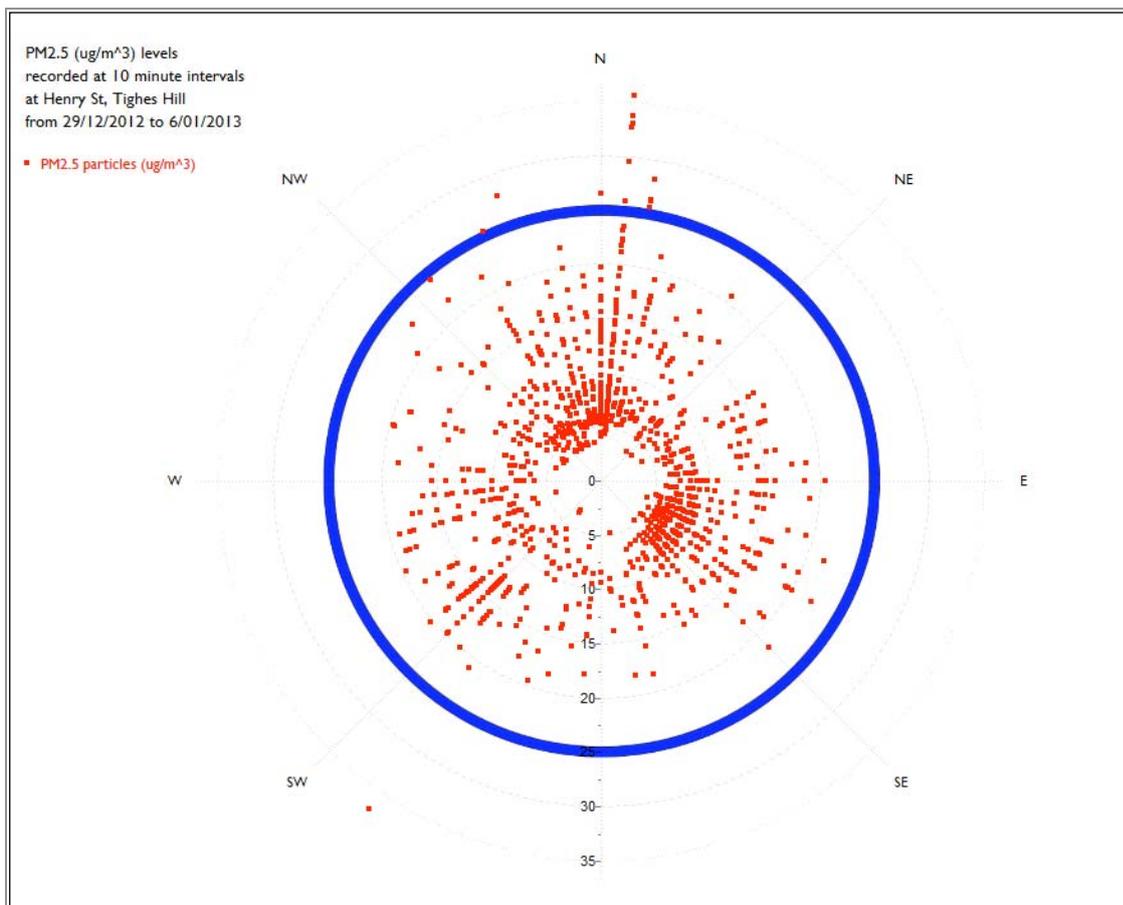
Figure 10: PM<sub>10</sub> concentrations recorded at 10-minute intervals at Henry Street, Tighes Hill

**Figure 11: PM<sub>2.5</sub> concentrations recorded at 10-minute at Henry Street, Tighes Hill**

The polar graphs in Figures 10 and 11 above show the breakdown of PM<sub>10</sub> and PM<sub>2.5</sub> concentration in relation to wind direction and speed. This indicates that wind generally came from all directions during this period. The higher 10-minute average PM<sub>10</sub> and PM<sub>2.5</sub> concentrations come from most wind directions, but slightly more from the northern quadrant, which includes substantial areas of industrial land including the Carrington Coal Terminal.

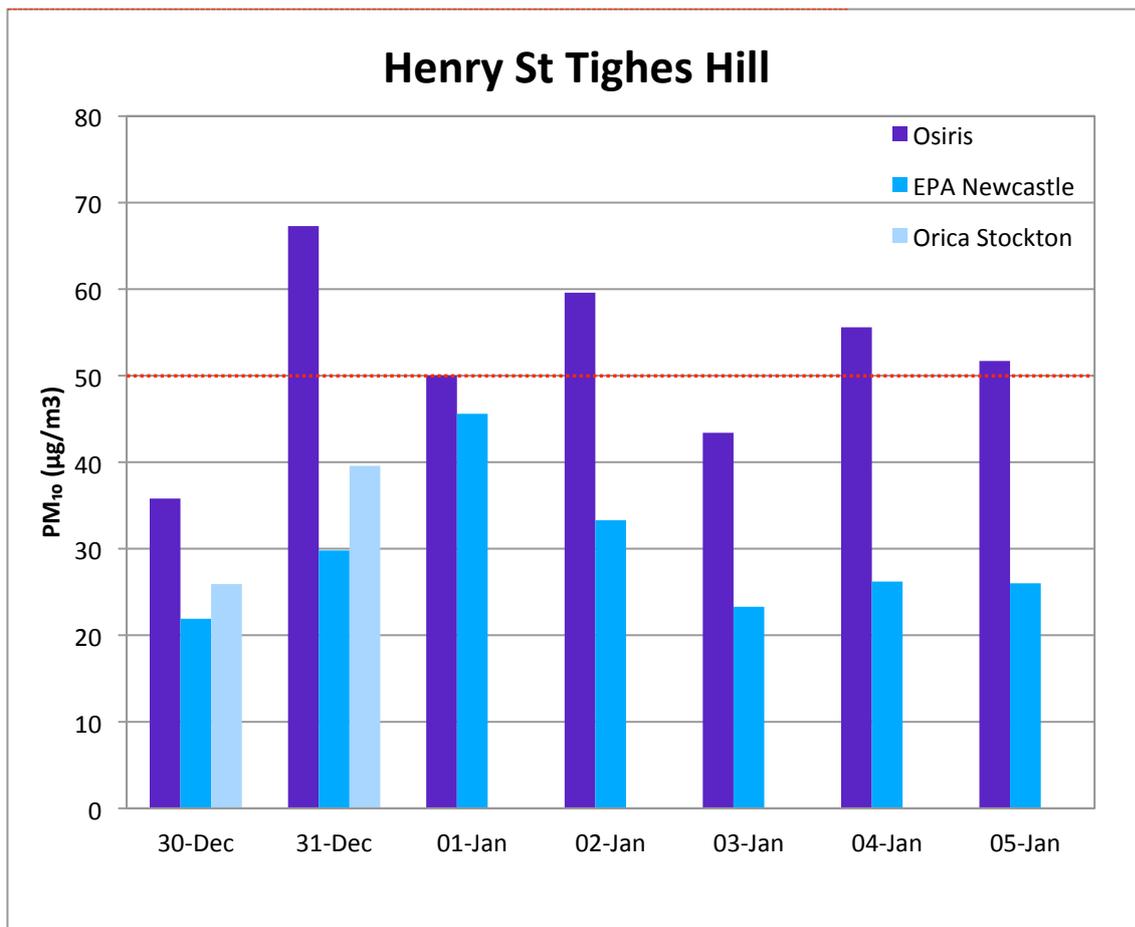
Figure 12: Comparative 24-hour averages of PM<sub>10</sub> recorded for Orisis at Henry Street, Tighes Hill, EPA at Cooks Hill and Orica at Stockton<sup>7</sup>

Date	Osiris Tighes Hill PM <sub>10</sub>	EPA Newcastle PM <sub>10</sub>	Orica Stockton PM <sub>10</sub>
30/12/2012	35.8	21.9	25.9
31/12/2012	67.3	29.8	39.6
1/01/2013	50	45.6	
2/01/2013	59.6	33.3	
3/01/2013	43.4	23.3	
4/01/2013	55.6	26.2	
5/01/2013	51.7	26

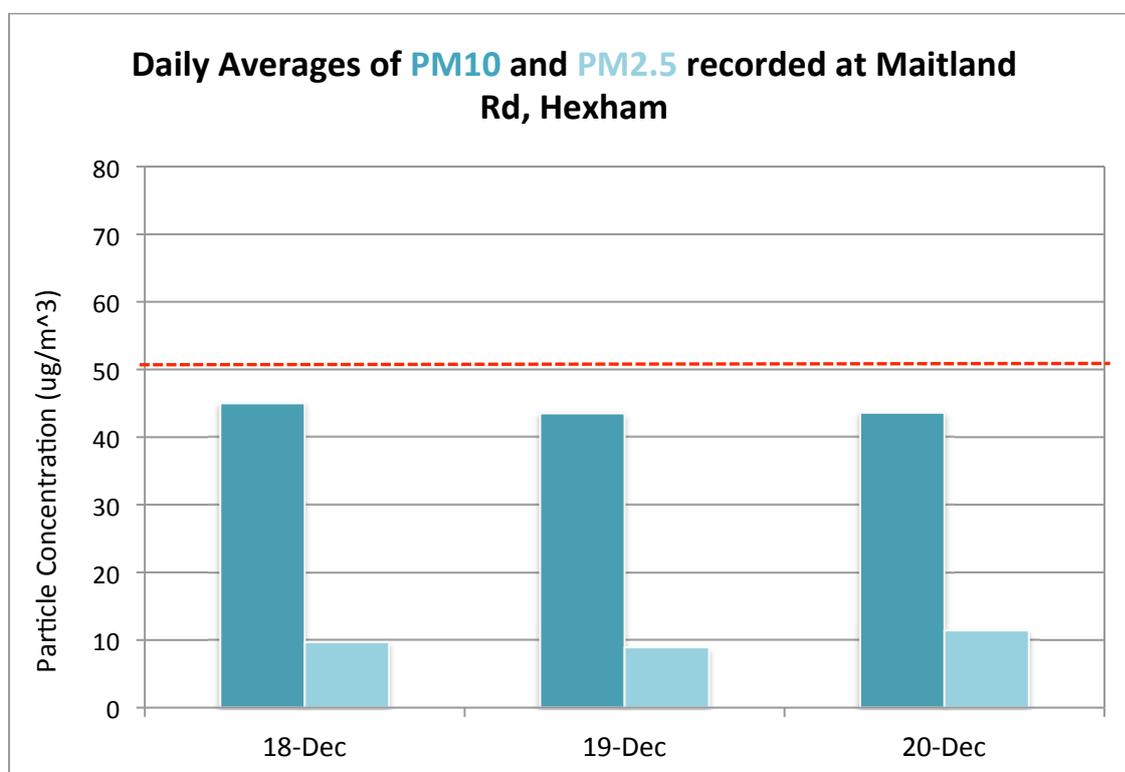
Figure 13: 24-hour averages at Maitland Road, Hexham<sup>9</sup>

Maitland Rd, Hexham		
Date	PM <sub>10</sub>	PM <sub>2.5</sub>
18/12/2012	45	9.7
19/12/2012	43.5	8.9
20/12/2012	43.6	11.4

<sup>9</sup> The heavy dashed red line signifies the NEPM  $\text{PM}_{10}$  standard.

results for average  $PM_{10}$  and  $PM_{2.5}$  concentrations show the least variability between days for all 11 sites monitored during the study period.

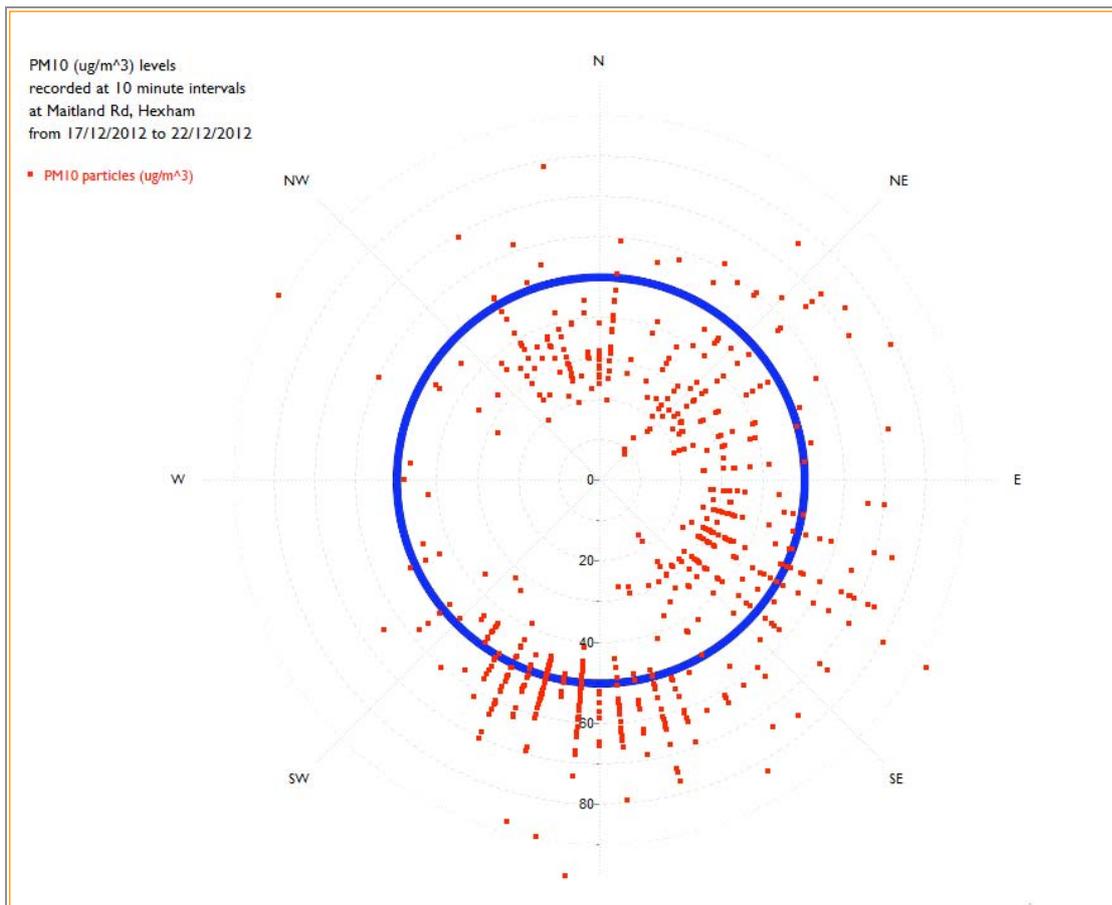
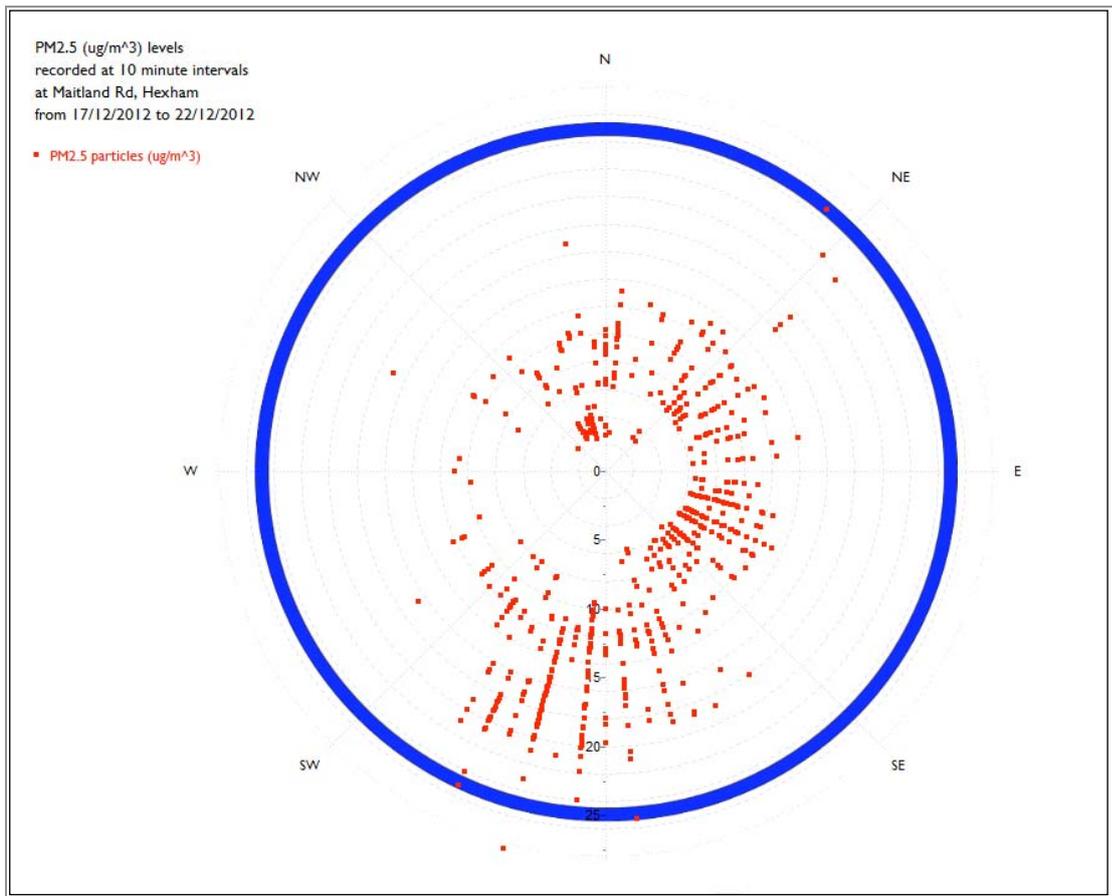
Figure 14:  $PM_{10}$  concentrations recorded at 10-minute intervals at Maitland Road, Hexham

Figure 15: PM<sub>2.5</sub> concentrations recorded at 10-minute intervals at Maitland Road, Hexham

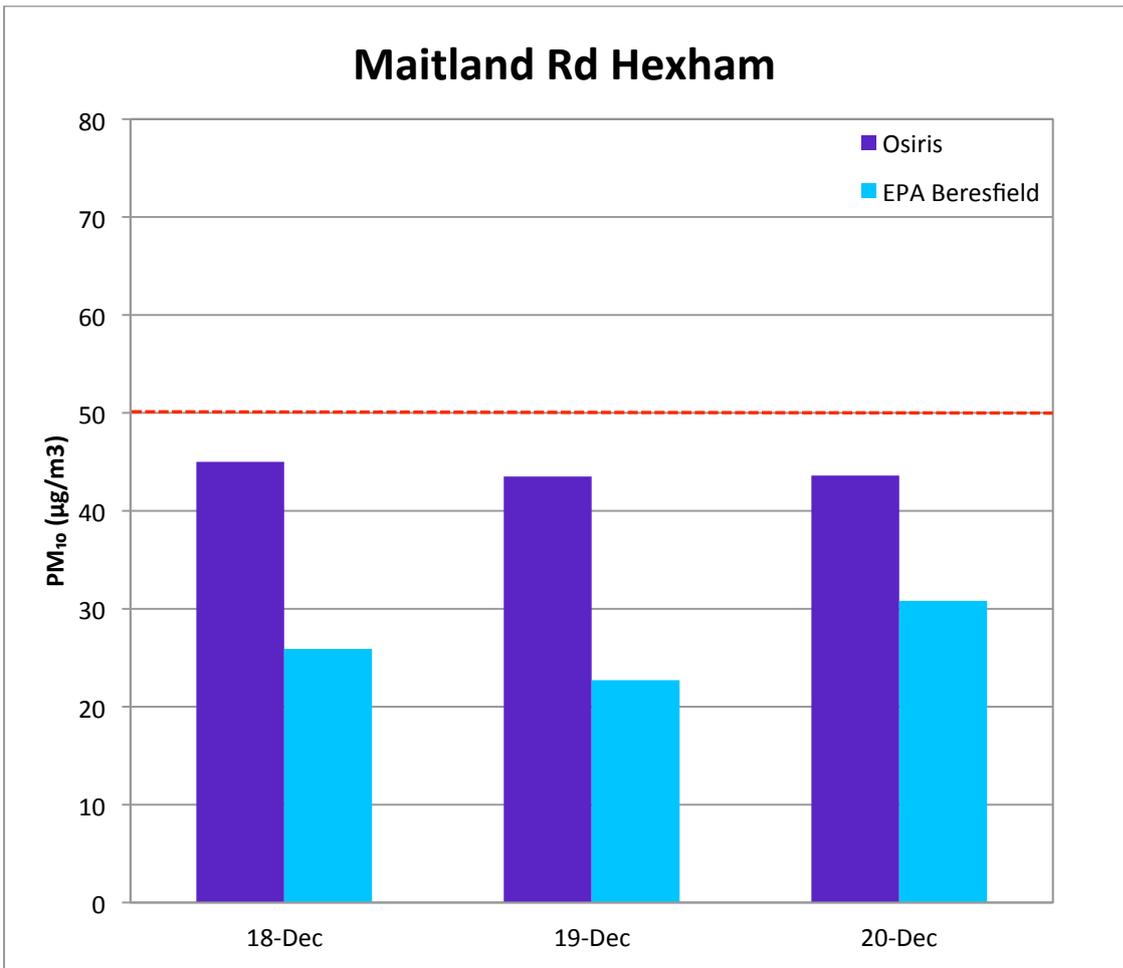
Figure 16: Comparative 24-hour averages of PM<sub>10</sub> for Osiris at Maitland Road, Hexham and EPA at Beresfield<sup>10</sup>

Date	Osiris Hexham PM <sub>10</sub>	EPA Beresfield PM <sub>10</sub>
18/12/2012	45	25.9
19/12/2012	43.5	22.7
20/12/2012	43.6	30.8

<sup>10</sup> The heavy dashed red line signifies the NEPM PM<sub>10</sub> standard.

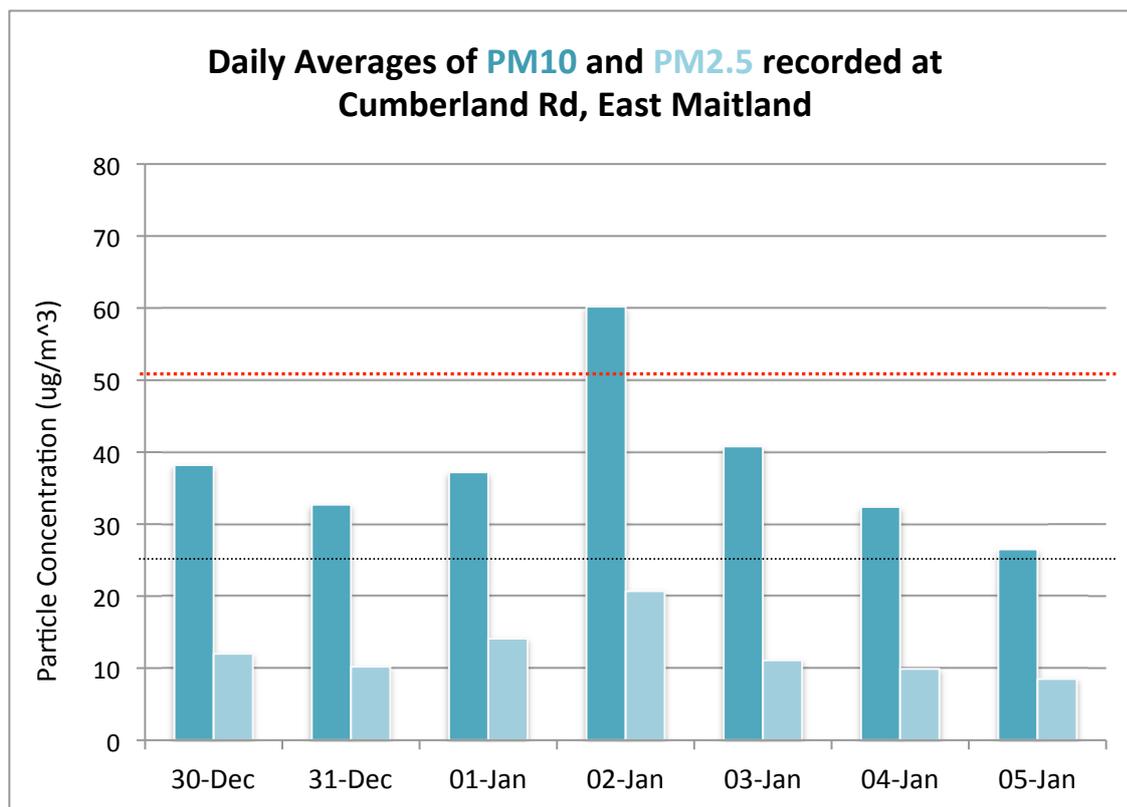
Figure 17: 24-hour averages at Cumberland Road, East Maitland<sup>11</sup>

Cumberland Rd, East Maitland		
Date	PM <sub>10</sub>	PM <sub>2.5</sub>
30/12/2012	38.2	12
31/12/2012	32.7	10.2
1/01/2013	37.2	14.1
2/01/2013	60.2	20.7
3/01/2013	40.8	11.1
4/01/2013	32.4	9.9
5/01/2013	26.5	8.5

<sup>11</sup> The heavy dashed red line signifies the NEPM PM<sub>10</sub> standard and the light dashed black line indicates the NEPM PM<sub>2.5</sub> guideline.

Figure 17 and Table 9 above shows that the PM<sub>10</sub> NEPM (50µgm<sup>-3</sup> average per 24 hours) was exceeded on 02 Jan all five days of monitoring. Five of the remaining six days showed PM<sub>10</sub> concentrations in the range of 30-40.8µgm<sup>-3</sup>, 60-80% of the NEPM level.

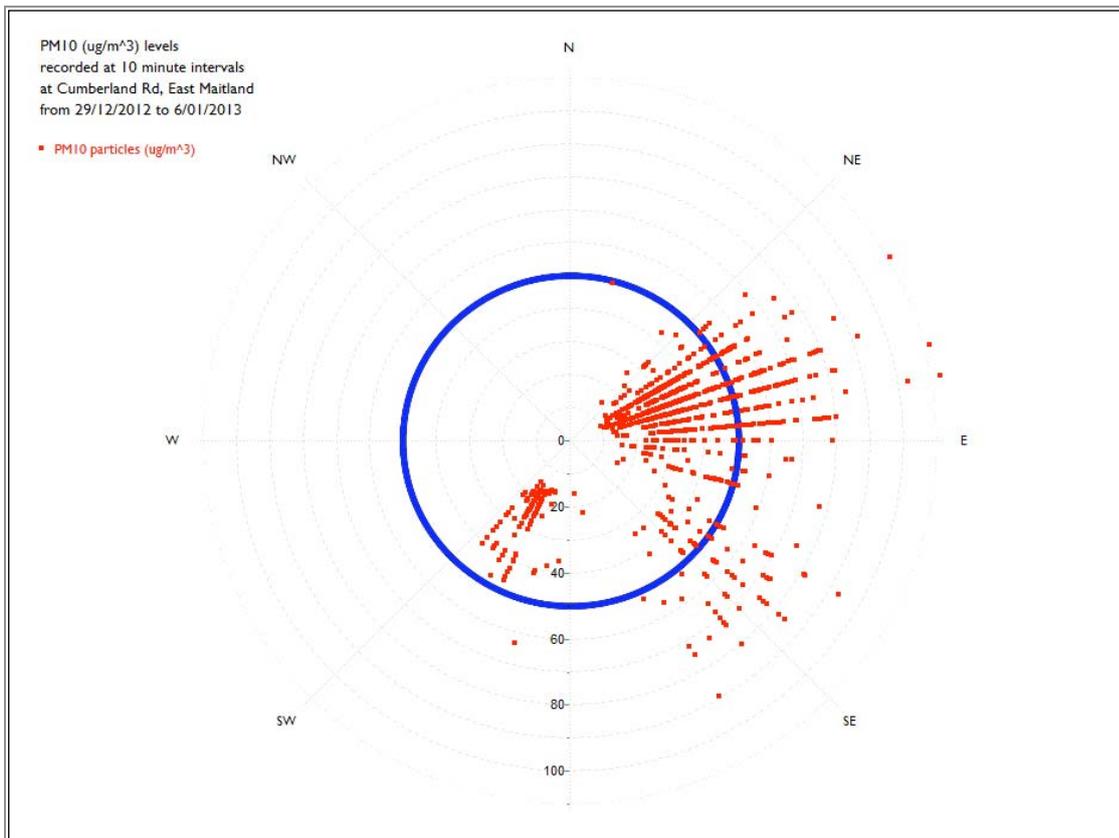
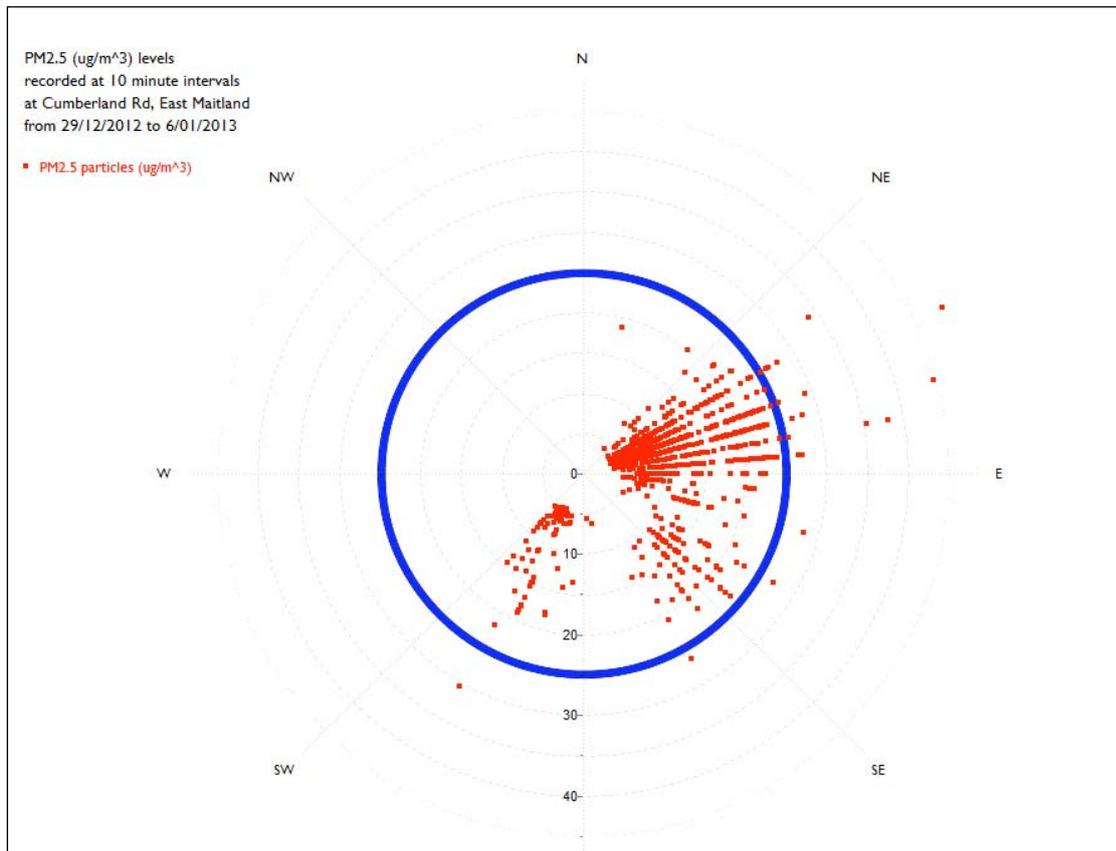
**Figure 18: PM<sub>10</sub> concentrations recorded at 10-minute at Cumberland Road, East Maitland**

**Figure 19: PM<sub>2.5</sub> concentrations recorded at 10-minute intervals at Cumberland Road, East Maitland**

The polar graphs above show that the distribution patterns of PM<sub>10</sub> and PM<sub>2.5</sub> sources are similar. Winds were dominated by east-northeast and south-southwest winds. No winds were recorded from the west or north. Higher 10-minute PM<sub>10</sub> concentrations occur when the wind is from the northeast to southeast directions.

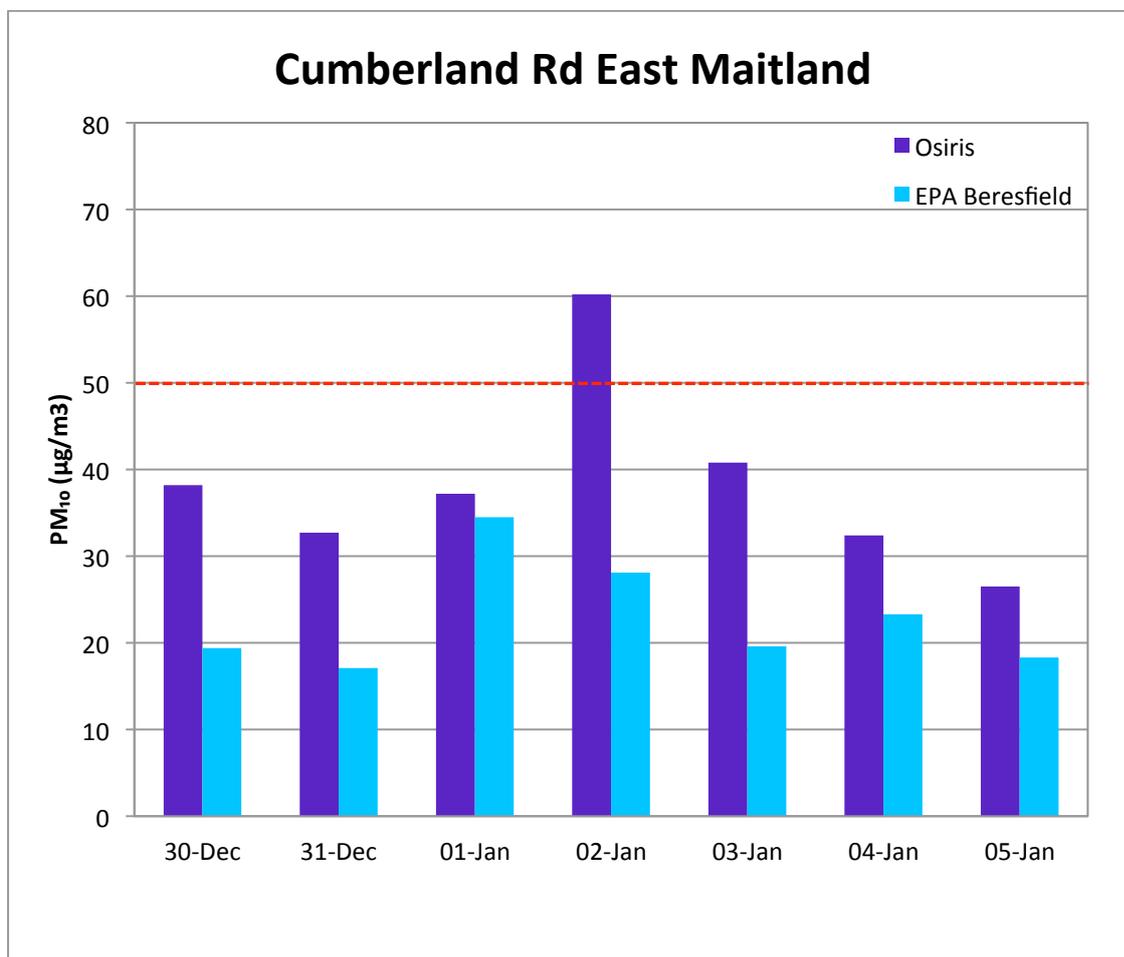
Figure 20: Comparative 24-hour averages of PM<sub>10</sub> for Osiris at Cumberland Road, East Maitland and EPA at Beresfield<sup>12</sup>

Date	Osiris East Maitland PM <sub>10</sub>	EPA Beresfield PM <sub>10</sub>
30/12/2012	38.2	19.4
31/12/2012	32.7	17.1
1/01/2013	37.2	34.5
2/01/2013	60.2	28.1
3/01/2013	40.8	19.6
4/01/2013	32.4	23.3
5/01/2013	26.5	18.3
