**NATIONAL  
RADIOACTIVE  
WASTE MANAGEMENT  
FACILITY**

## Site Characterisation Technical Report - Lyndhurst

**Client: Commonwealth Department of Industry, Innovation and Science**

**AECOM Australia Pty Ltd**

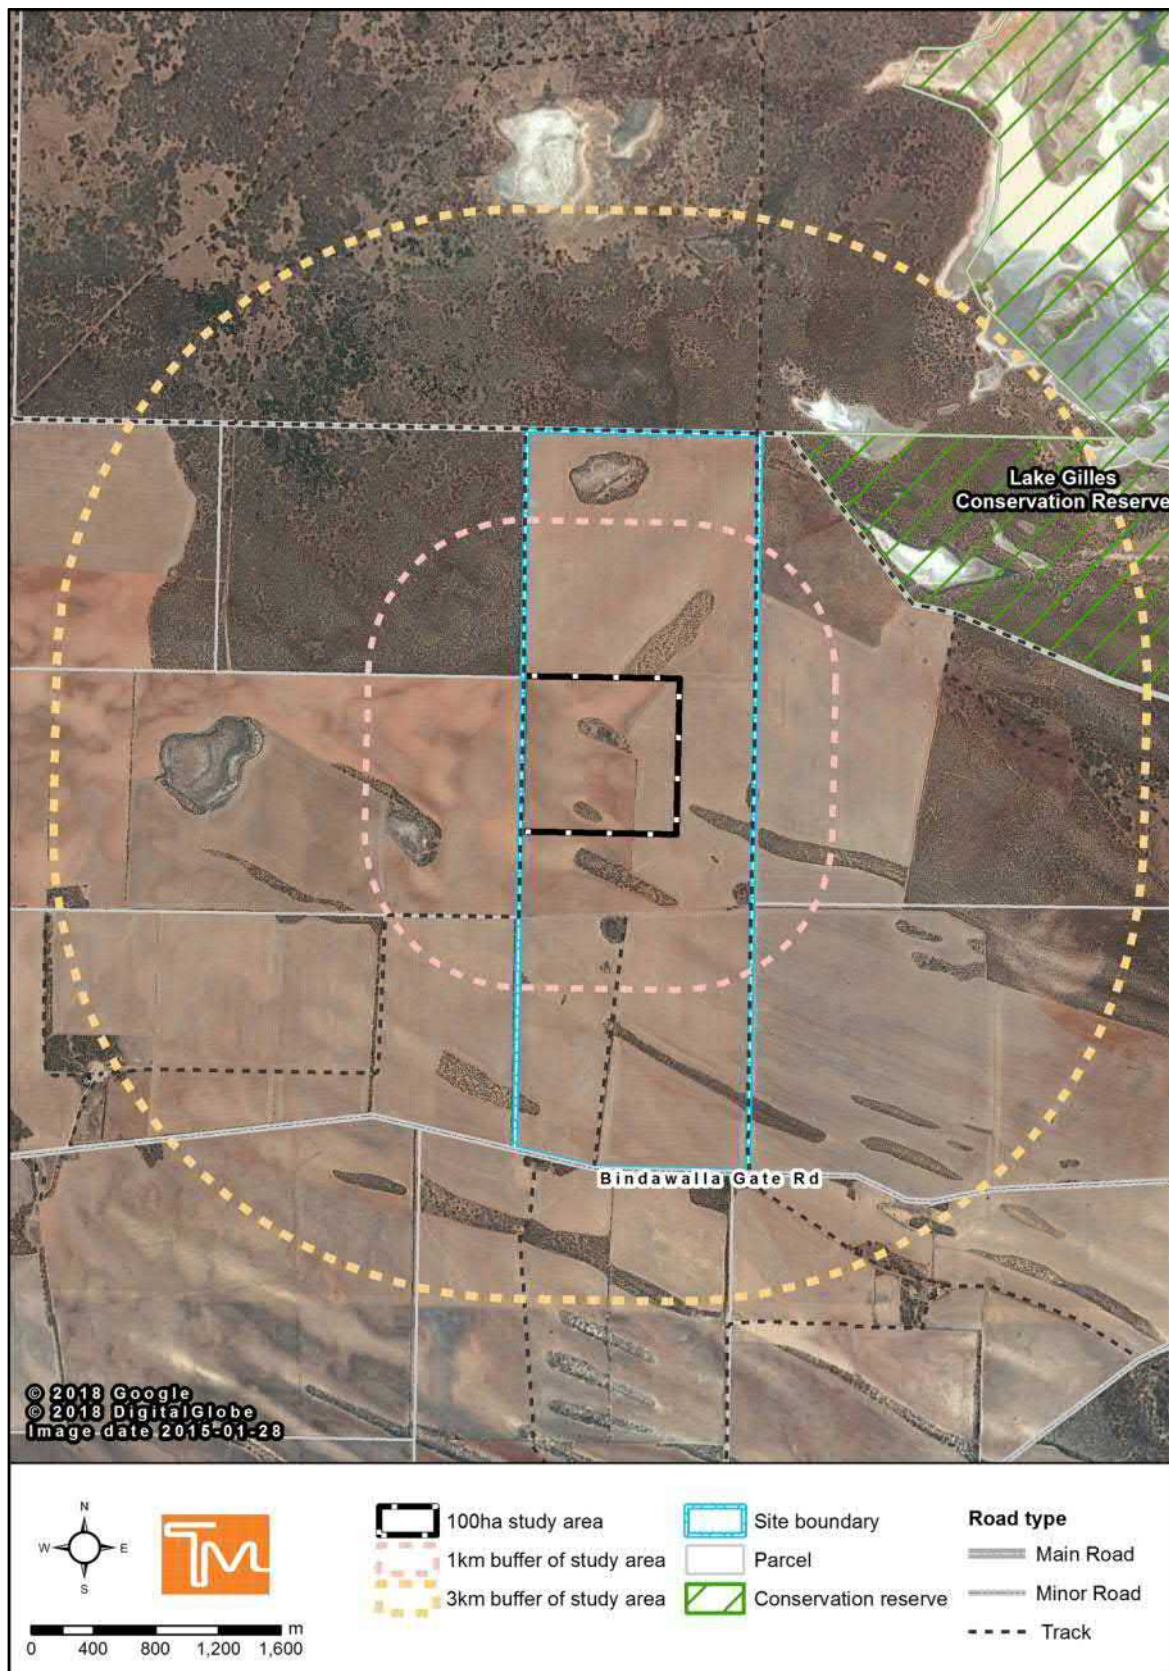
Figure 8 Lyndhurst landscape assessment to 3km.

The South Australian prescribed burning guide identifies that semi-arid Mallee vegetation occurs across large areas of the central to northern Eyre Peninsula and describes this vegetation as '*Low open eucalypt dominated vegetation with an understorey of smaller shrubs, grasses and herbs. The fuel array is typically highly discontinuous*' (DENR, 2011). AECOM provided photos and descriptions of vegetation on and round the site (MacDonnell, 2018; AECOM, 2018a) that match this descriptor and accord best with a Mallee-Mulga classification under AS 3959-2009.

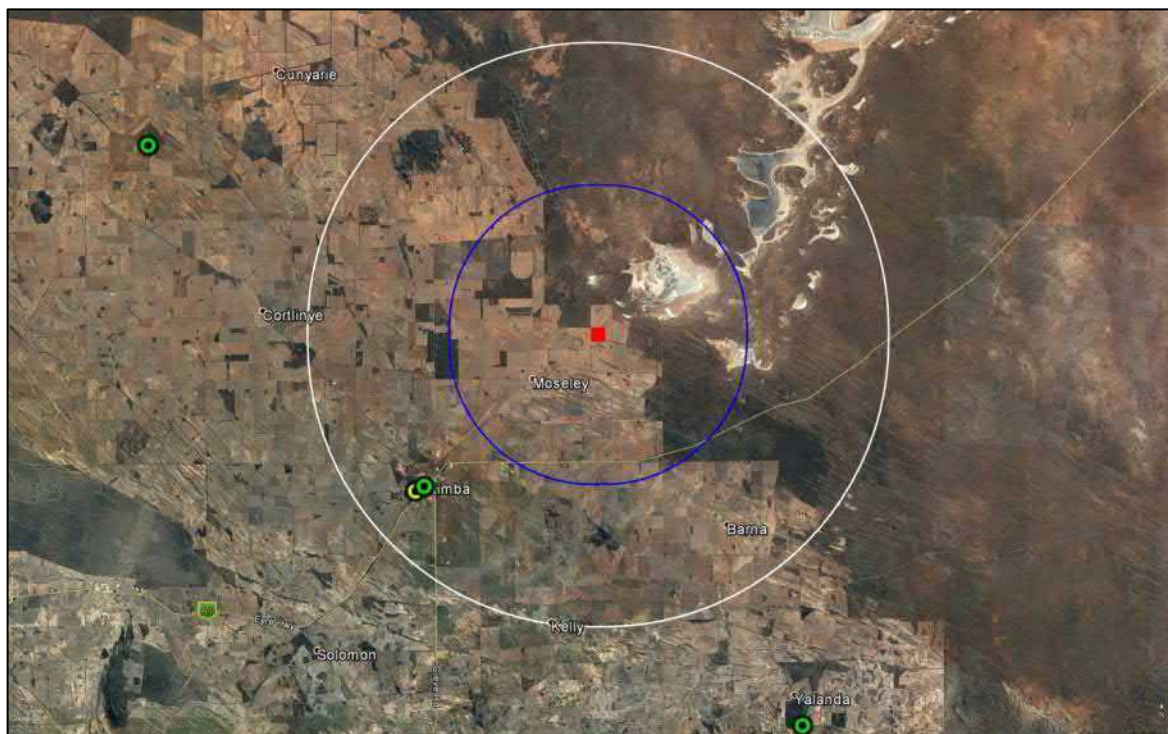
**Figure 9 The landscape surrounding the Lyndhurst 100ha site and expanded Study Area (show in red fill)**

*A 10km buffer of the site is shown in blue outline and a 20km buffer is shown in white outline. The yellow circle shows the location of the BOM weather station from which weather data was obtained and analysed (see Section 2.4.2.3). Green circles identify the locations of the nearest CFS brigades (see Section 2.4.2.4.4).*

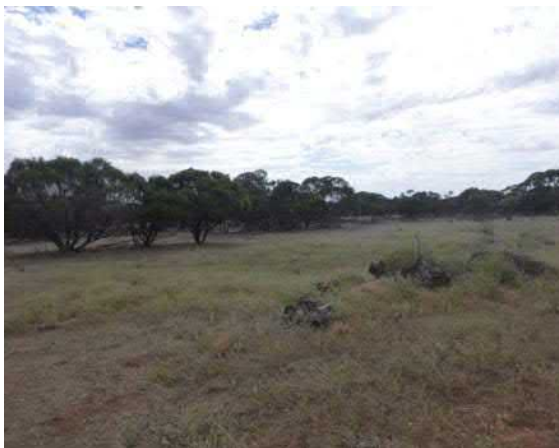
**Low lying area to the south of the site (mapped as H2 soil subgroup) where ponded water has previously been observed.**

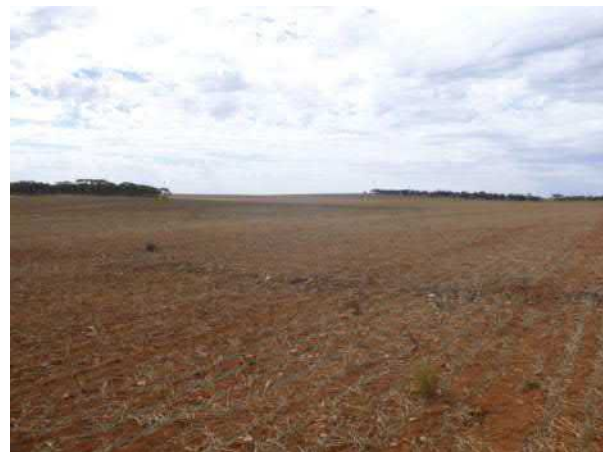
**Majority of site showing red-brown soils (D3 soil subgroup) with nodular calcrete. Vegetated dunes in the distance.**

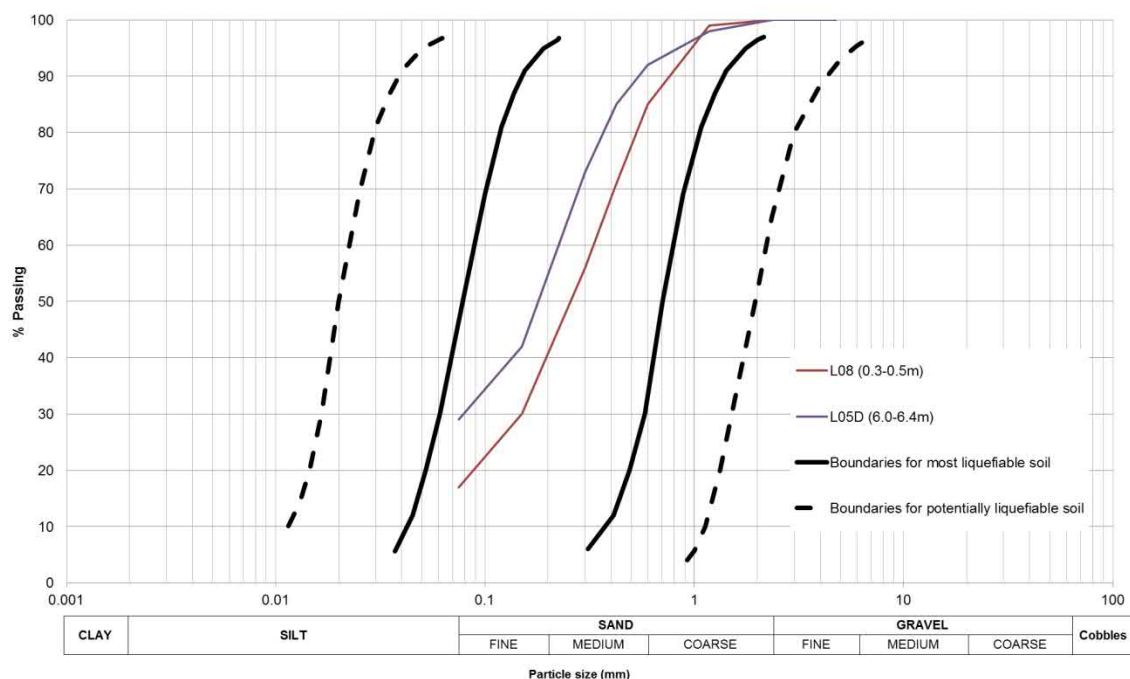
**Figure 24 Particle Size Distribution of Tested Materials**

Based on the above figure, the tested site materials can be characterised as liquefiable soil based on particle size distribution.

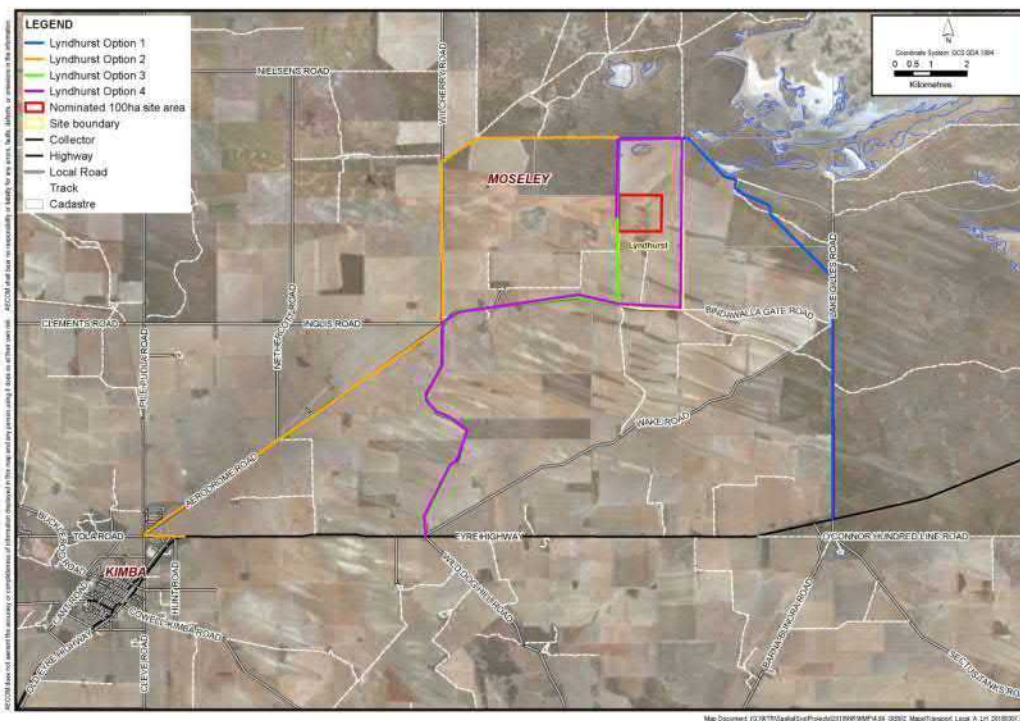
**Figure 45 Local access routes**

As can be seen in Figure 45, there is not a substantial difference in length for each of the potential local access routes. Key differentiating factors are likely to be the proximity to the township of Kimba and the upgrade requirements for each route. Required upgrades for the chosen access route will be determined during later design stages. Access routes may also be adjusted to minimise potential disruption to the local community. It should also be noted that if a road is upgraded to a higher standard (i.e. sealed), locals may use this road in preference to the surrounding unsealed roads. This would benefit the local community by improving local transport infrastructure and reducing the maintenance requirements compared to the existing roads.

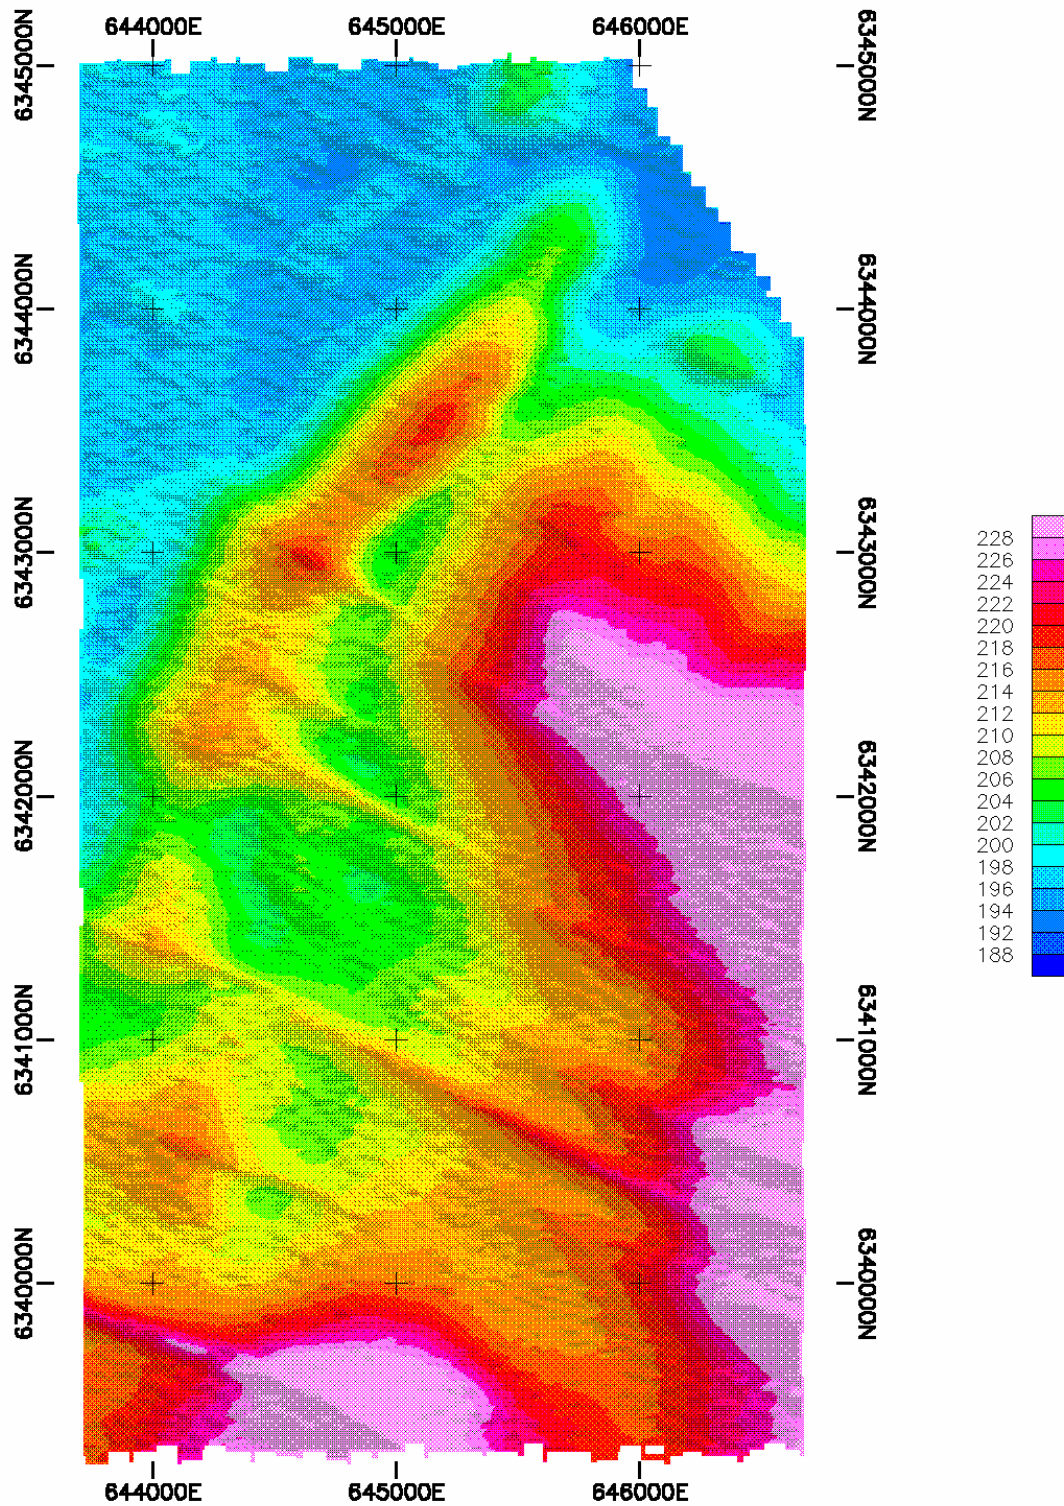
Min Contour Interval = 2.000 m  
 Grid cell size = 10  
 Base easting = 0  
 Base northing = 0  
 Base elevation = 0 m  
 Base value = 0 nT  
 Survey date = Apr2018  
 Author: JEH  
 Data File: LY\_1804M.MAG

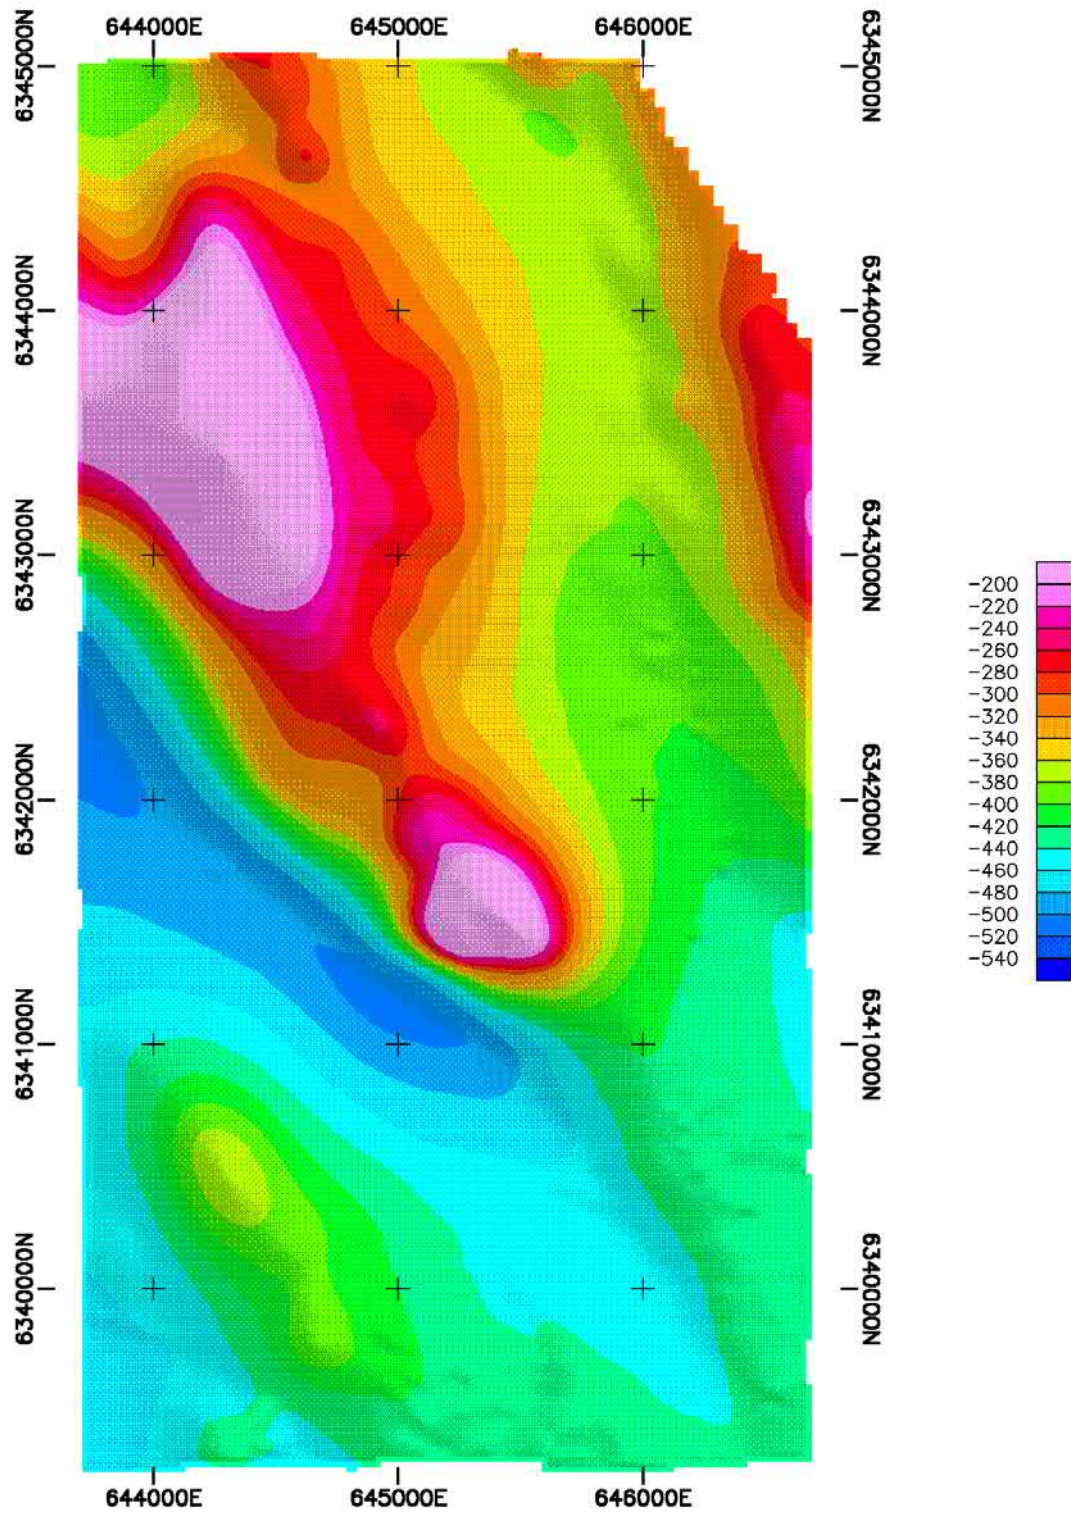
Min Contour Interval = 20.000 nt  
 Grid cell size = 20  
 Base easting = 0  
 Base northing = 0  
 Base elevation = 0.0 m  
 Base value = 0.0 nT  
 Survey date = Apr2018  
 Author: JEH  
 Data File: LY\_1804M.8TH

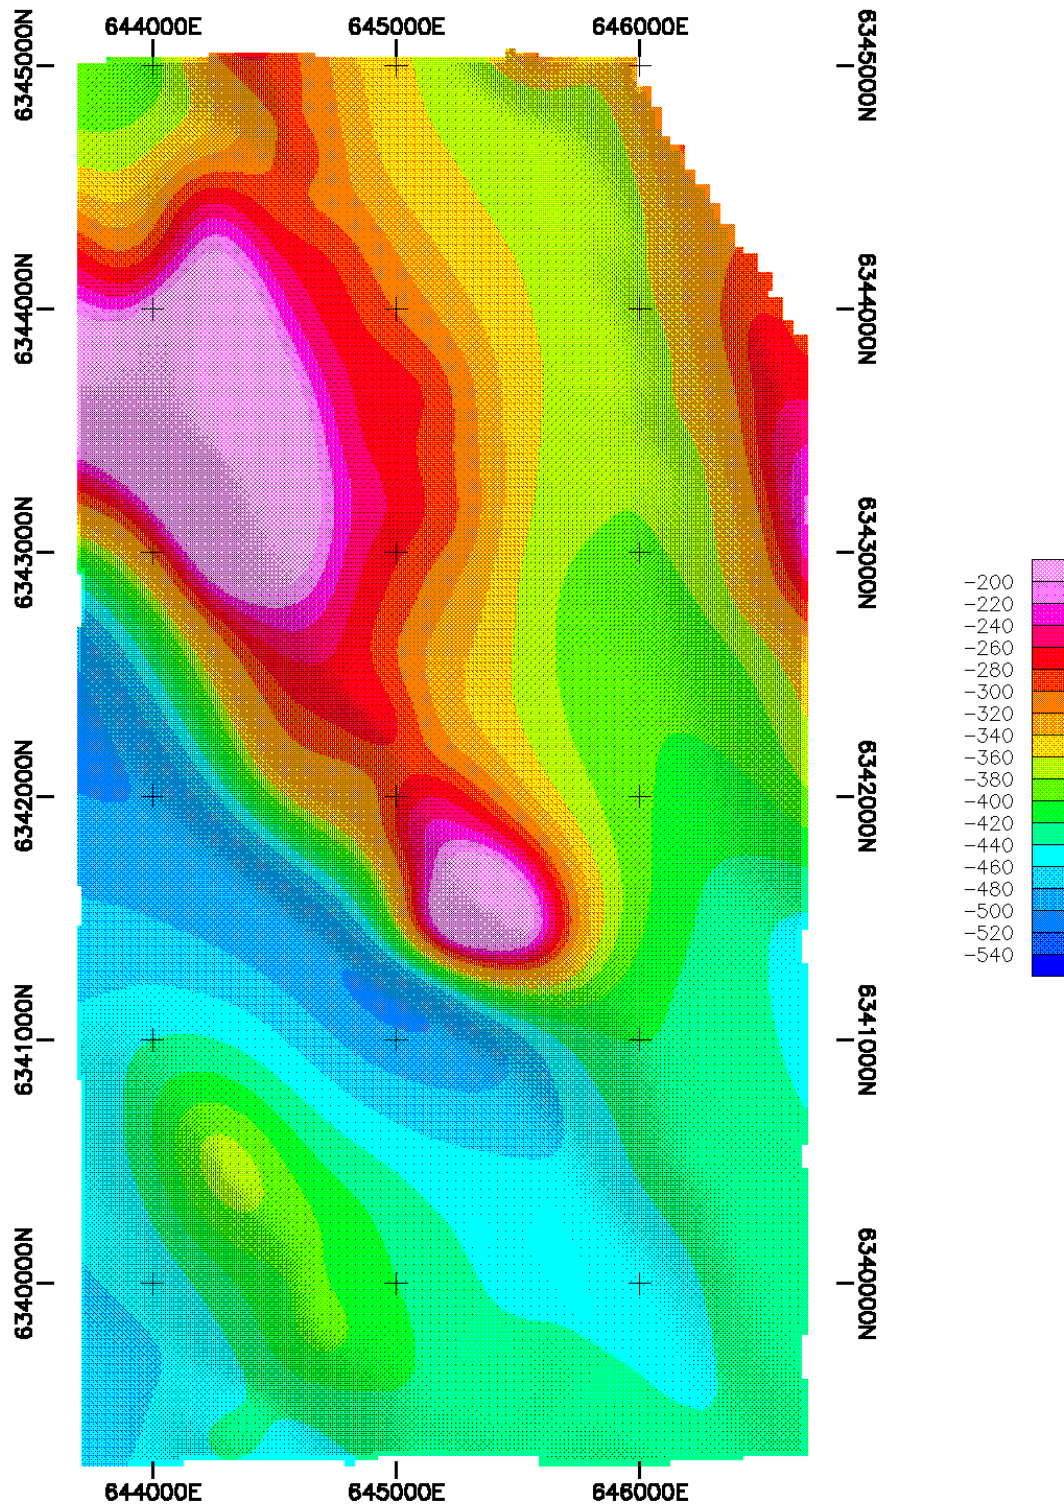
Min Contour Interval = 20.00nT  
 Hanning passes = 32  
 Grid cell size = 20  
 Base easting = 0  
 Base northing = 0  
 Base elevation = 0.0 m  
 Base value = 0 nT  
 Survey date = Apr2018  
 Author: JEH  
 Data File: LY\_1804M.8TH

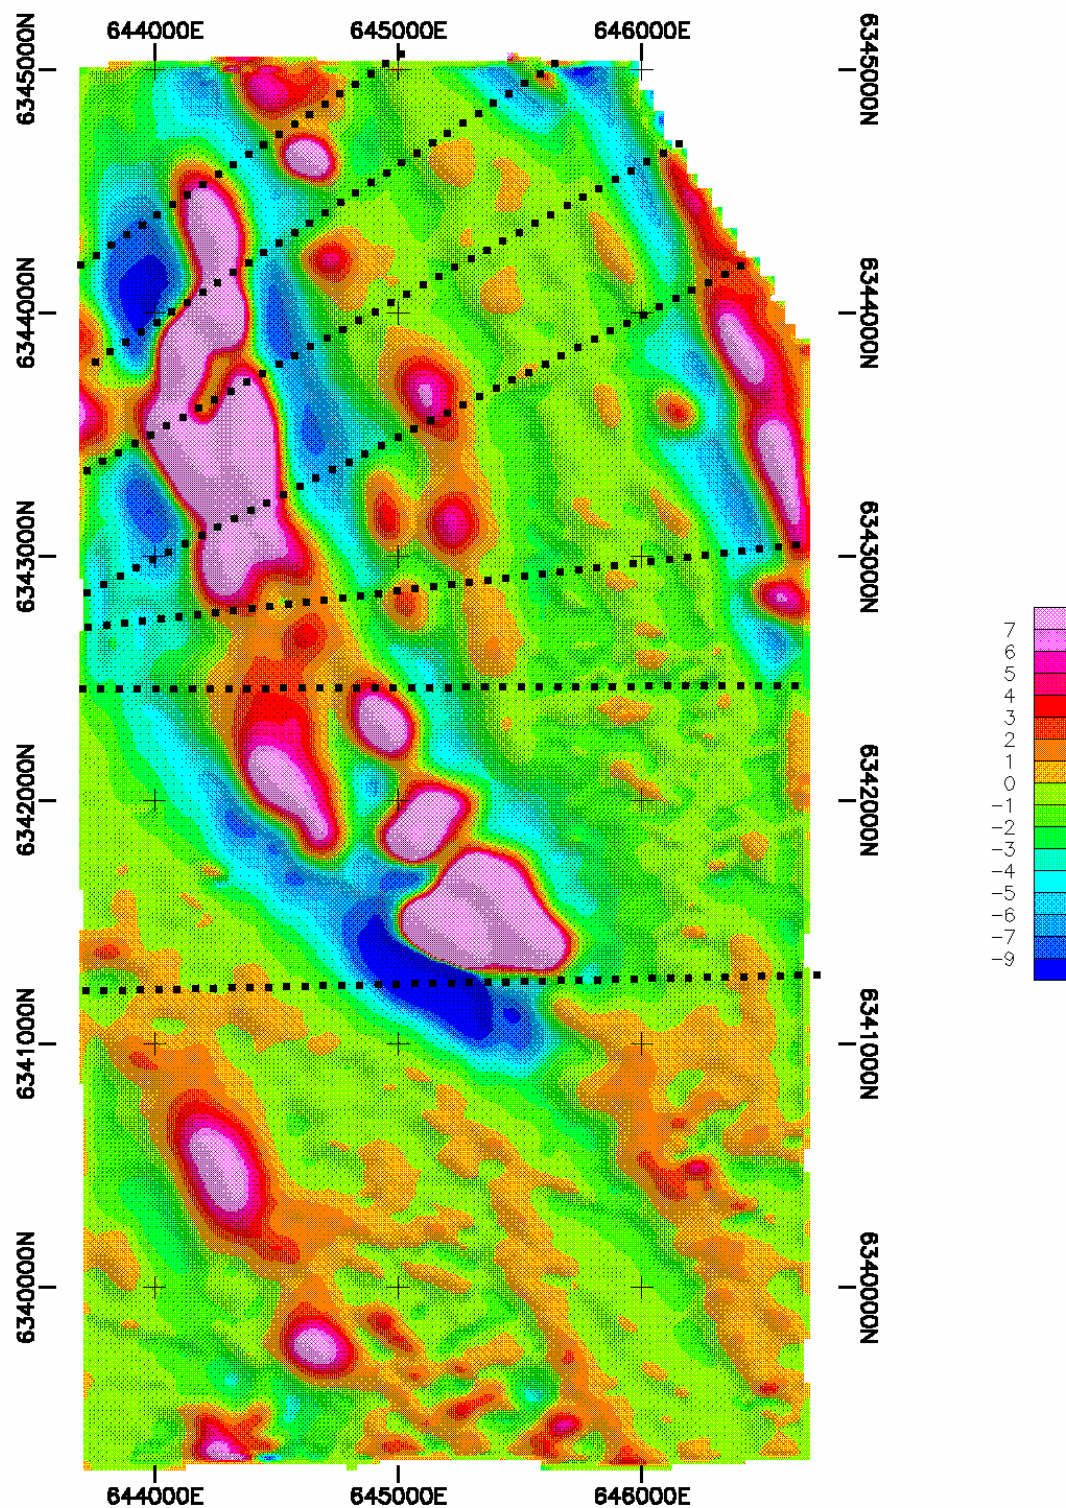
Min Contour Interval = 1.00nT  
 Hanning passes = 32  
 Grid cell size = 20  
 Base easting = 0  
 Base northing = 0  
 Base elevation = 0.0 m  
 Base value = 0.0 nT  
 Survey date = Apr2018  
 Author: JEH  
 Data File: LY\_1804M.8TH

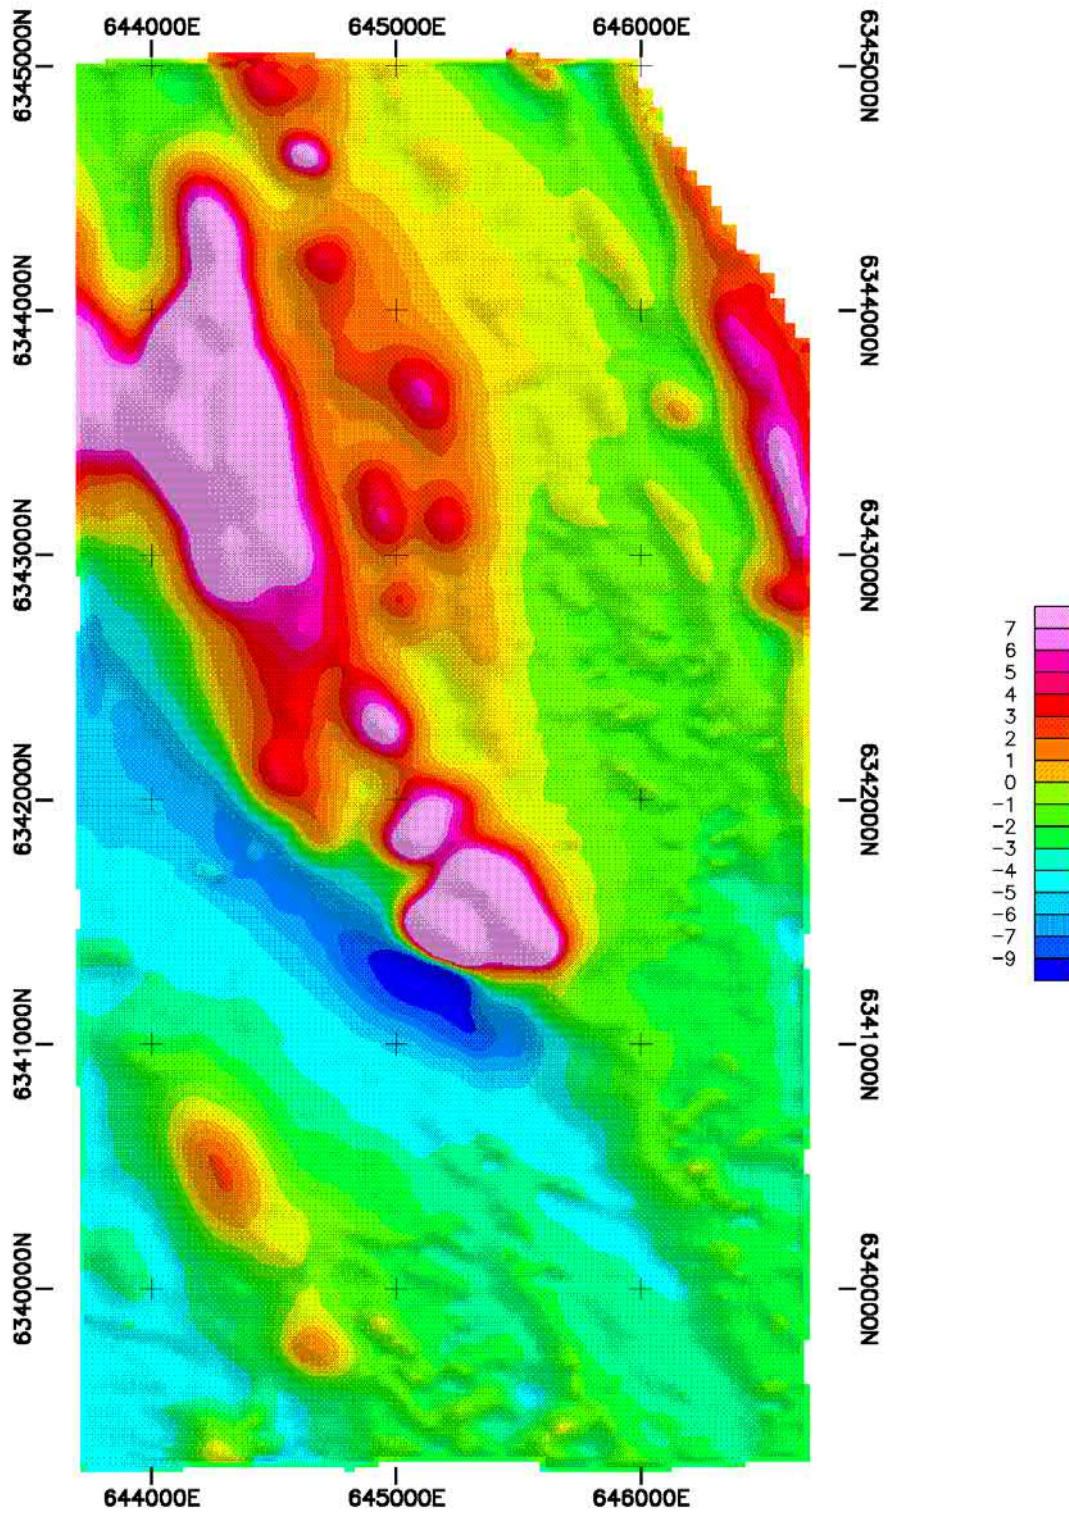
Hanning passes = 32 Fctr = 10  
 Min Contour Interval = 20.000 nt  
 Grid cell size = 20  
 Base easting = 0  
 Base northing = 0  
 Base elevation = 0.0 m  
 Base value = 0.0 nT  
 Survey date = Apr2018  
 Author: JEH  
 Data File: LY\_1804M.8TH

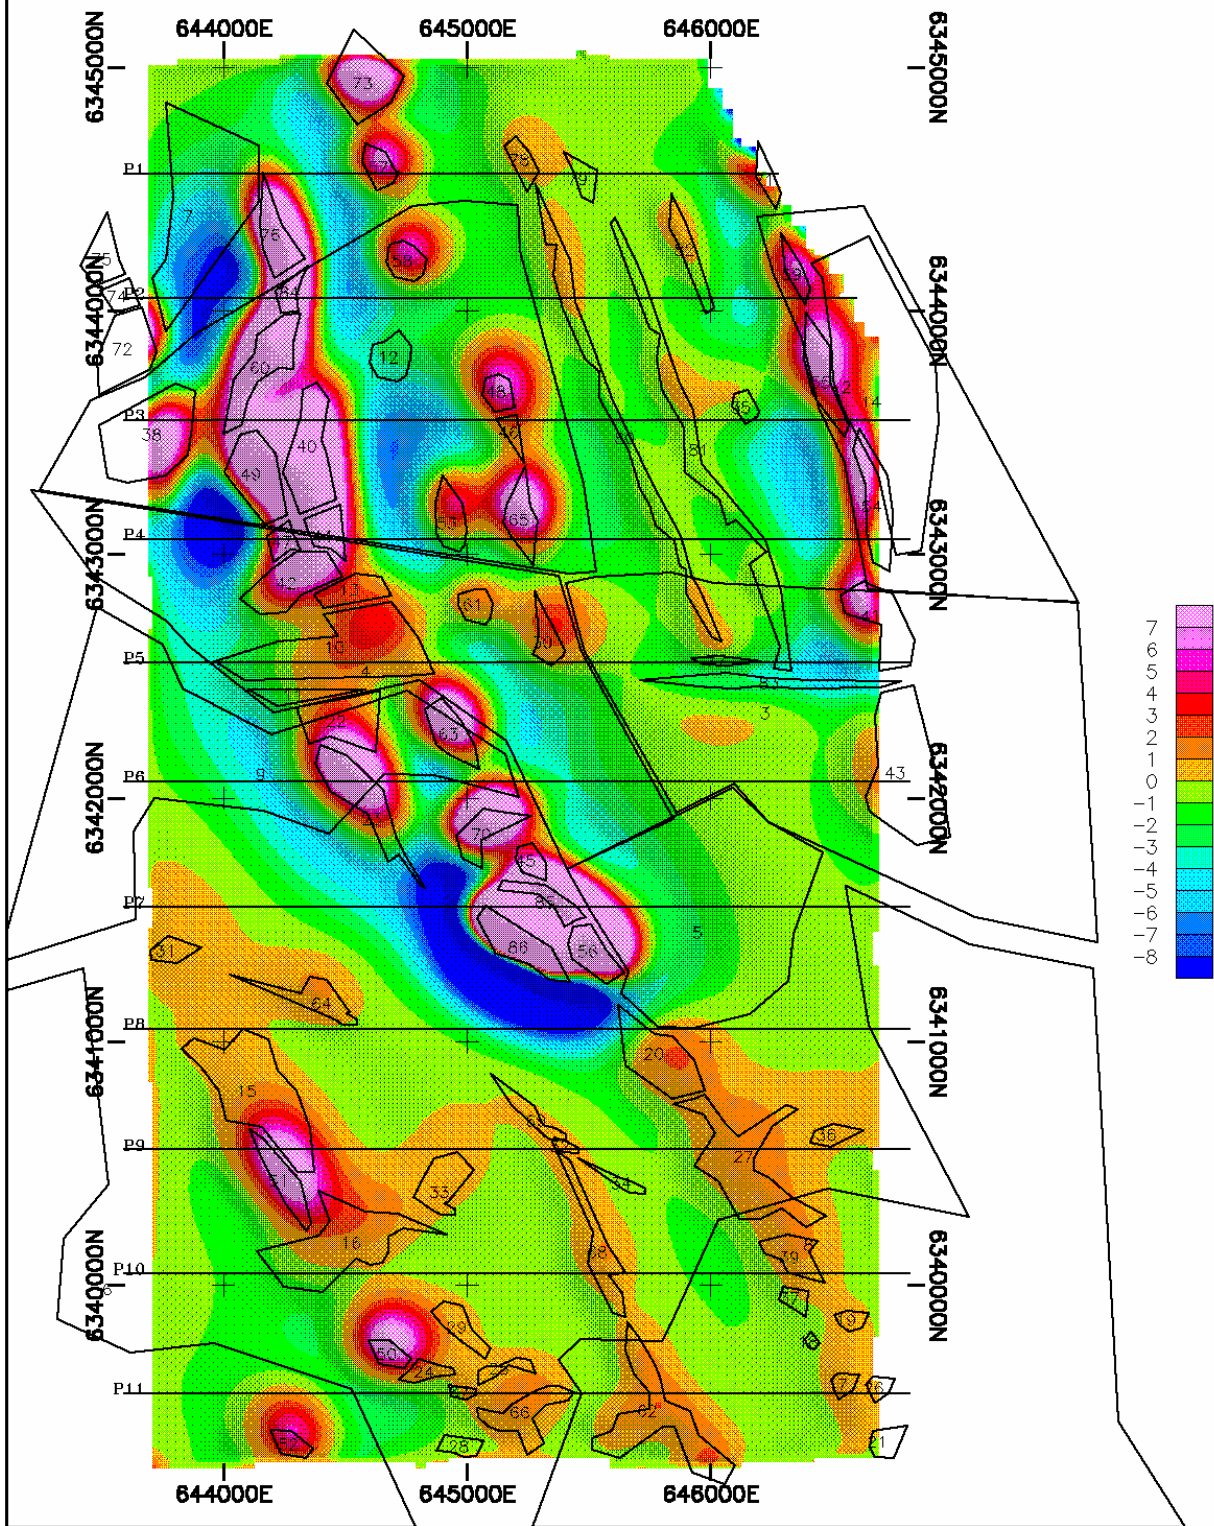
Min Contour Interval = 1.00nT  
 Hanning passes = 32  
 Grid cell size = 20  
 Base easting = 0  
 Base northing = 0  
 Base elevation = 0.0 m  
 Base value = 0.0 nT  
 Survey date = -  
 Author: JEH  
 Data File: maggrav.mag

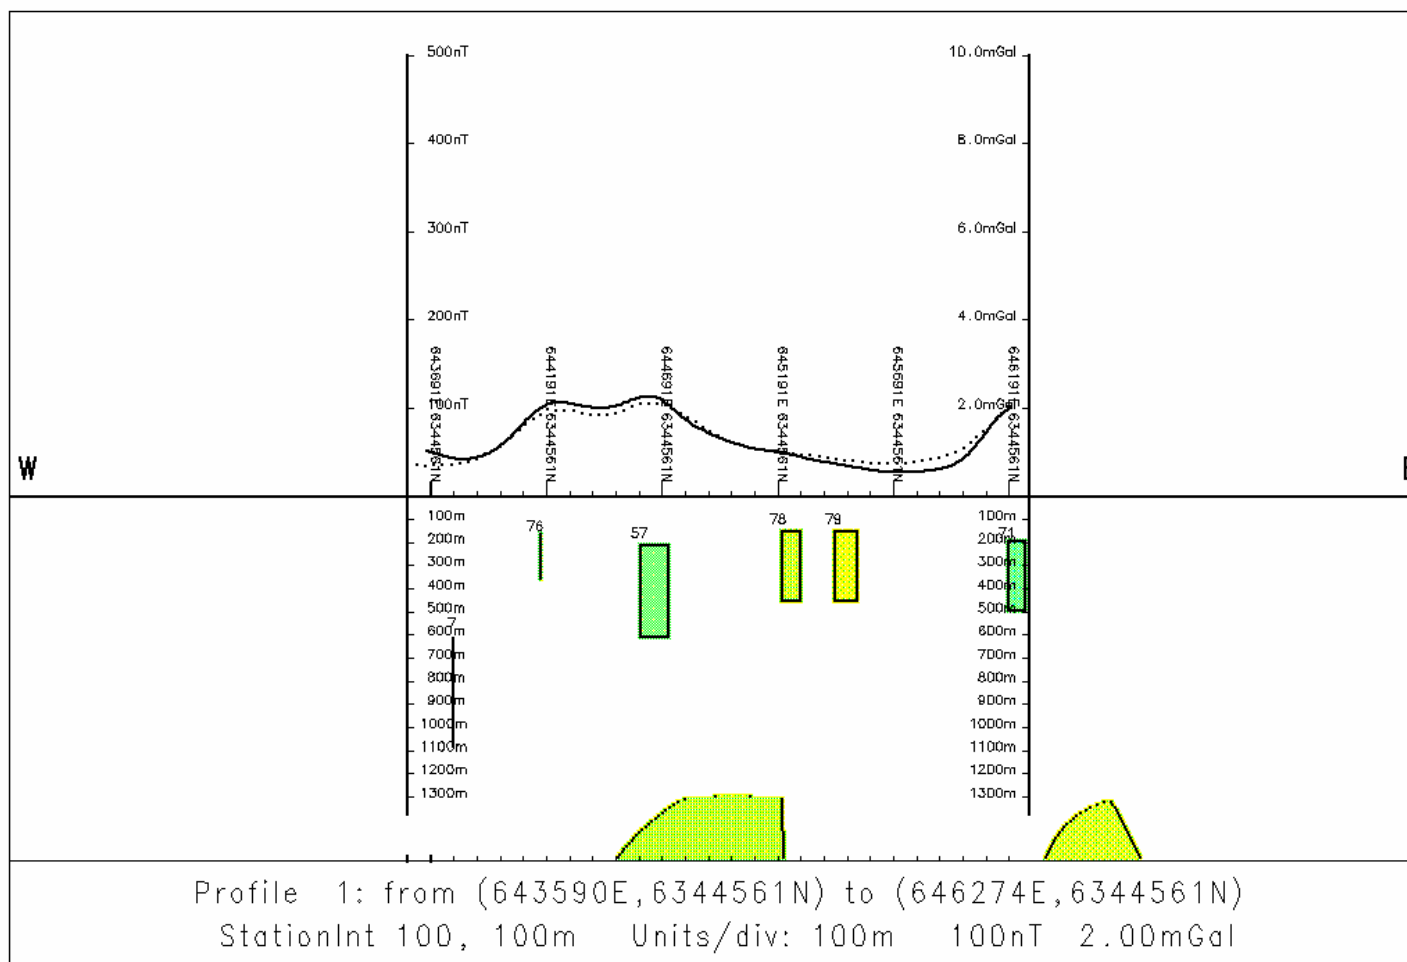
**MAGNETIC PROFILES:**  
 Solid: data  
 Dotted: model response

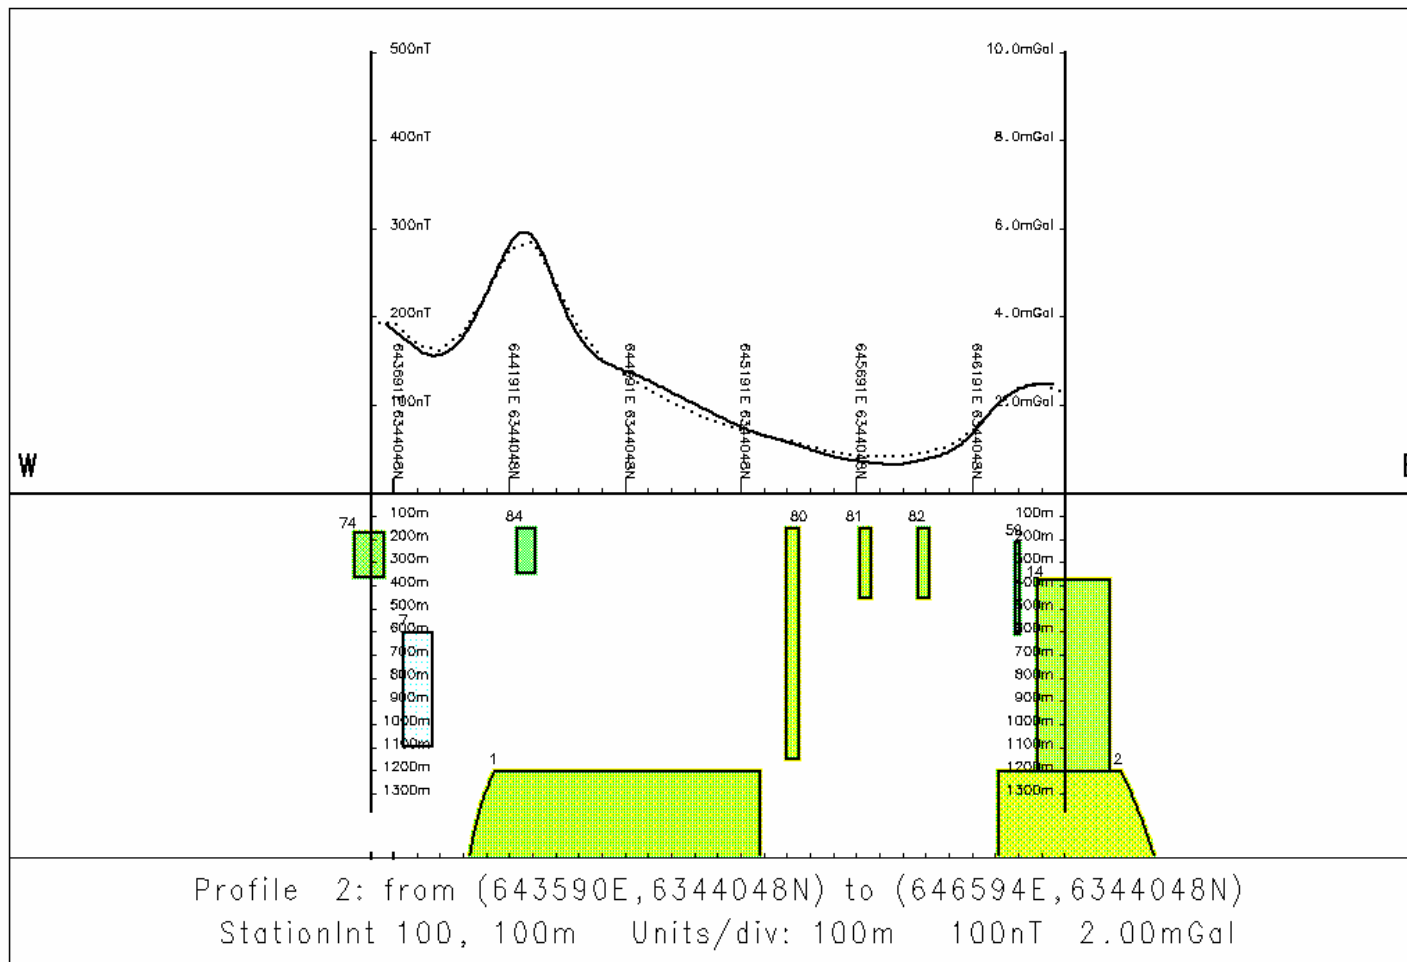
MAGNETIC PROFILES:  
 Solid: data  
 Dotted: model response

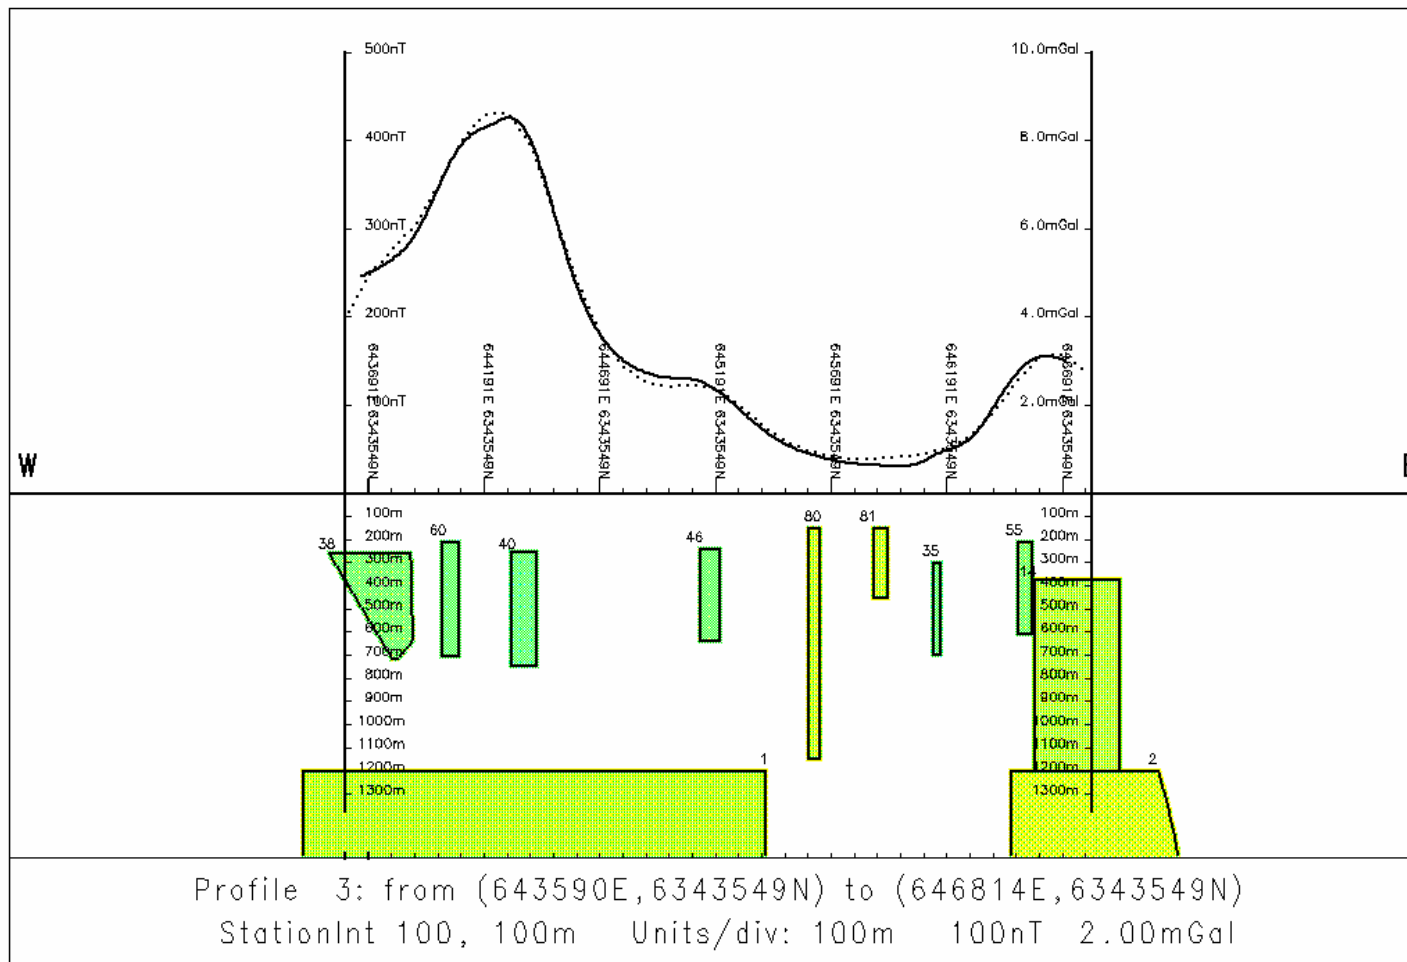
MAGNETIC PROFILES:  
 Solid: data  
 Dotted: model response

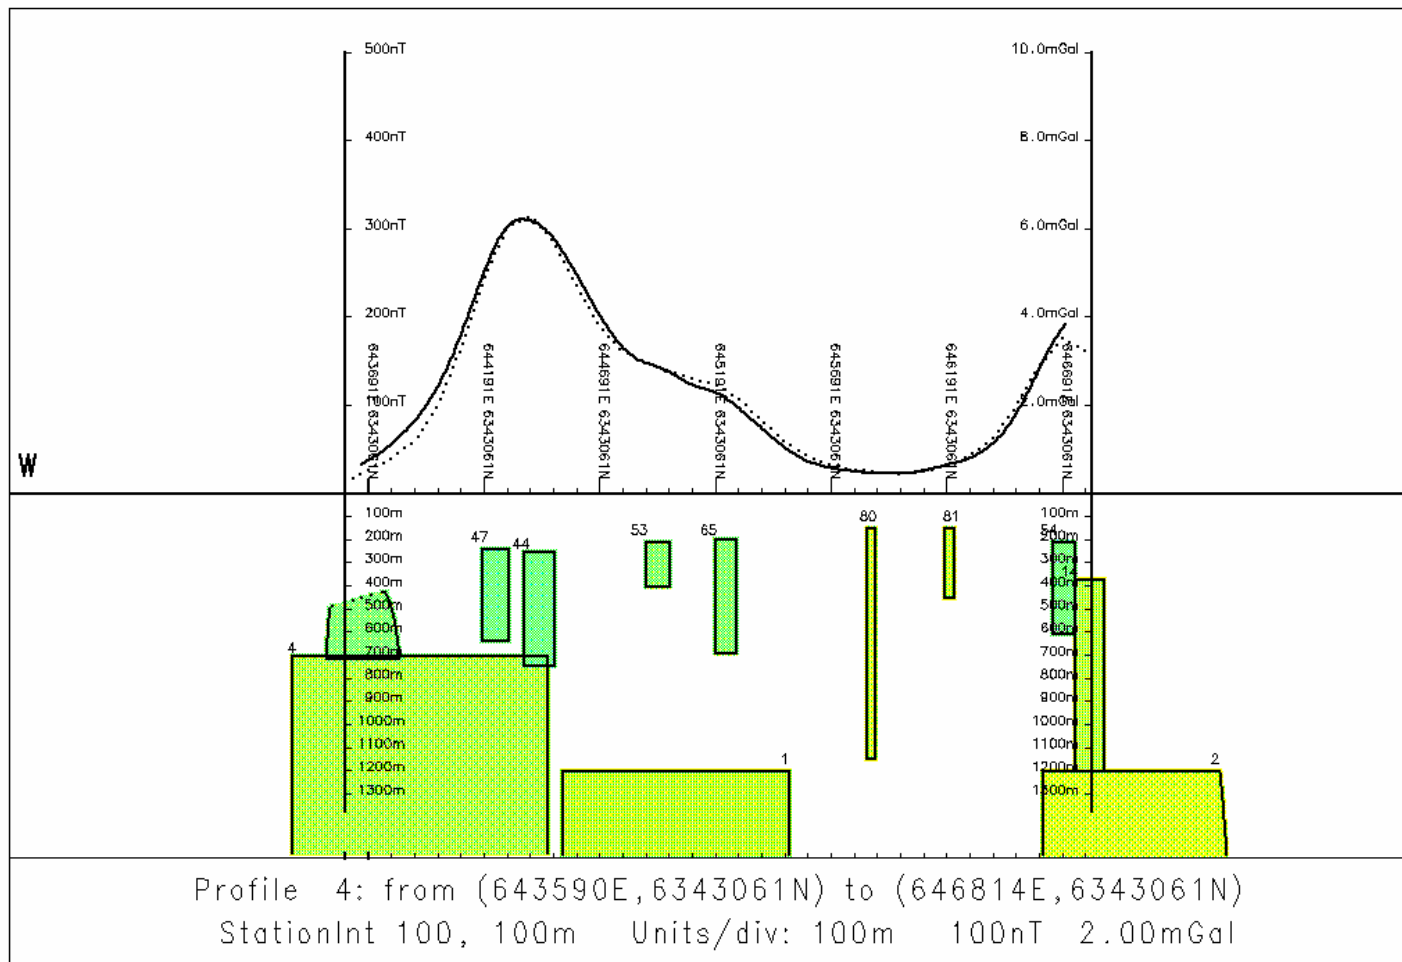
MAGNETIC PROFILES:  
 Solid: data  
 Dotted: model response

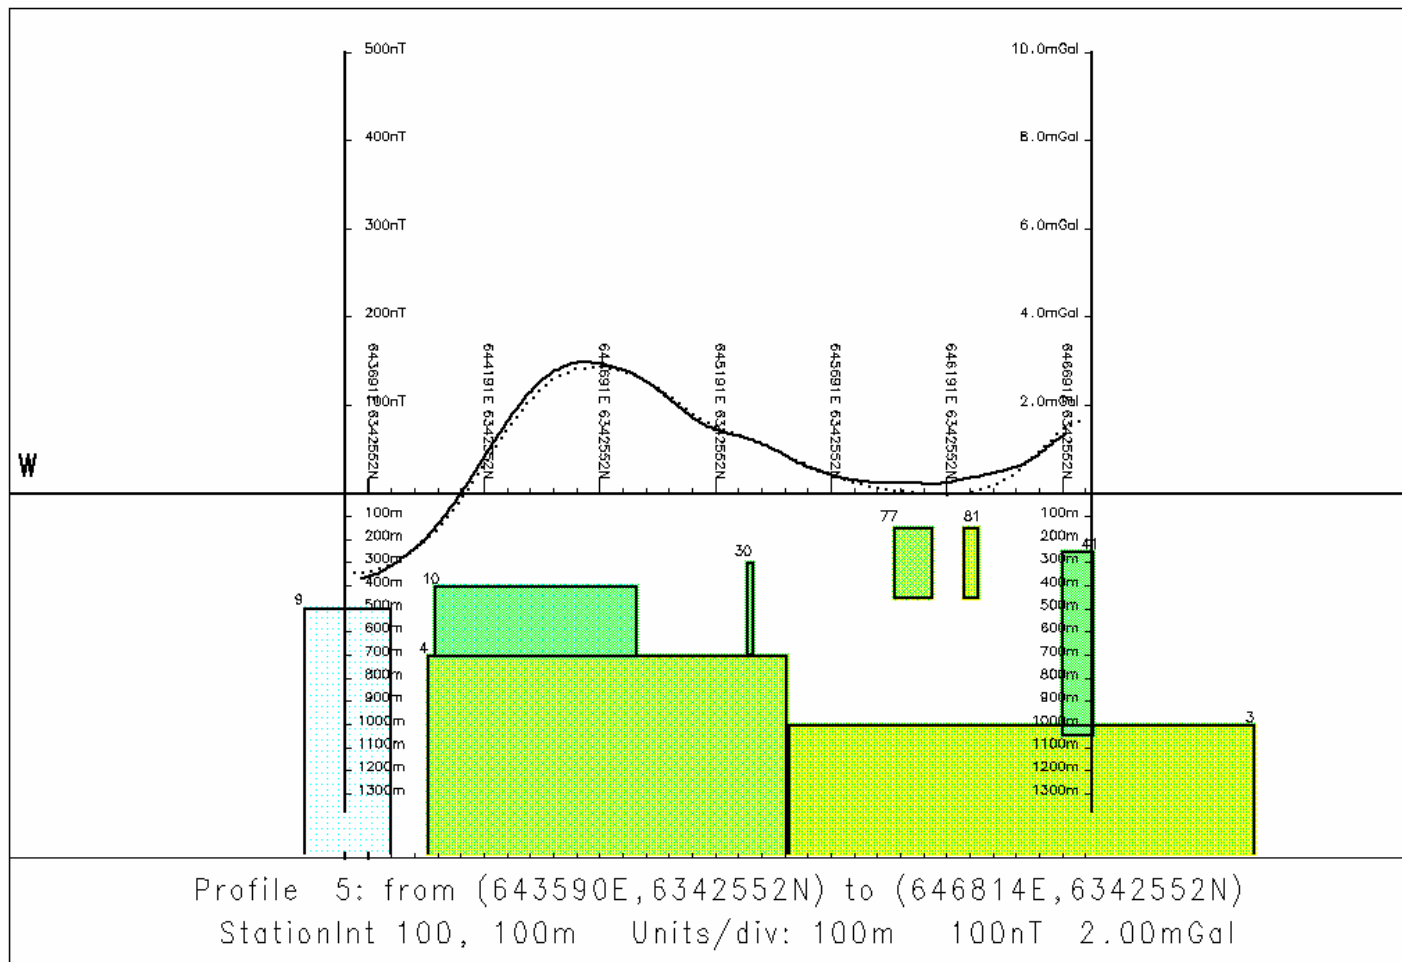
MAGNETIC PROFILES:  
 Solid: data  
 Dotted: model response
