Application of Highland Wind Farm, LLC, for a
Certificate of Public Convenience and Necessity
To Construct a 102.5 Megawatt Wind Electric Generation
Facility and Associated Electric Facilities, to be Located
In the Towns of Forest and Cylon, St. Croix County,
Wisconsin

Docket No. 2535-CE-100

# Report Number 122412-1

# A Cooperative Measurement Survey and Analysis of Low Frequency and Infrasound at the Shirley Wind Farm in Brown County, Wisconsin

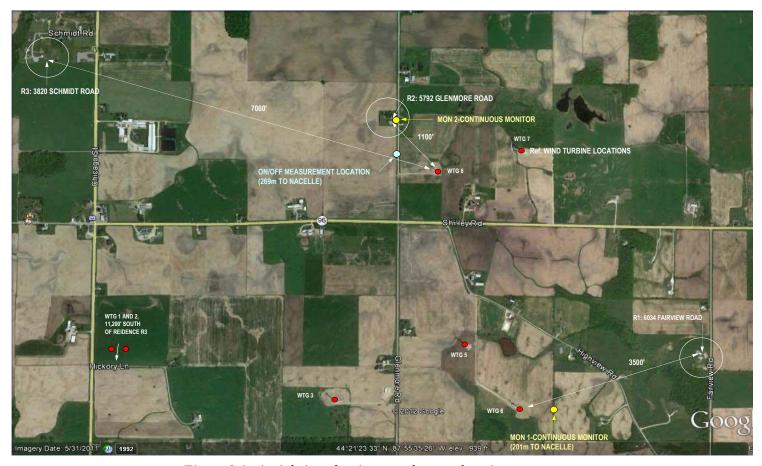
Measurements were made at three unoccupied residences labeled R1, R2 and R3 on Figure 2.1. The figure shows only the five closest wind turbines and other measurement locations. All in all, the investigators worked very well together and there is no question or dispute whatsoever about measurement systems or technique and competencies of personnel. Of course, conclusions from the data could differ. Mr. M. Hankard, acoustical consultant for the Highland and Shirley projects, accompanied, assisted and observed the investigators on Wednesday, 12/5.

Figure 2.1: Aerial view showing sound survey locations

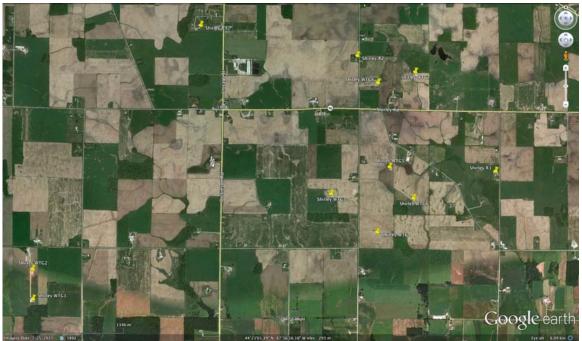
The Shirley Wind park consists of eight Nordex turbines with 85 meter hub height and 100 meter rotor diameter. These turbines are distributed over an approximately six square mile area in Brown County, WI as shown in Figure 1. The turbines are of similar in size to those investigated in Ref. 1.

Figure 1. Environs of Shirley Wind Park, Showing Eight Turbines and Three Abandoned Residences Investigated in the Program

The tests included acoustic measurement at multiple locations inside and outside three abandoned residences, at nominal distances and bearings from the three turbines as shown in Table 1, and will be described in greater detail in a subsequent section. Test methodology and schedule were constrained to a testing period December 4-7 and inability to park the turbines to establish a reliable background noise baseline.
