Residential Defect Inspection

Ceiling Insulation

To comply with Australian Standard AS/NZS 3000: 2007

SAMPLE REPORT ONLY

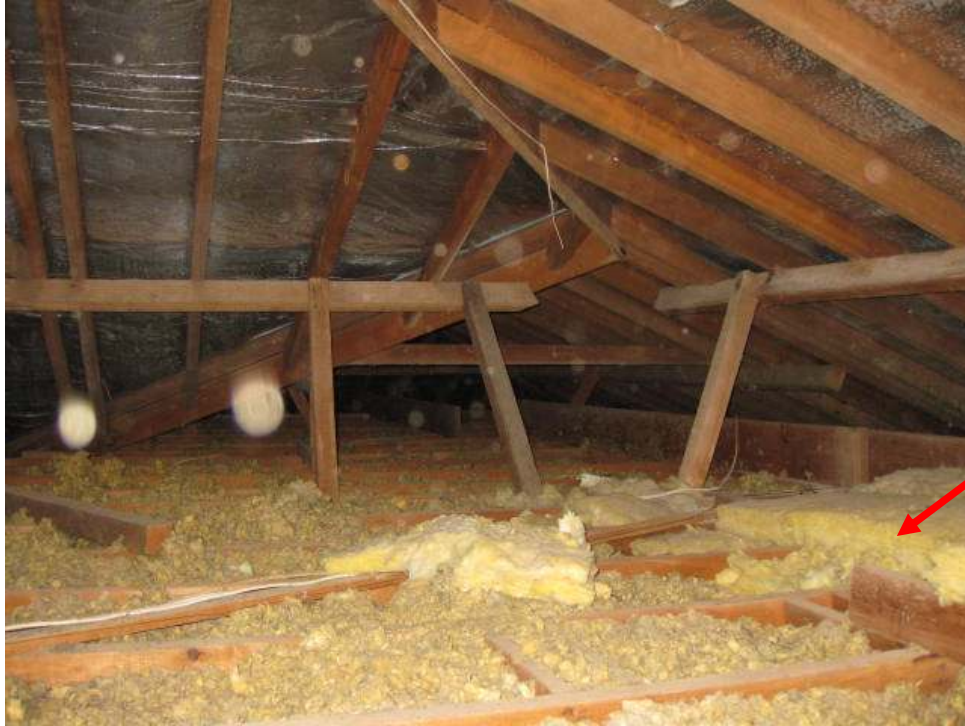
- This dwelling had existing insulation and only the incomplete areas were insulated over the bathroom ceiling areas. This insulation covers the IXL fan fitting to the bathroom. **NON COMPLIANT Finding!**

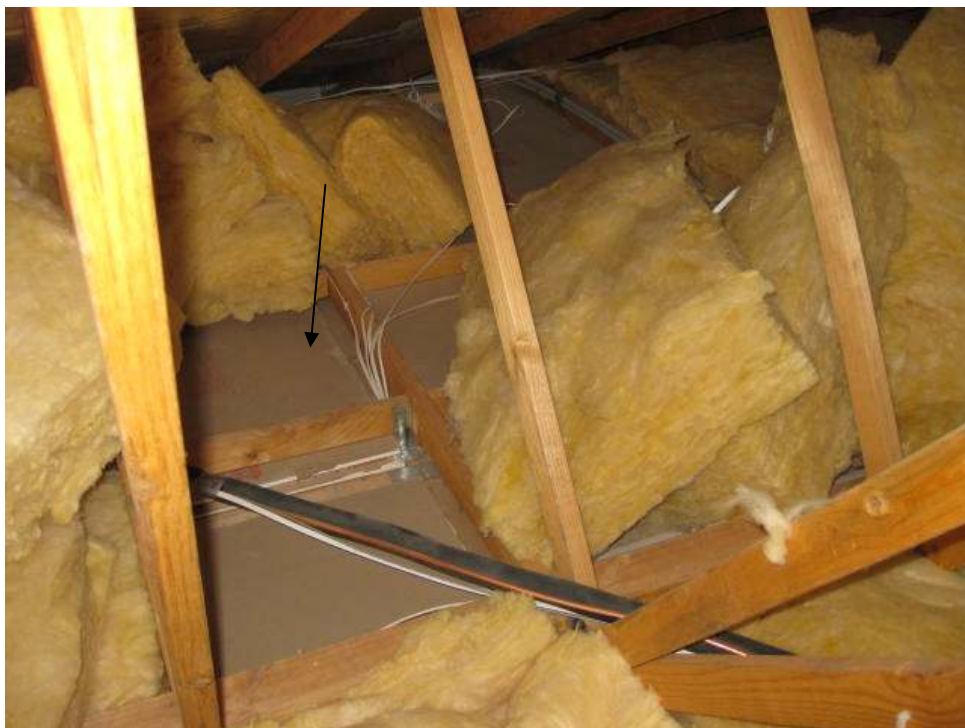
- The ceiling insulation is incomplete and poorly laid as shown.

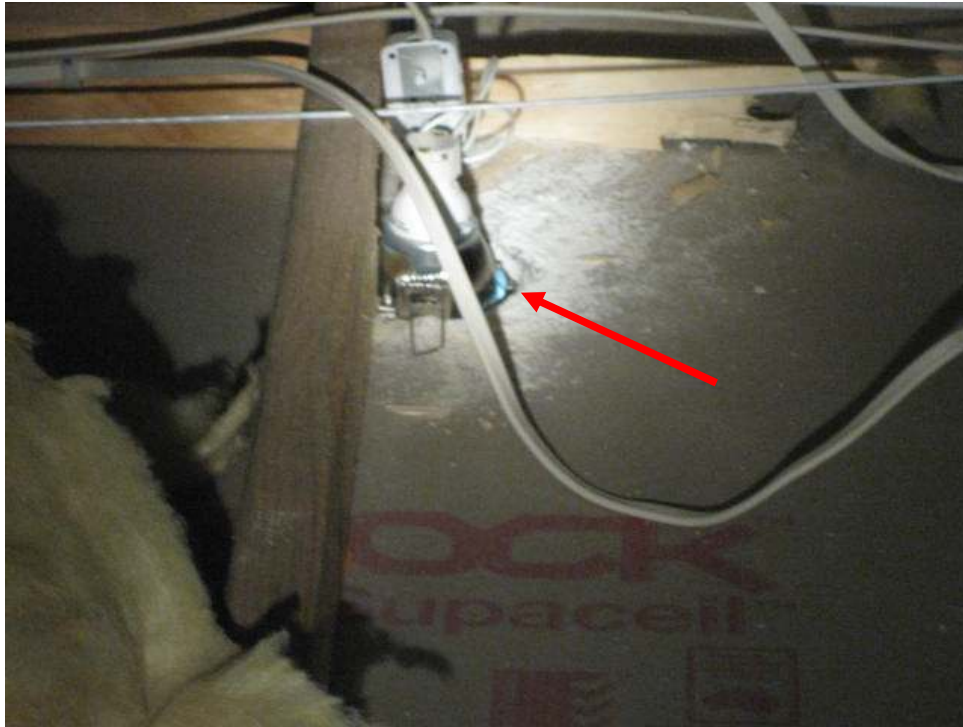
- We removed the ceiling insulation away from this bathroom downlight area. **NON COMPLIANT Finding!**

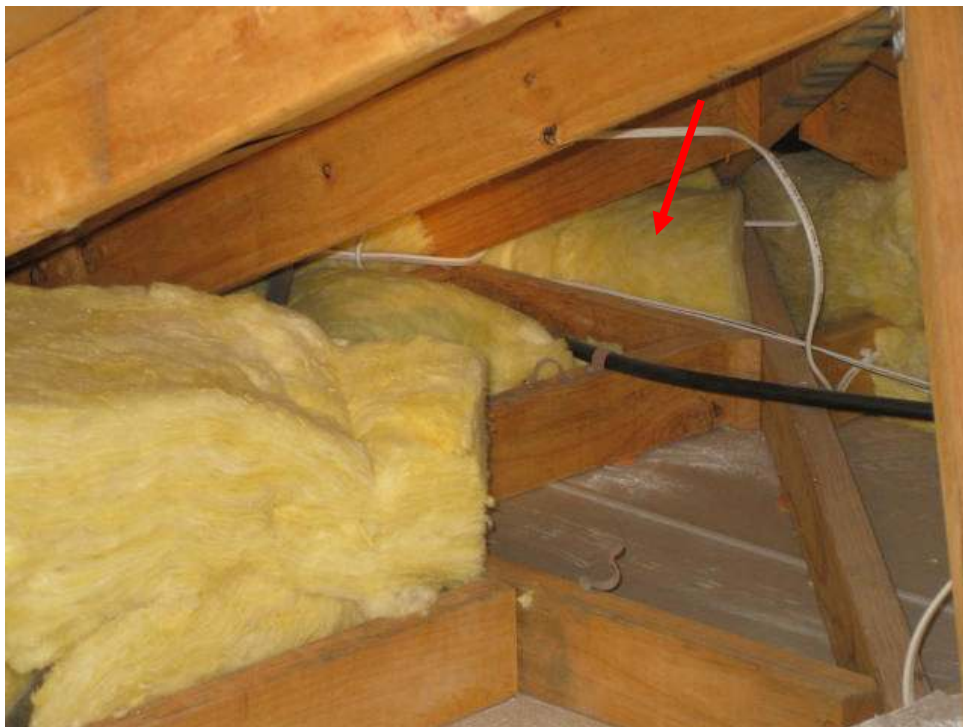
- This ceiling insulation batt covers the ensuite ceilings downlight. Difficult access to this low pitched area as shown. **NON COMPLIANT Finding!**

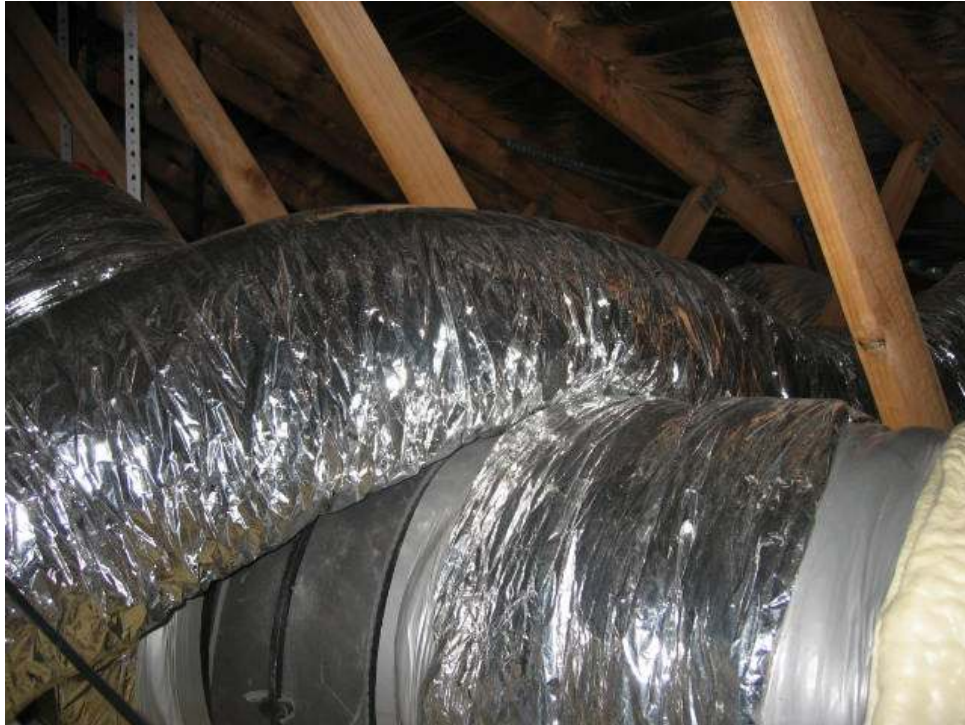
- This ceiling area can not be accessed yet a claim was made as being insulated.

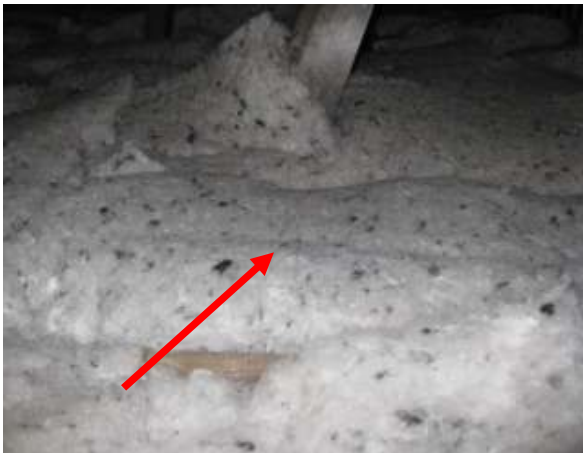
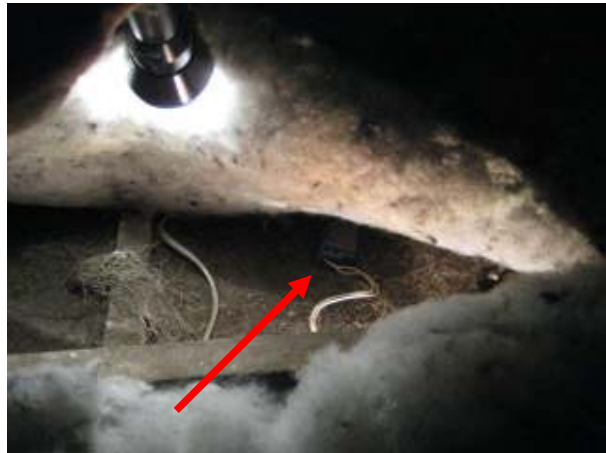
- This ceiling area has insulation installed over downlights. **NON COMPLIANT Finding!**

PASSED OR FAILED: FAILED, RECTIFICATION WORKS ARE REQUIRED PRIOR TO ACCEPTANCE AND PAYMENT OF THESE CEILING INSULATION WORKS.
