Site Characterisation -  
Technical Report  
**WALLERBERDINA**

**NATIONAL  
RADIOACTIVE  
WASTE MANAGEMENT  
FACILITY**

## Site Characterisation - Technical Report - Wallerberdina

Client: Commonwealth Department of Industry, Innovation and Science

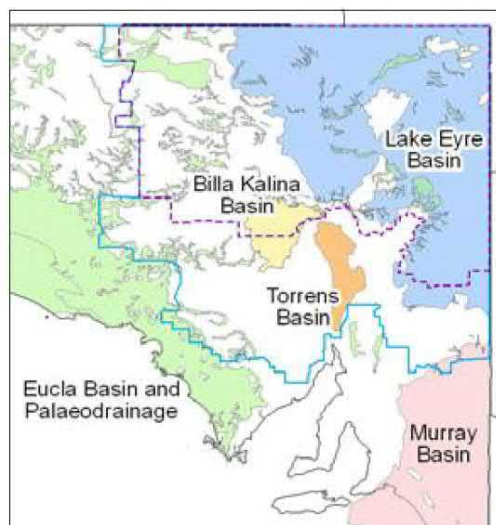
**Figure 28 Location of the Torrens Basin (from Watt *et al*, 2012)**

Watt *et al* (2012) provide an excellent summary of the recent geological setting (Cainozoic) for the Torrens Basin which appears to underlie the site (see Figure 28) which has been paraphrased here.

- The Torrens Basin contains sediments of fluvio-lacustrine depositional environments (Eocene and Miocene age) and overlies Precambrian and Cambrian rocks (Alley & Benbow 1995).

- Work by Martin *et al* (1998) suggests that Tertiary sediments within the Torrens Basin are likely to range in thickness from 80 m up to 270 m. The fluvio-lacustrine Cotabena Formation contains partly carbonaceous, fine to coarse-grained sand, silt, and sandstones with occasional thin carbonaceous clay beds; including lignites. The overlying Neuroodla Formation is commonly about 100 m thick and generally comprises green, grey to black argillaceous and white calcareous mudstone.

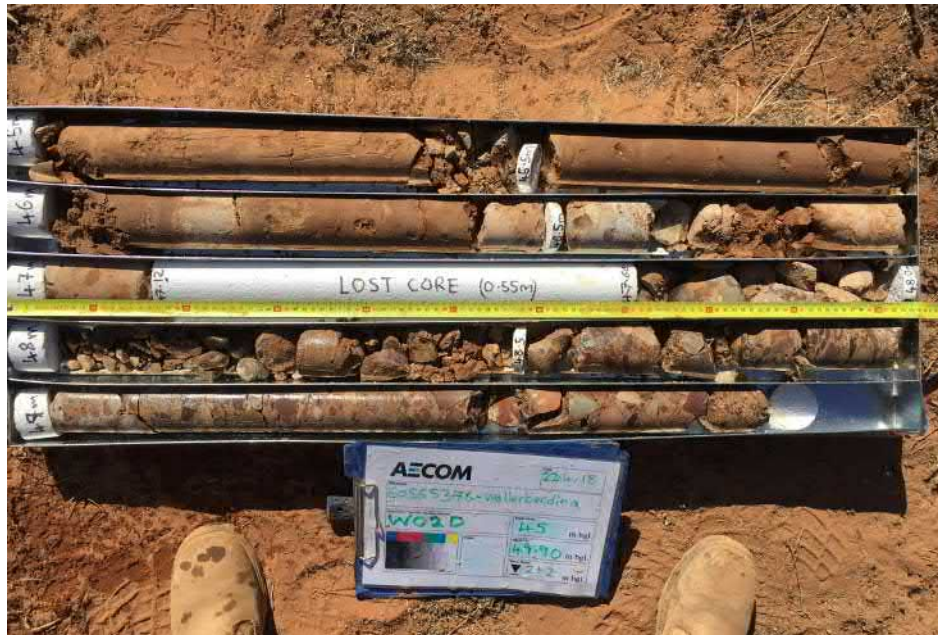
**Figure 33 Core box showing intersected conglomerate at W02D**

The conglomerate unit intersected at W02D is possibly the sub-surface extension of the conglomerate observed outcropping at the Hookina Springs and Hookina Waterhole and was encountered at shallower depths at W01 and W04. Photographs of sonic core samples obtained from W01 and W04 are shown in comparison to the Hookina Waterhole conglomerate below.

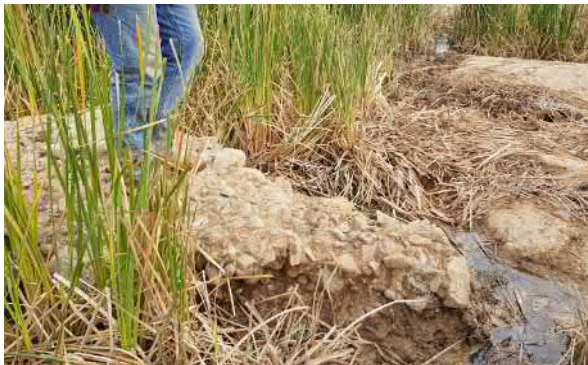
**Figure 34 Comparison of intersected conglomerate with outcropping conglomerate**

**Conglomerate outcrop at Hookina Springs – 26/05/18**

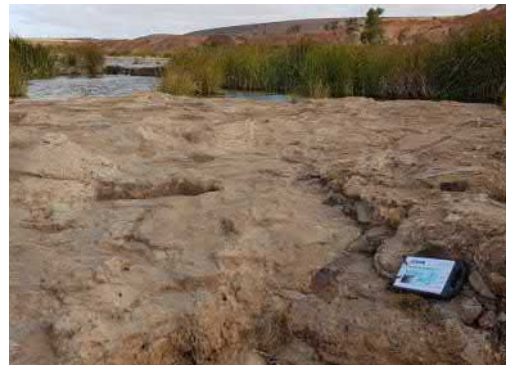
In general, the sub-surface profile may be summarised as alluvial clay with interbedded moderate permeability sand – gravel lenses from the surface, intersected by a high-permeability, dipping, conglomerate at 50 - 35 mAHD, depending on the location on the site. Lithology grades to low permeability siltstone / mudstone with interbedded by layers of high permeability sand / sandstone.

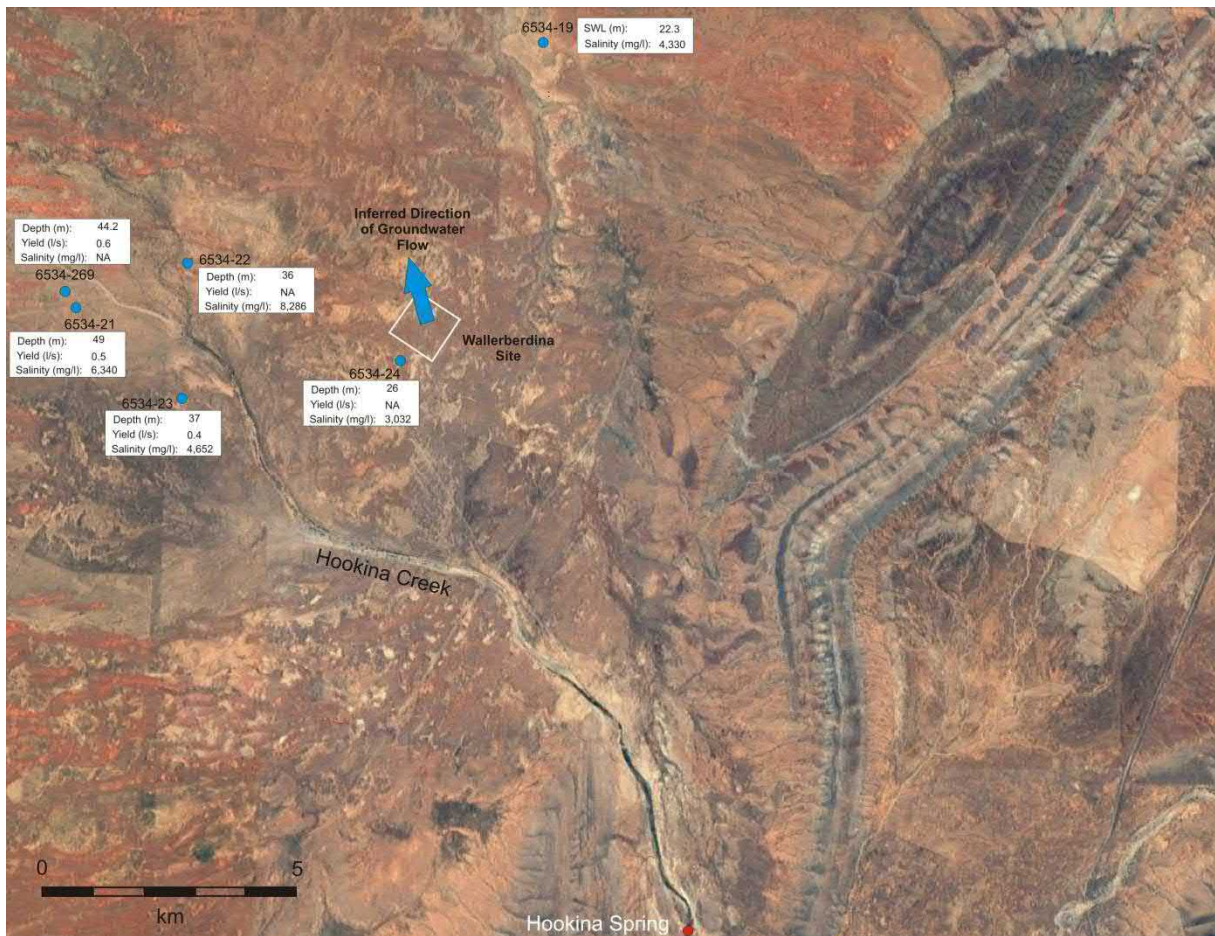
**Figure 36 WaterConnect registered bore information and inferred watertable aquifer flow direction (23/05/18)**

A review of nearby registered groundwater bores from the South Australian WaterConnect database shows a number of bores within a 5 km radius of the site. Figure 36 below shows bores registered for the purpose of stock watering and a reported operational status. The inferred direction of groundwater flow from site derived groundwater level data suggests watertable groundwater flow is to the north-north-west. While there are several registered operating stock watering bores reported within 5 km of the site, several located to the north-west or north east of the site and are sited lateral to the direction of groundwater flow. There are a number of registered operational stock watering bores located in the down hydraulic gradient direction of the site, Bores 6534-5, 6534-10 and 6523-12 at distances of approximately 17 km, 12 km and 20 km respectively.

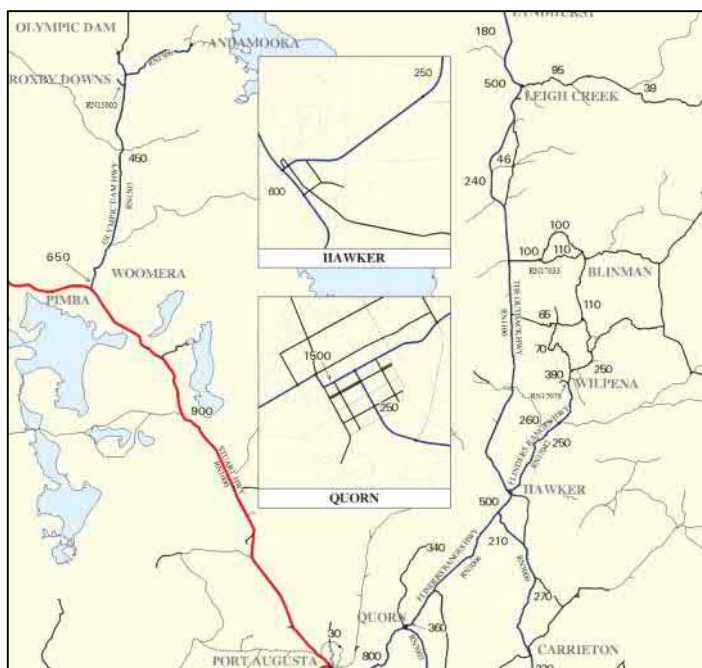
**Figure 68 Annual Average Daily Traffic Estimate 24 hour two way flows (Department of Planning, Transport and Infrastructure, 2015)**

The Outback Highway is a two-way, sealed and marked road with a designated speed limit of 110 km/hr. Annual Average Daily Traffic (AADT) estimates are provided for the state-managed arterial roads in the vicinity of the site, as shown in Figure 68. The Outback Highway has low AADT, with traffic flows of 260 vehicles / day along the section between Hawker and Leigh Creek.

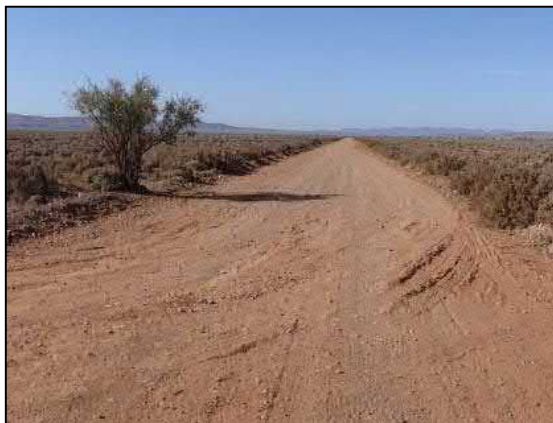
**Figure 70 Lake Torrens Homestead Road**

The area surrounding the potential site has a local road network mostly consisting of unsealed, low trafficked roads. Some are all-weather roads however may be less suitable for carrying heavy loads during the winter months as a result of rainfall. The site is bounded to the south by Lake Torrens Homestead Road and to the west by unnamed vehicle tracks (refer to Figure 70 and Figure 71 below).

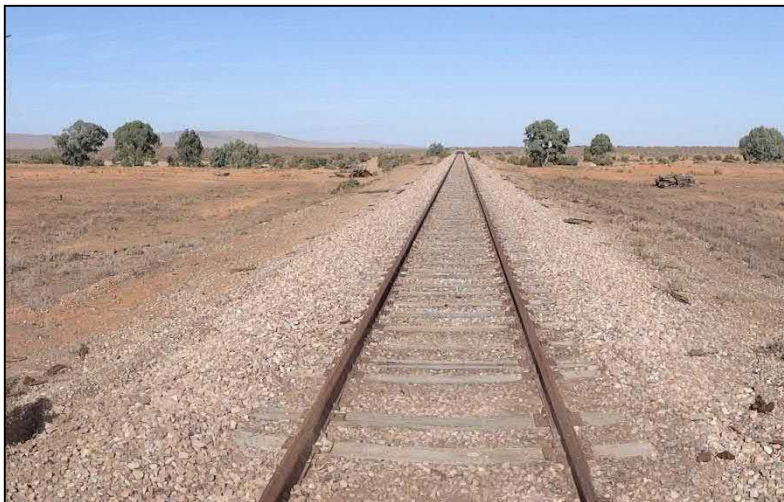
Figure 72 Cotabena Railway

The disused Cotabena Railway (refer to Figure 72) that was used to transport materials between the Leigh Creek Coal Mine (closed in 2015) and Port Augusta is located east of the proposed site. There is potential to use this to transport waste materials to the site. However, this would require additional works such as the construction of a siding to the NRWMF and remediation of the existing rail line. It should also be noted that the use of rail to transport waste will require transfer from one mode of transport to another. This process would be subject to relevant approvals. Many existing intermodal facilities are in built-up urban areas.

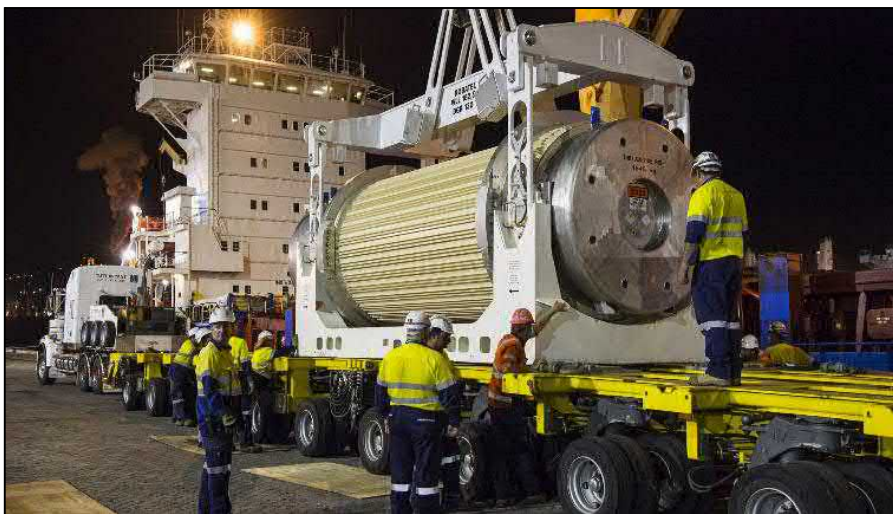
Figure 74 TN81 Container being transported (Department of Industry, Innovation and Science, 2016)

An aspect of the operation phase for the NRWMF is the movement of TN81 Containers used to transport intermediate level waste. The TN81 Containers are 6.5 metres long, 3 metres in diameter and weigh approximately 100 tonnes when empty (Australia Nuclear Science and Technology Organisation, 2011). Therefore, the use of an over-dimensional / mass vehicle is required.

Further investigations into the type of vehicle required and suitable transport routes will be performed as part of the Stage 2 works. As shown in Figure 74, it is likely that a prime mover and low loader combination will be necessary to transport the container over the road network.

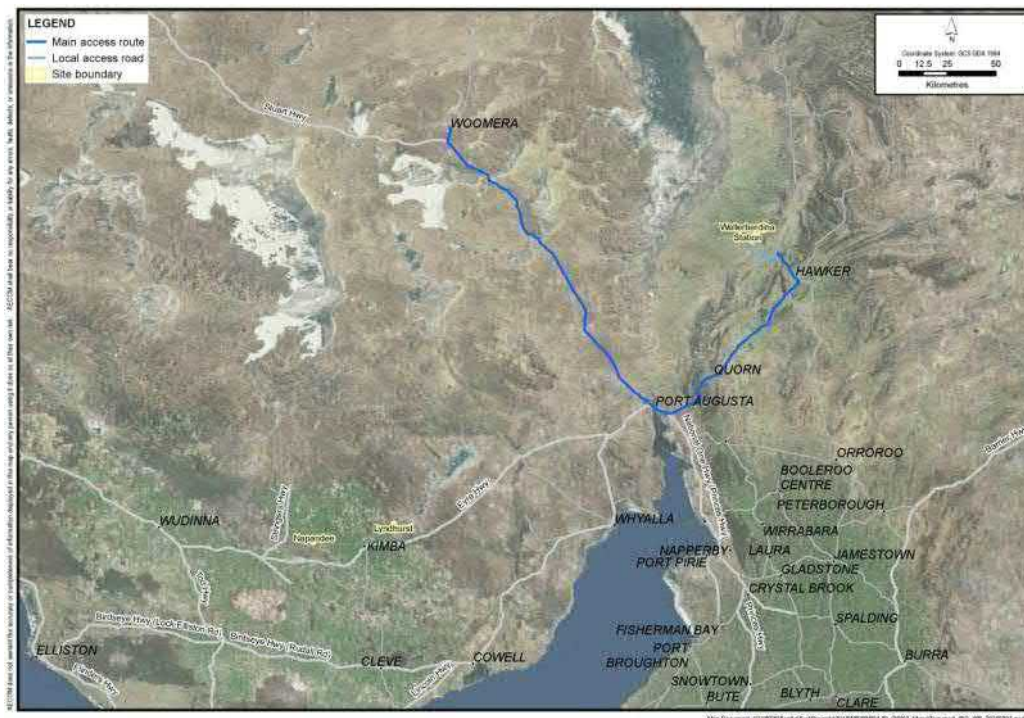
Figure 75 Access route from Woomera

There is no feasible alternate route along the National Highway Network to travel between Woomera and Wallerberdina. This is mainly due to there being no approved B-double routes that do not run through Port Augusta between Woomera and Wallerberdina, and Olympic Dam Highway terminating north of Woomera at Olympic Dam.

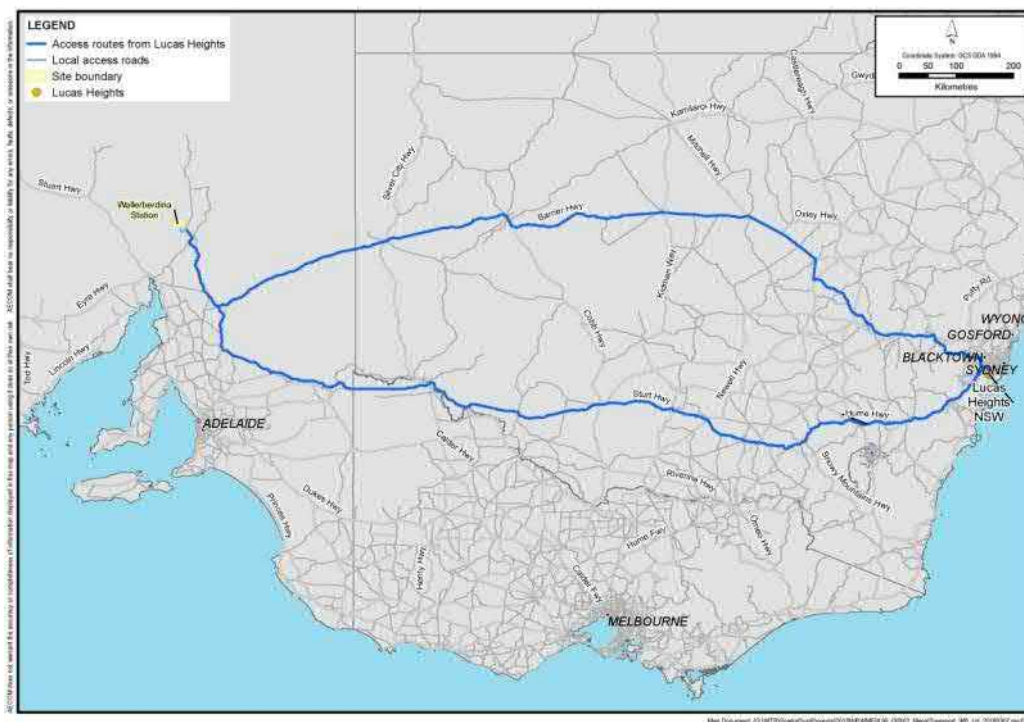
Figure 76 Access routes from Lucas Heights

1. Hume Highway (M31)
2. Sturt Highway (A20)
3. Goyder Highway (B64)
4. Barrier Highway (A32)
5. Orroroo – Peterborough Road (B56)
6. RM Williams Way (B80)
7. Barndioota Road / The Outback Highway (B83)

Further investigations will need to consider the local road network through key towns and cities along the proposed routes to determine if there are approved heavy vehicle routes that will allow shipments to bypass these towns. Future investigations will further narrow down this route to minimise the number of towns / cities that are travelled through and select a preferred route.

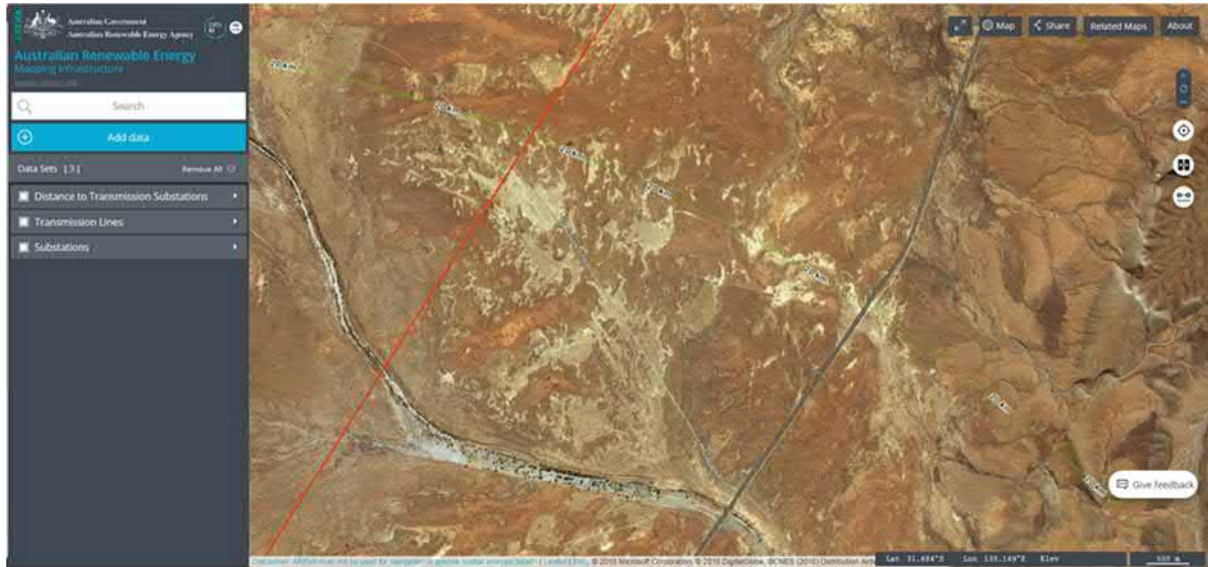
**Figure 80 AREMI – Site Map**

The site considered for Wallerberdina is close (< 1km) to the 132 kV Leigh Creek South Tee to Neuroodla Tee. It is also approximately 20km from the closest substation, Neuroodla. This can be seen in Figure 80 below from AREMI showing in red the 132kV transmission line, and the green line showing the distance from the closest transmission substation.

The proximity to the 132kV line and the substation provide two options that can be considered for the Wallerberdina site:

- Building a new substation for connecting directly to the 132kV Leigh Creek South Tee to Neuroodla Tee line; or
- Building a medium voltage line to the existing Neuroodla substation.

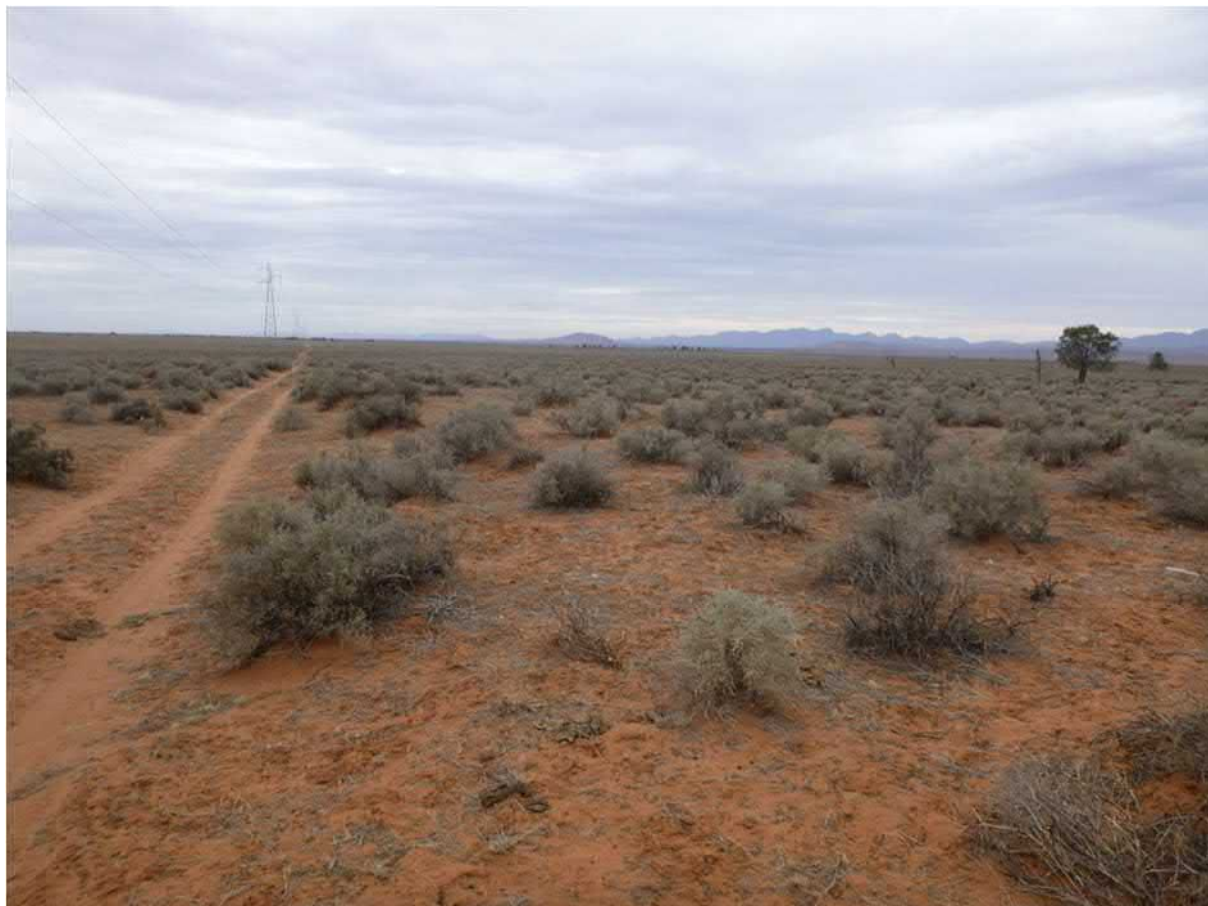
**Figure 81 Wallerberdina – Site photograph looking North showing existing 132kV line**

The image in Figure 81 also shows the 132kV line running adjacent on the West side of the site.

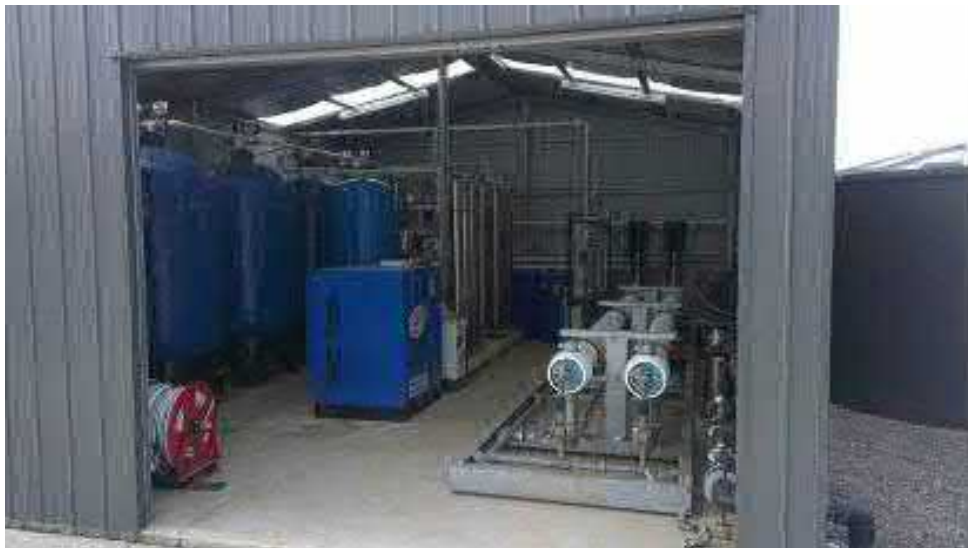
**Figure 83 Desalination Plant Example (Desal Systems)**

A network of groundwater extraction bores would be required to be installed. The water would then be pumped to an onsite desalination plant similar to that show in the figure below.

The treated water would then be pumped to storage tanks on site for Fire Fighting Supply, process use and general use.

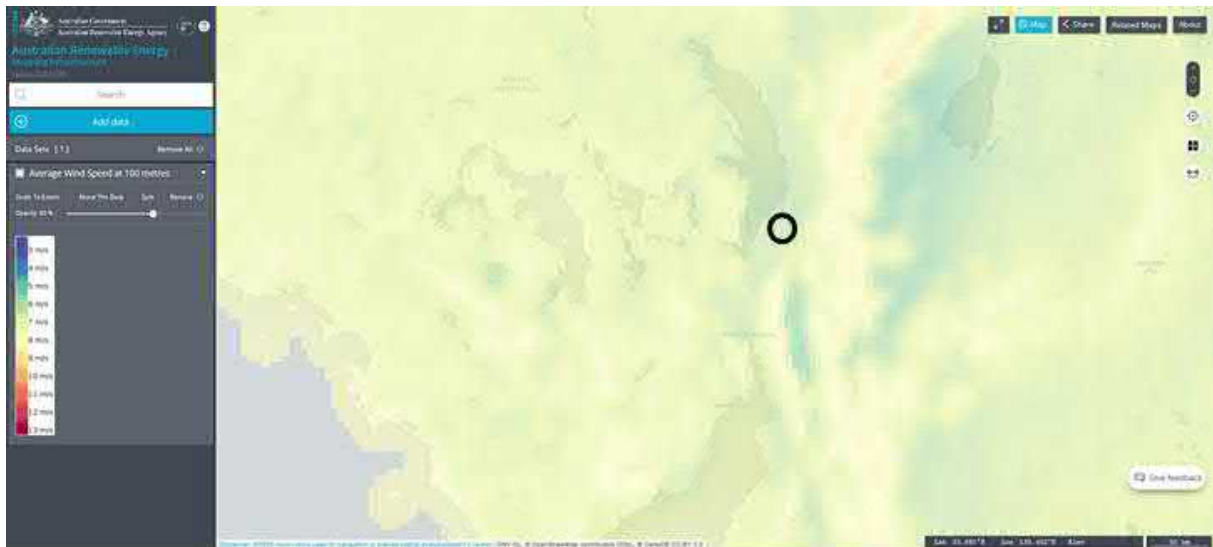
Figure 85 Wind resource at Wallerberdina site [1]

The area for Wallerberdina shows a relatively low wind resource area as outlined in Figure 85 below (Wallerberdina is the black circle). Wallerberdina is in a region of green colour, representing a lower wind resource than the lighter yellow areas. The surrounding Flinders Ranges have a higher resource but additional land procurement would be required along with potentially challenging development approvals. Transmission between a wind farm in a satisfactory resource area back to the NRWMF at Wallerberdina would need to be assessed for cost effectiveness. Additionally, some turbines derate at high temperatures and some stop operating at temperatures between 40°C and 45°C. This region reaches these temperatures and must be taken into account when considering annual output.

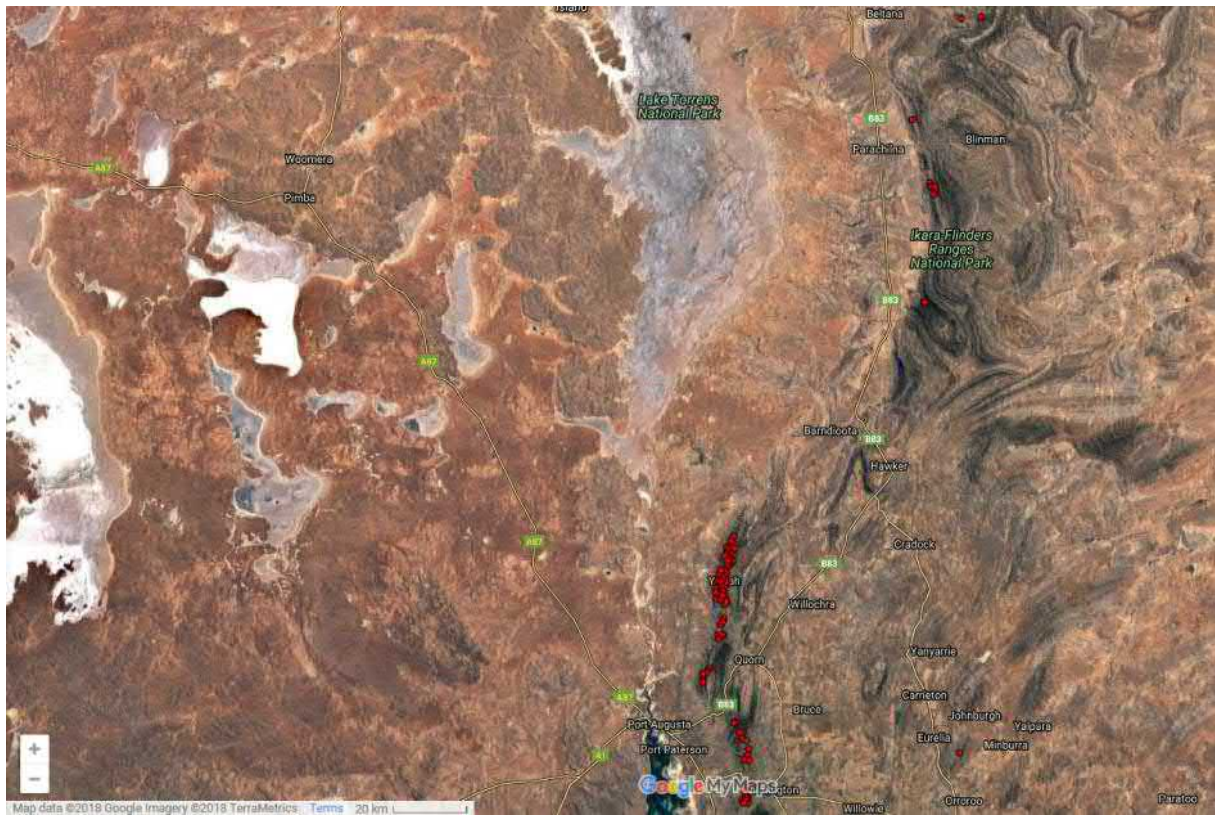
Figure 87 Pumped Hydro atlas, red circles indicate identified potential pumped hydro sites [29]

While pumped hydro is a form of storage, rather than generation, noted below is potential sites identified through studies recently conducted by the Australian National University. The image below shows the identified sites near the Wallerberdina region. The surrounding Flinders Ranges have potential sites nominated but the transmission between the pumped hydro sites back to the NRWMF at Wallerberdina would unlikely be cost effective.

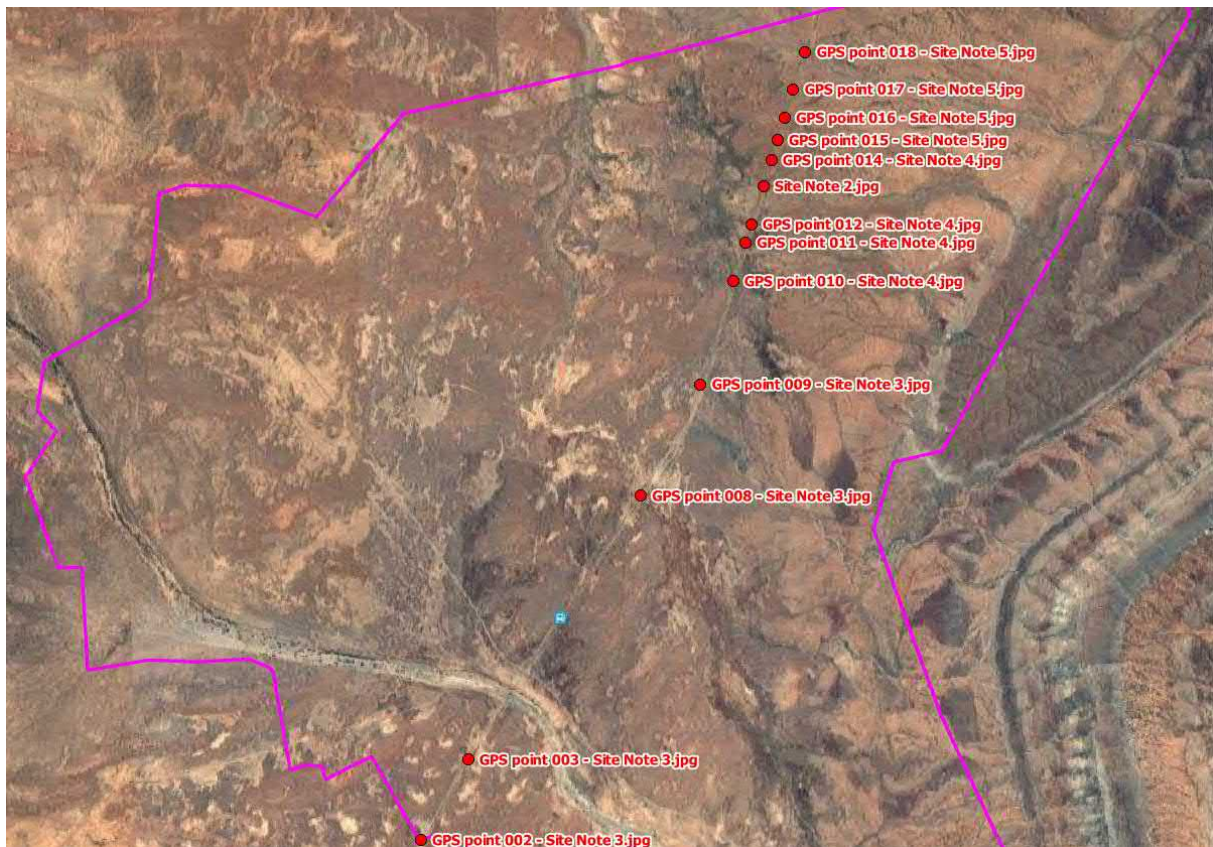
Figure 88 Structure location – GPS points and site note name

Approximate bridge and culvert dimensions were captured as part of the field work. The data was captured and sent via image to expedite the hydraulic modelling. The railway bridge over Hookina Creek is covered in its own site note (*Site Note 1.jpg*). The location of each remaining structure and the reference to the site note image is illustrated in Figure 88 below. Each of the site notes are presented in Figure 89 to Figure 93.

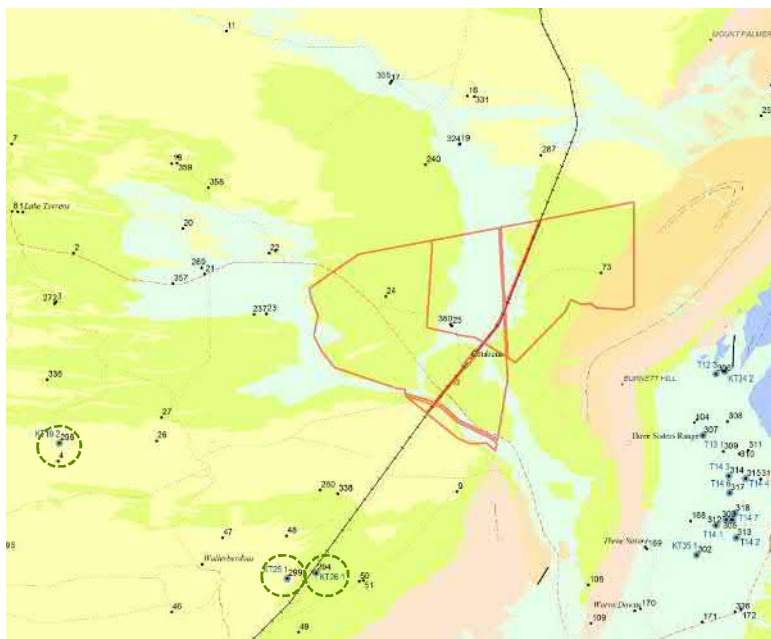
**Figure 109 Map provided by Geological Survey of SA showing SAGRIG drillhole locations**

The locations of these drill holes are shown with a green circle below and support the interpretation that basement depths increase away from the ranges based on KT192 being the most westerly investigation location.

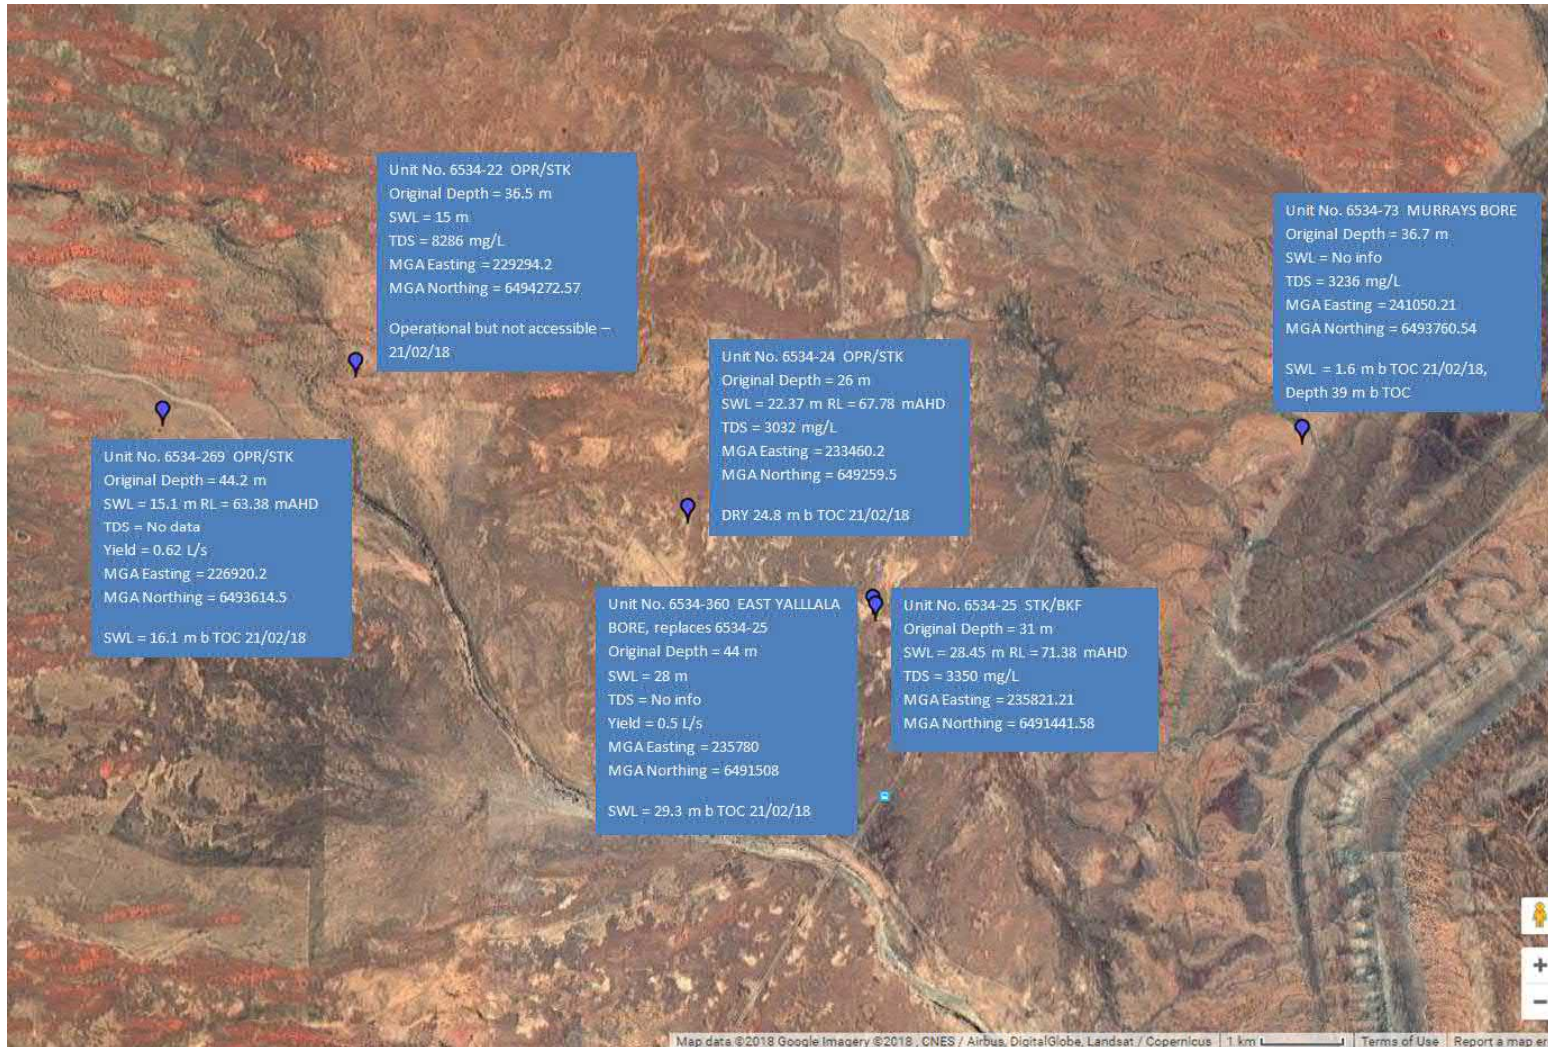
Figure 111 Summary of selected registered bores include the AECOM site reconnaissance – 21/02/18, basemap from WaterConnect on-line query 13/03/18

There is currently no site specific groundwater information indicative of the hydrostratigraphy or hydrogeochemistry underlying the nominated site within the Wallerberdina Station site. The results of the WaterConnect registered well search within a 10 km radius of the centre of the Wallerberdina Station site are shown on Figure 111.

- The standing water level at 6534-360 was recorded at 29.3 m below the top of casing (m bTOC) in February 2018, slightly lower than originally recorded in June 2016 (28 m). This well was drilled to 44 m and water was intersected between 33 and 40 m bgs with a yield of 0.5 L/s. The driller's log for this well suggests that it is installed within unconsolidated sediments extending to the base of the well.

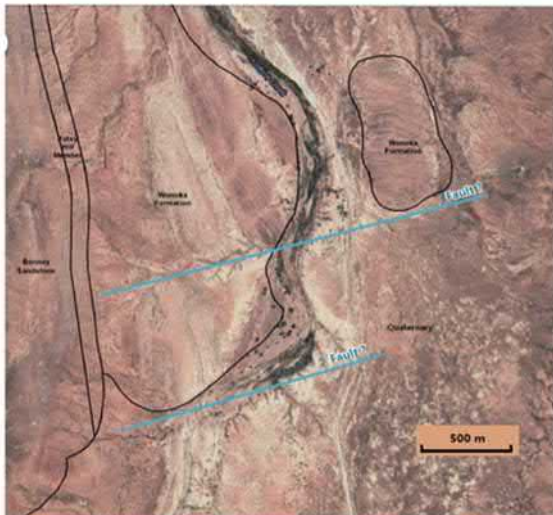
Figure 112 Hookina Spring inferred source area (from Barnett *et al*, 2015)

*“The geological outcrops appear to be much more complex than the published geology suggests. The occurrence of lush vegetation coincides with two south-west to north-east trending faults that seem to control the direction of Hookina Creek and a tributary. This suggests that faulting may provide a conduit for groundwater discharge from deeper aquifers, which appear to be the Wonoka Formation or possibly the Bonney Sandstone.”*

Figure 112 from Barnett *et al* (2015) shows inferred geology and faults in vicinity of Hookina Spring.

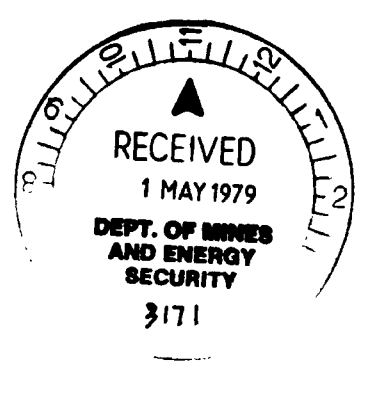
**COMALCO**  
 SOUTH AUSTRALIA  
 LAKE TORRENS  
 EL 371  
**COMPOSITE WELL LOG - DRILL HOLE** *C/T3*

Location: Latitude 31°44'00" S Longitude 138°10'15" E Date Spudded: 16 - 11 - 78 Date completed: 17 - 11 - 78 Drilled by: Thompson Drilling Co. Drill: Mayhew 1000 Well site Geologist: SKC/GC Logged by: Geoscience Associates Logging unit: AL - 7 Logger: Waldron

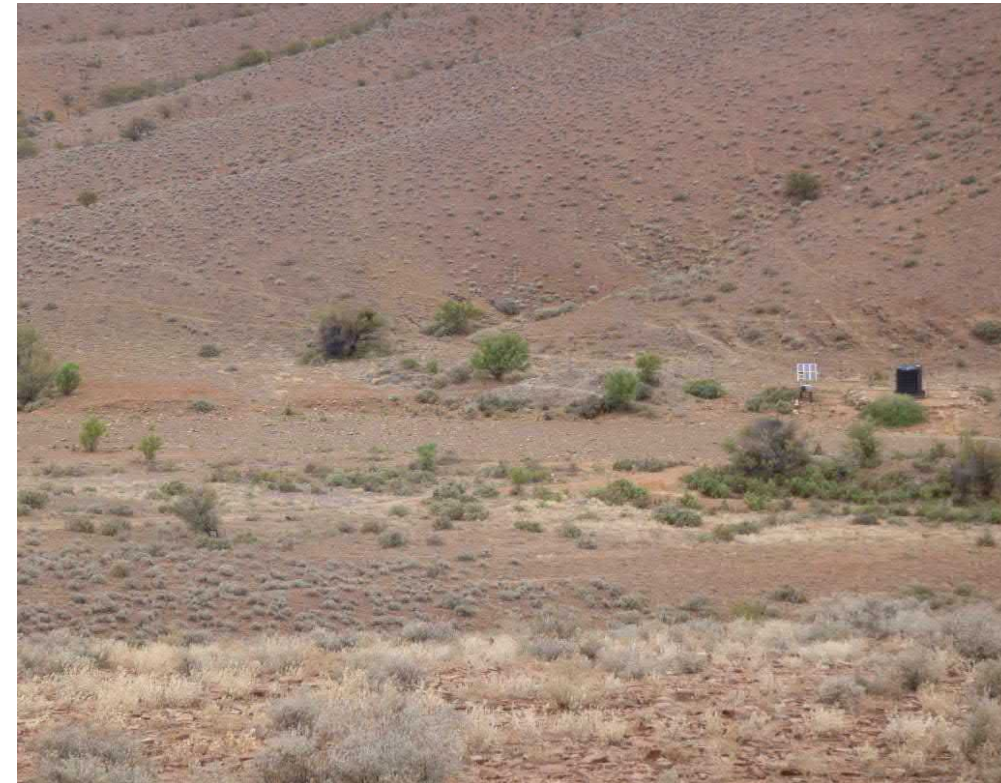
Unit 6534-73 – Murrays Bore showing location adjacent drainage line, black tank and solar panel visible.

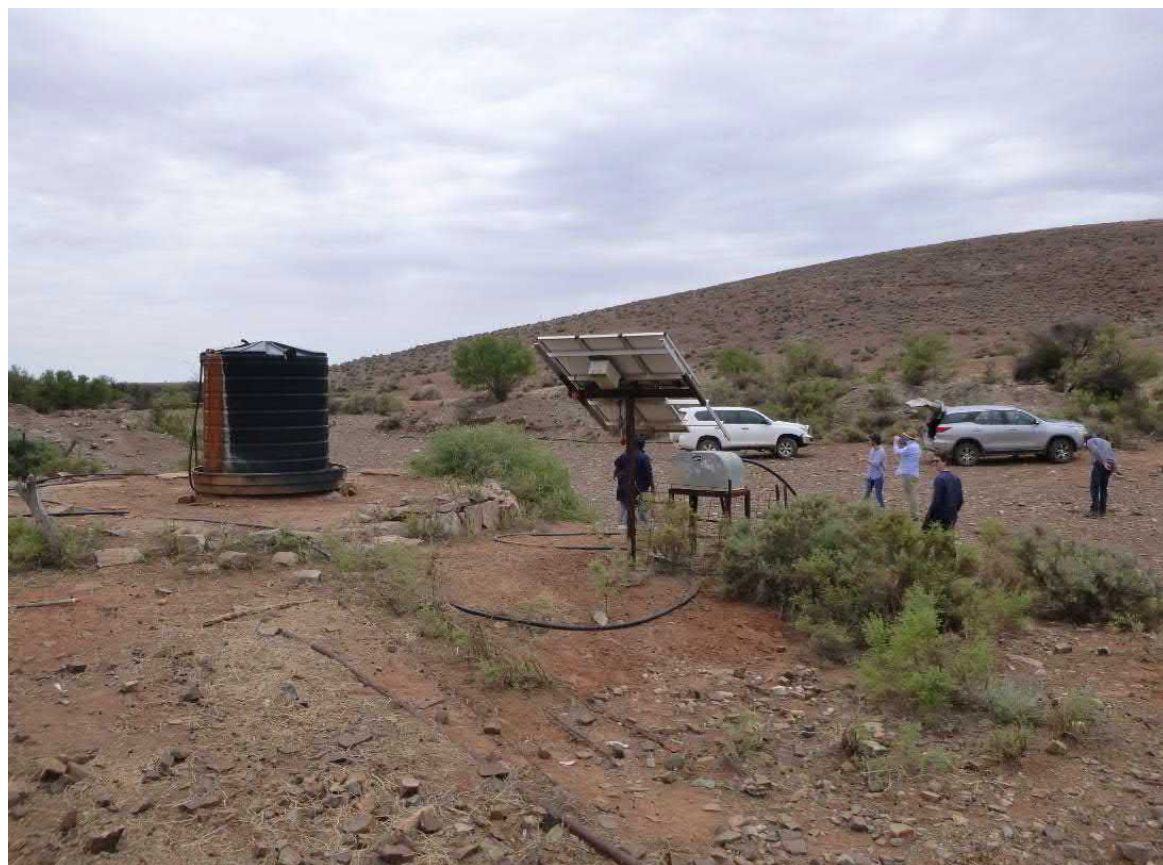
Close up of Murrays Bore set up. Water level was measured at 1.6 m below top of casing, total well depth was 39 m below top of casing on 21/02/18.

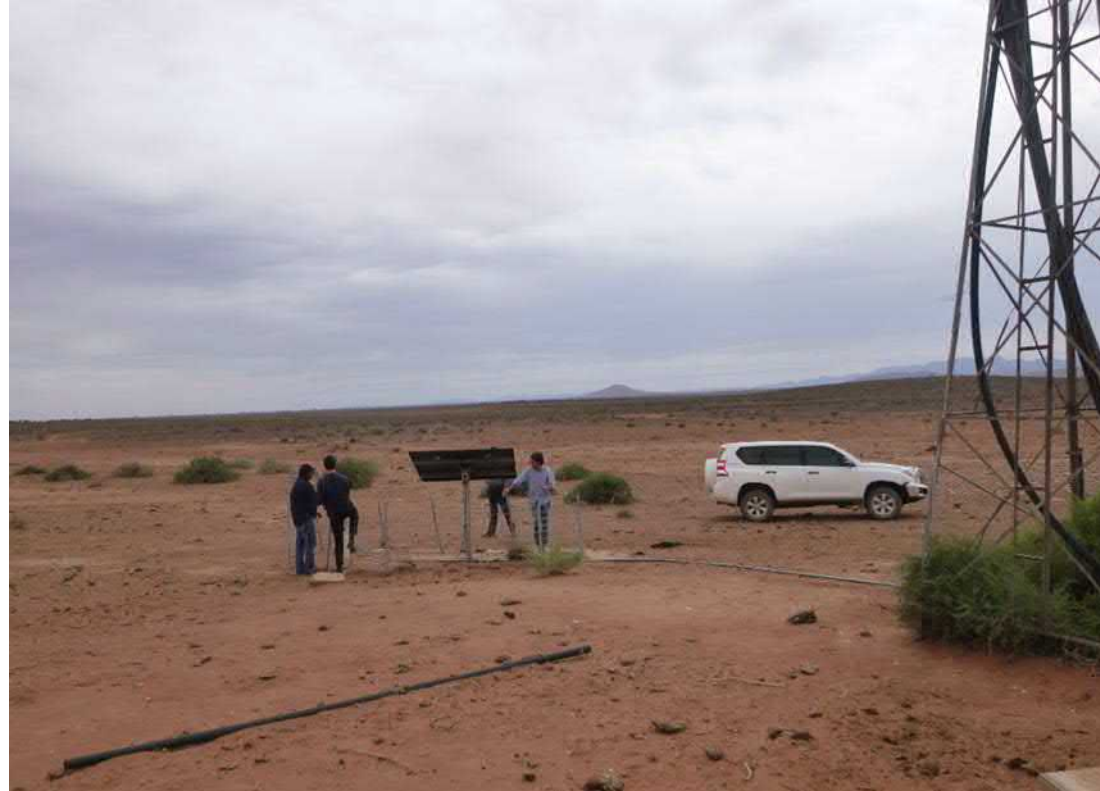
Well 6534-360 (East Yallala Bore) replacing 6534-25, solar pump relaces windmill for stock water.

Standing water level measured at 29.3 m below top of casing on 21/02/18.

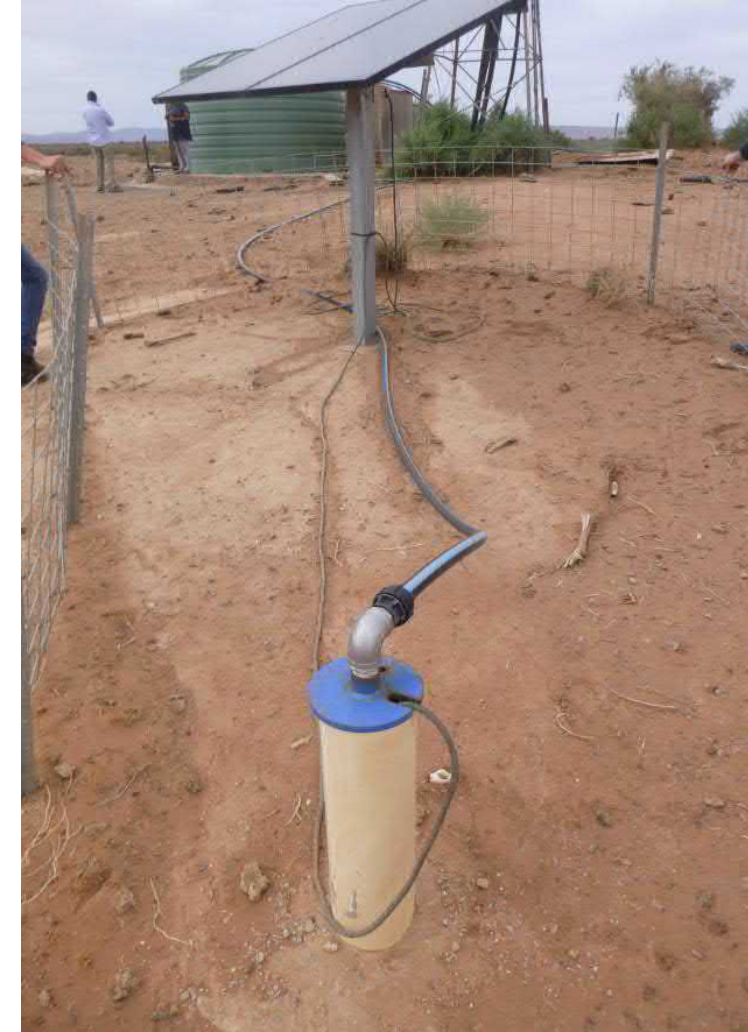
Well 6534-360 pump, power and tank set up.

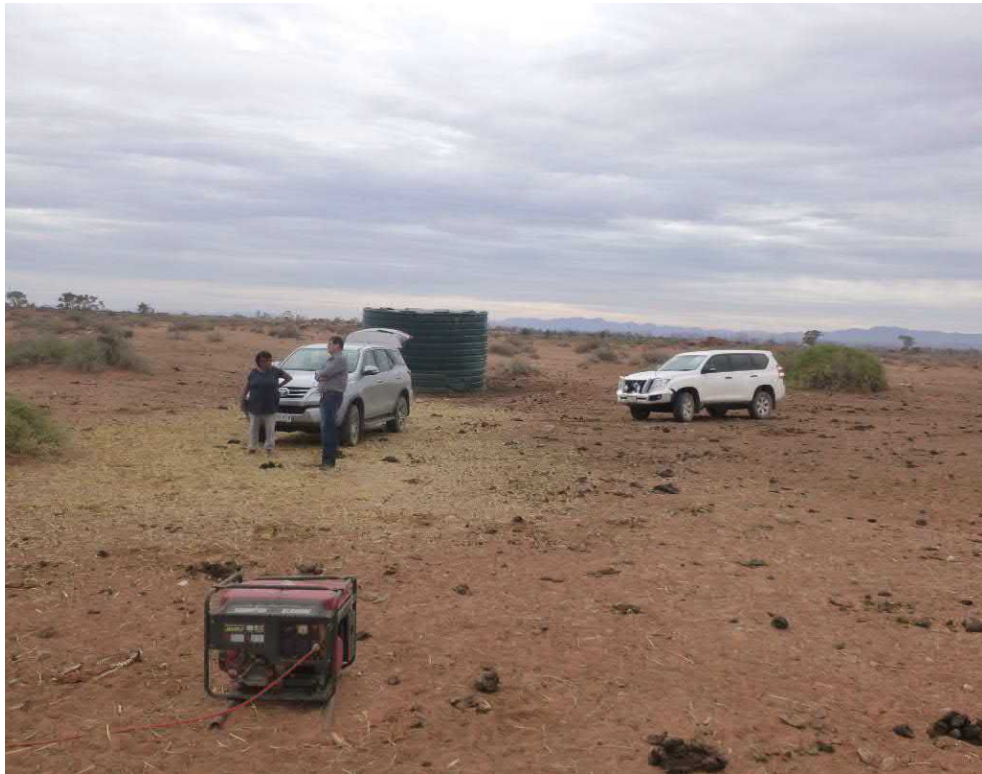
Well west of Hookina Creek outside of Wallerberdina Station property (6534-269). Standing water level measured at 16.1 m below top of casing on 21/02/18. Generator on site. Cattle observed nearby. Water trough adjacent well.

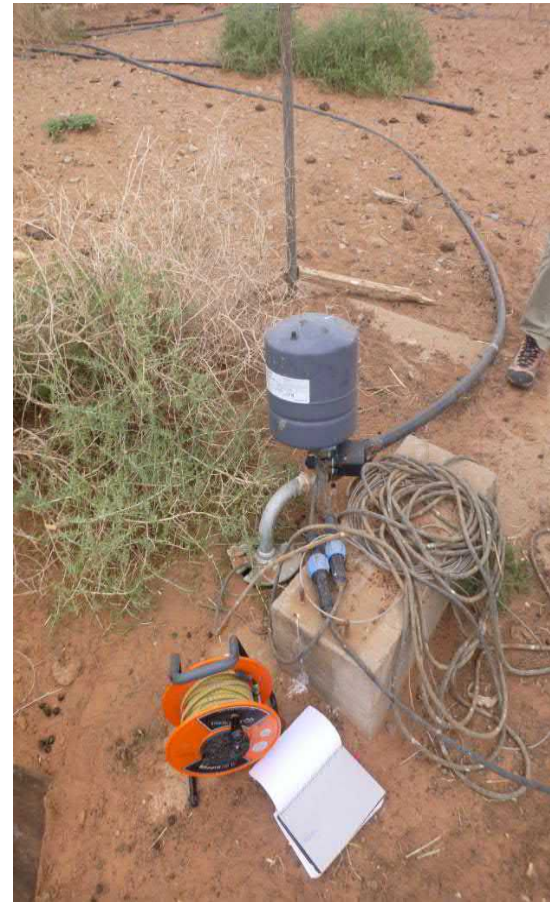
Close up of pump set up at well west of Hookina Creek (6534-269)

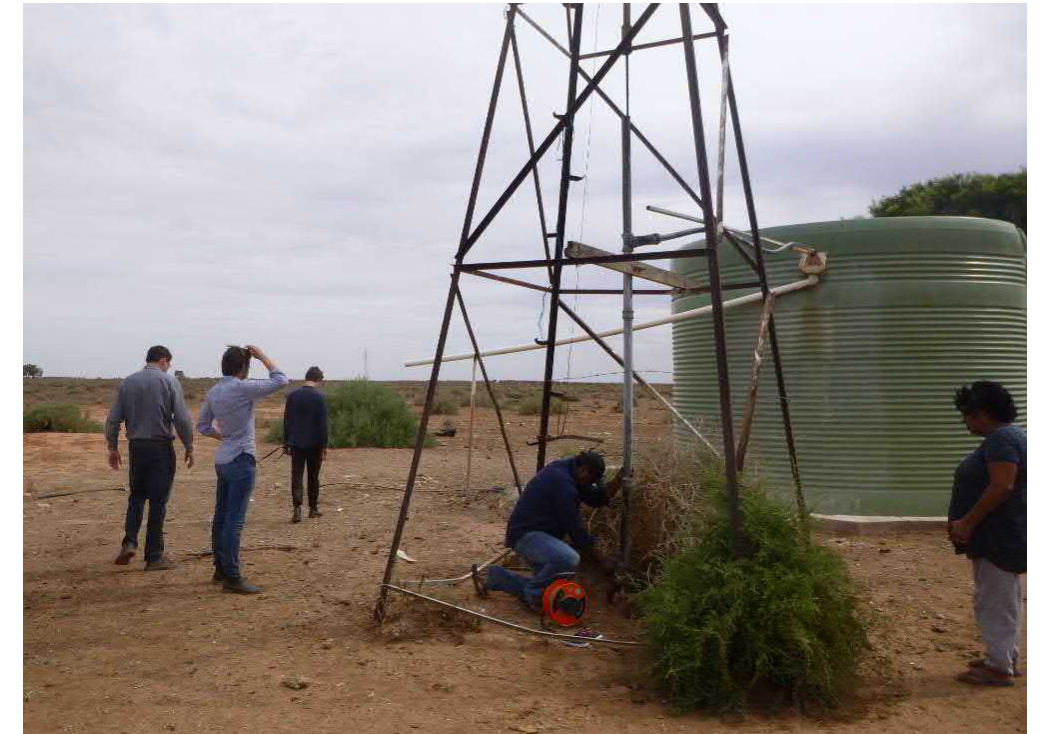
Well 6534-24, measured as dry at 24.8 m below top of casing on 21/02/18.

Recorded as an operational stock bore with an original standing water level of 22.37 m in 1980, total depth 26 m.

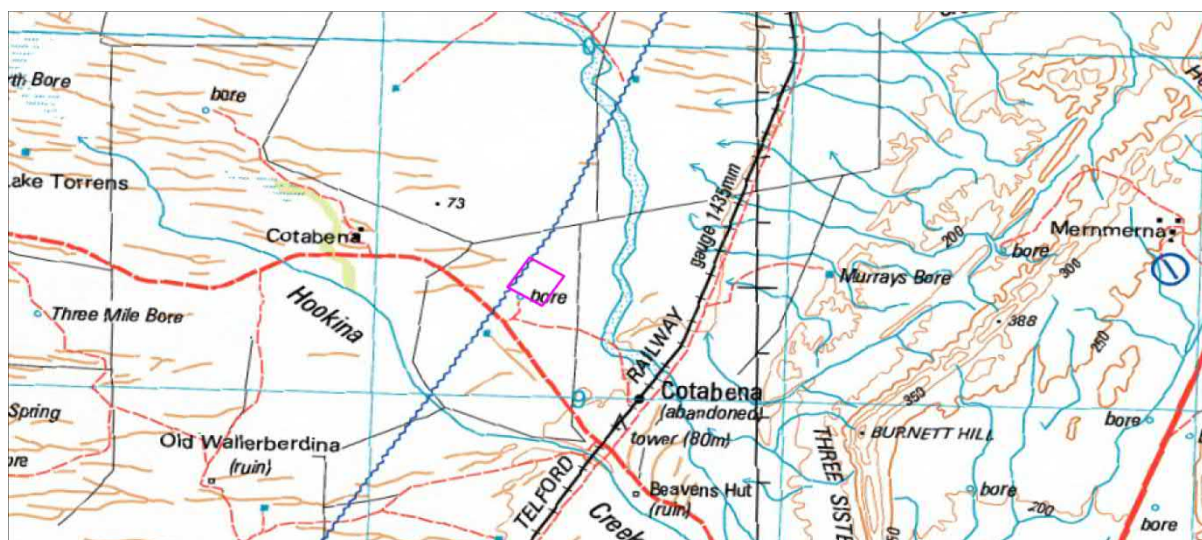
Image 1 Wallerberdina Survey Site outline on topographic background

The study area under consideration at Wallerberdina Station is the magenta square shown below. The area is approximately 1km<sup>2</sup> and is located on recent surface sediments adjacent to the Flinders Ranges.
