## **HMAS *Moreton*, Brisbane**

### **Heritage Impact Assessment**

**Report prepared for the Department of Defence**

**July 2017**

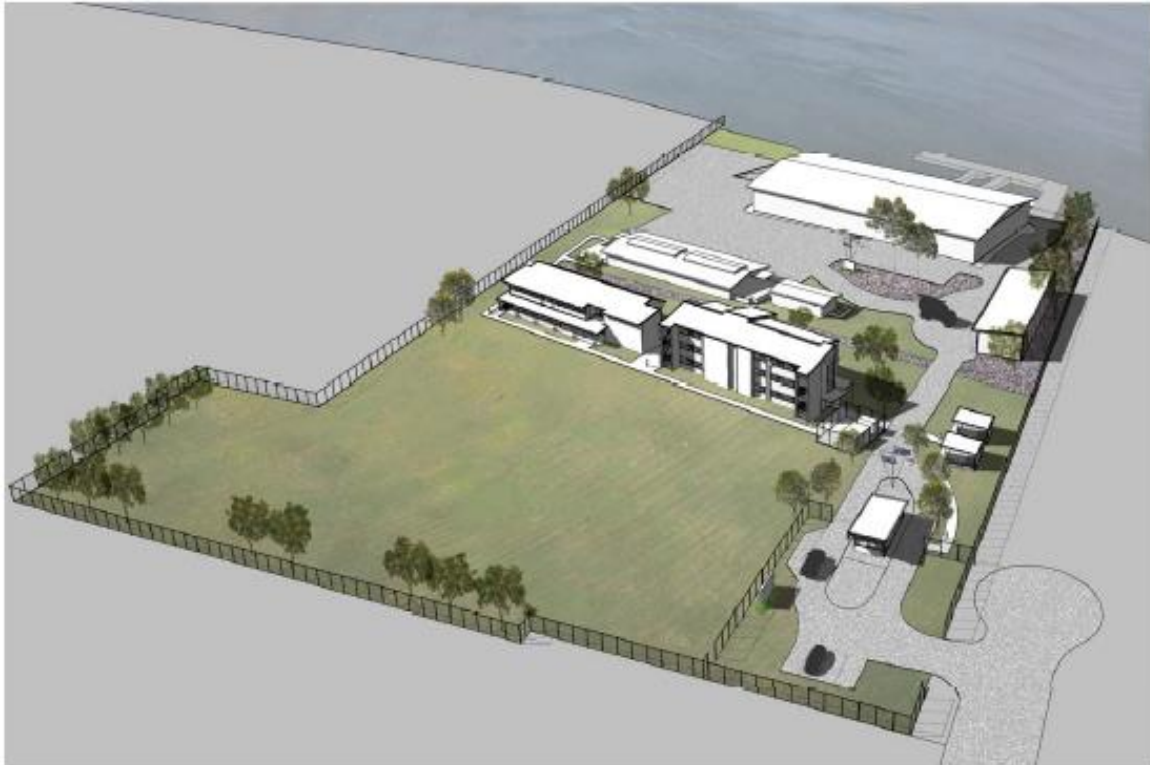
**Figure 24:** Concept design showing proposed site layout post development. (Source: Defence PWC Statement of Evidence, March 2017)

The plans showing the proposed 30% concept are provided at Figures 23 and 24. Additional explanatory photographs are provided at Figures 25 to 38.

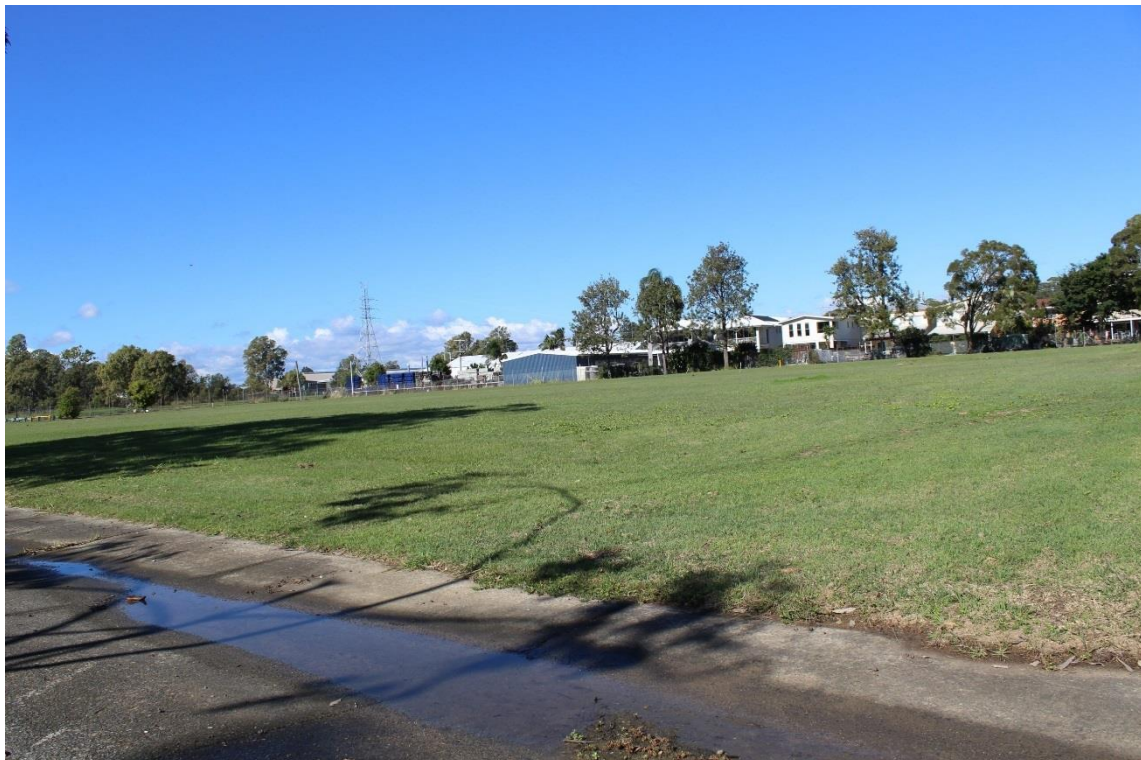
**Figure 25:** The proposed MUF and Transit Accommodation buildings will be located in the grassed area behind A008 and A006. (GML 2017)

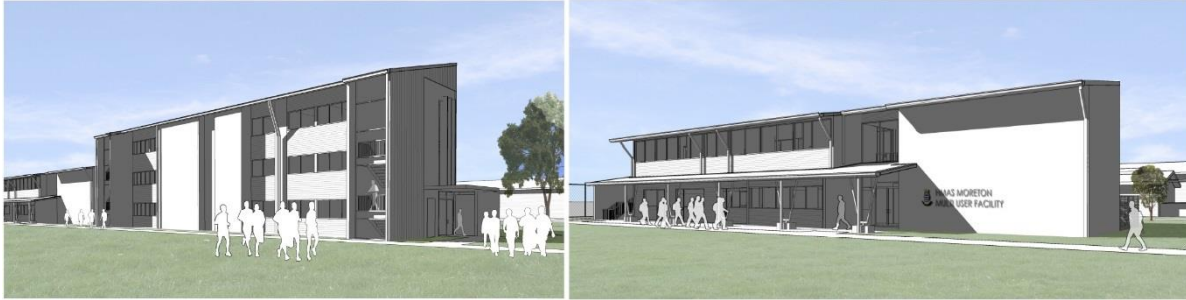
**Figure 26:** Concept drawings showing the proposed MUF and Transit Accommodation buildings. (Source: Defence PWC Statement of Evidence, March 2017)

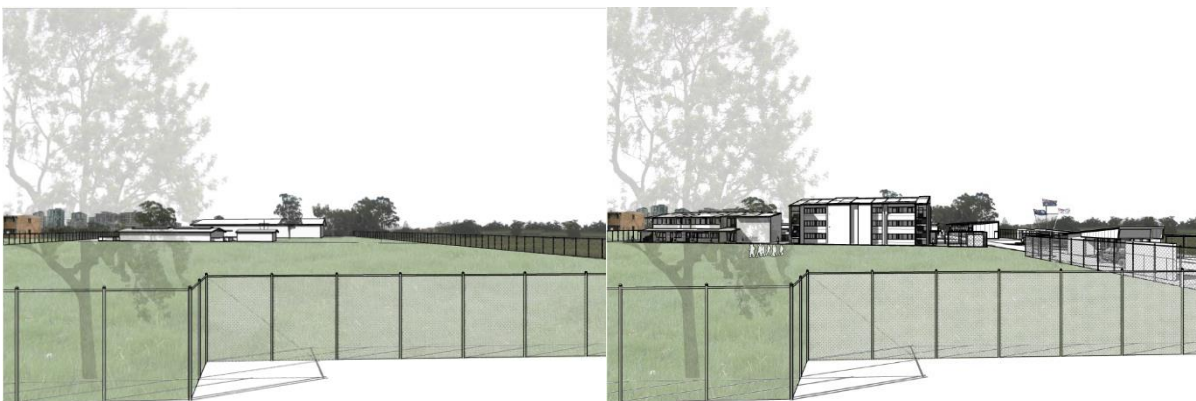
**Figure 28:** Left: existing view from the southern end of the site. Right: post construction view from the southern end of the site. (Source: Department of Defence 2017)

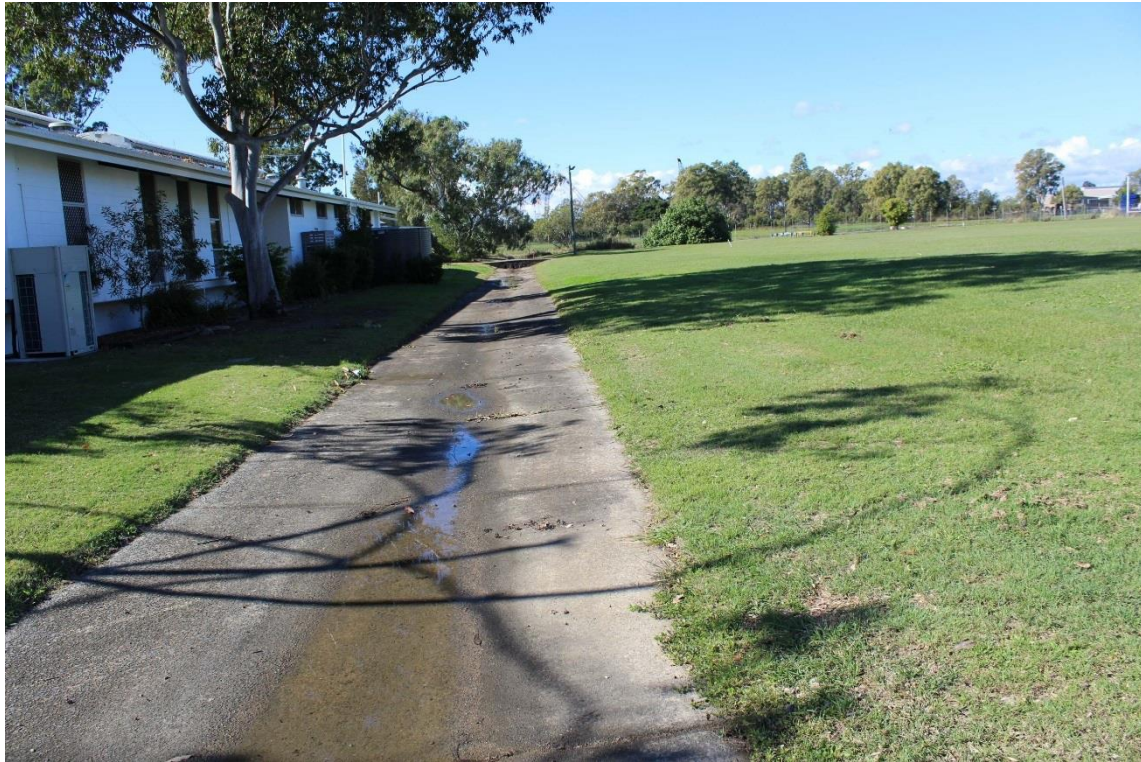
**Figure 29:** The existing swale to be expanded. (GML 2017)

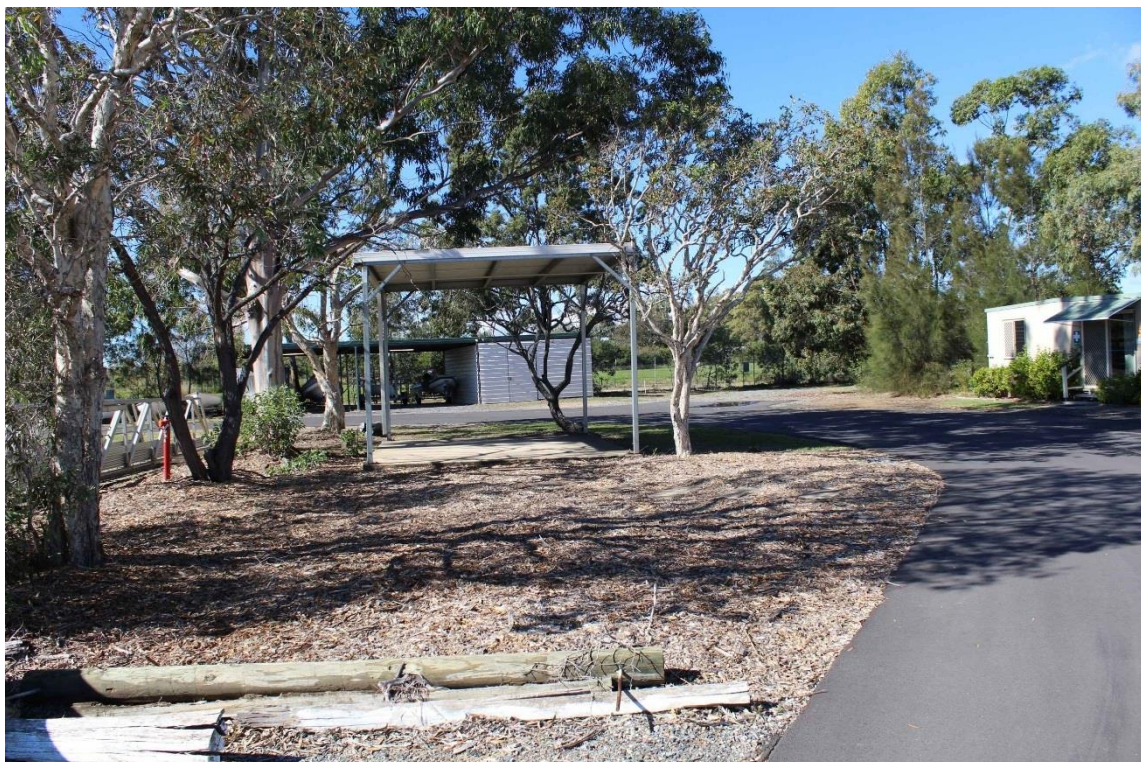
**Figure 30:** Assets A005 (right), A007 (rear) and A014 (foreground) to be removed. The location of A014 is proposed for the new memorial garden. The location of A007 will be used for a new storage structure. (GML 2017)

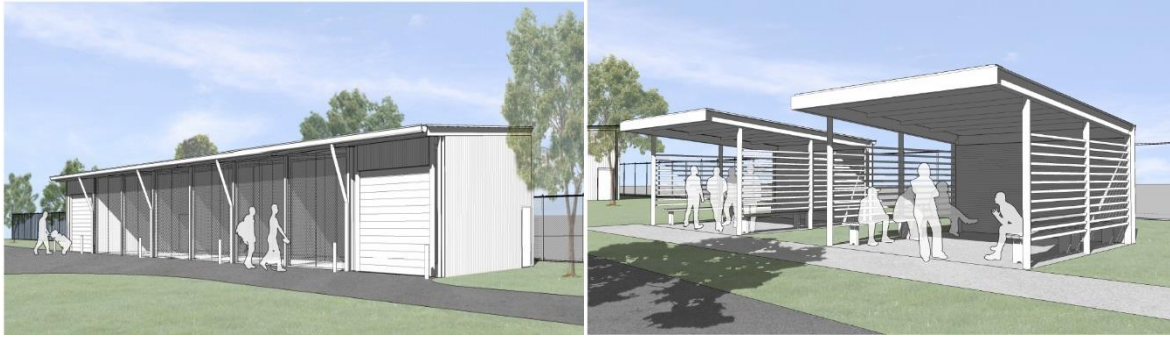
**Figure 31:** Proposed new storage sheds (left) in the location of A007, and proposed training shelters to be located adjacent to the eastern end of the new Transit Accommodation Building. (Source: Defence PWC Statement of Evidence, March 2017)

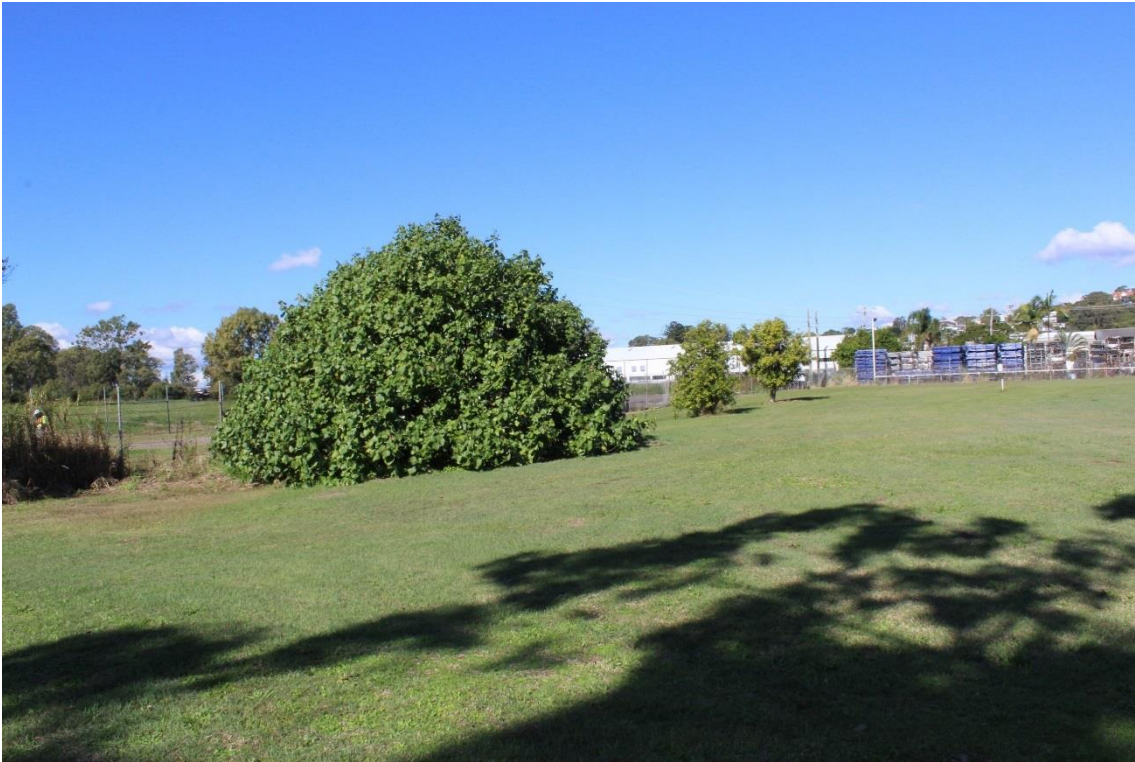
**Figure 32:** The general location of the proposed new Gatehouse. The large shrub will need to be removed during the works, along with the construction of a new entry road from Taylor Street into the site. (GML 2017)

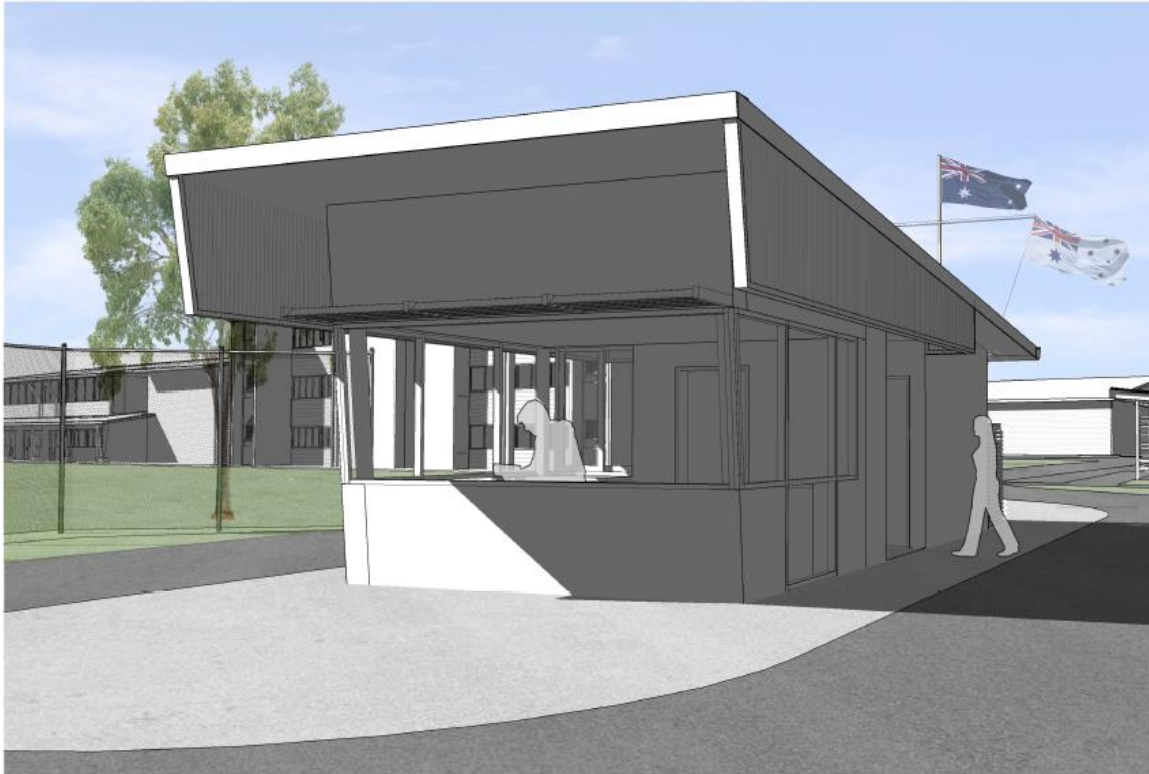
**Figure 33:** Concept design for the proposed new Gatehouse, looking north-west. (Source: Defence PWC Statement of Evidence, March 2017)

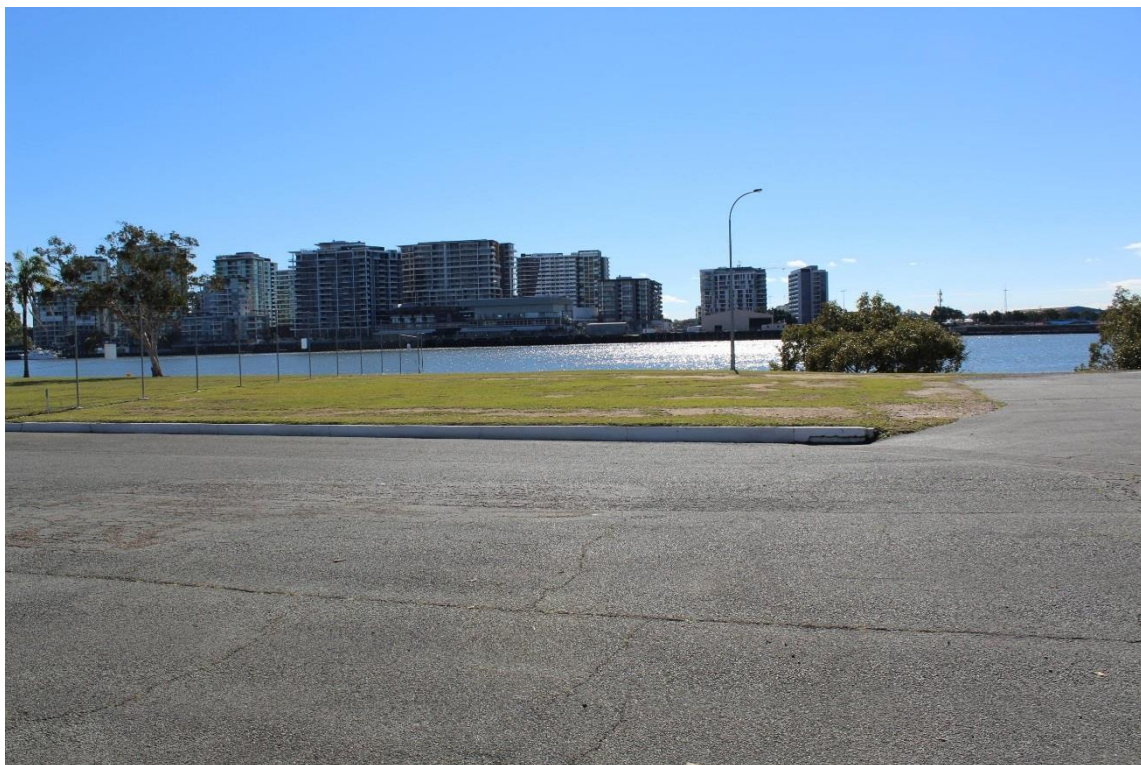
**Figure 34:** Grassed area to the west of Asset A002 proposed for a new hardstand area. The entry to the proposed boat ramp can be seen to the right side of this image. (GML 2017)

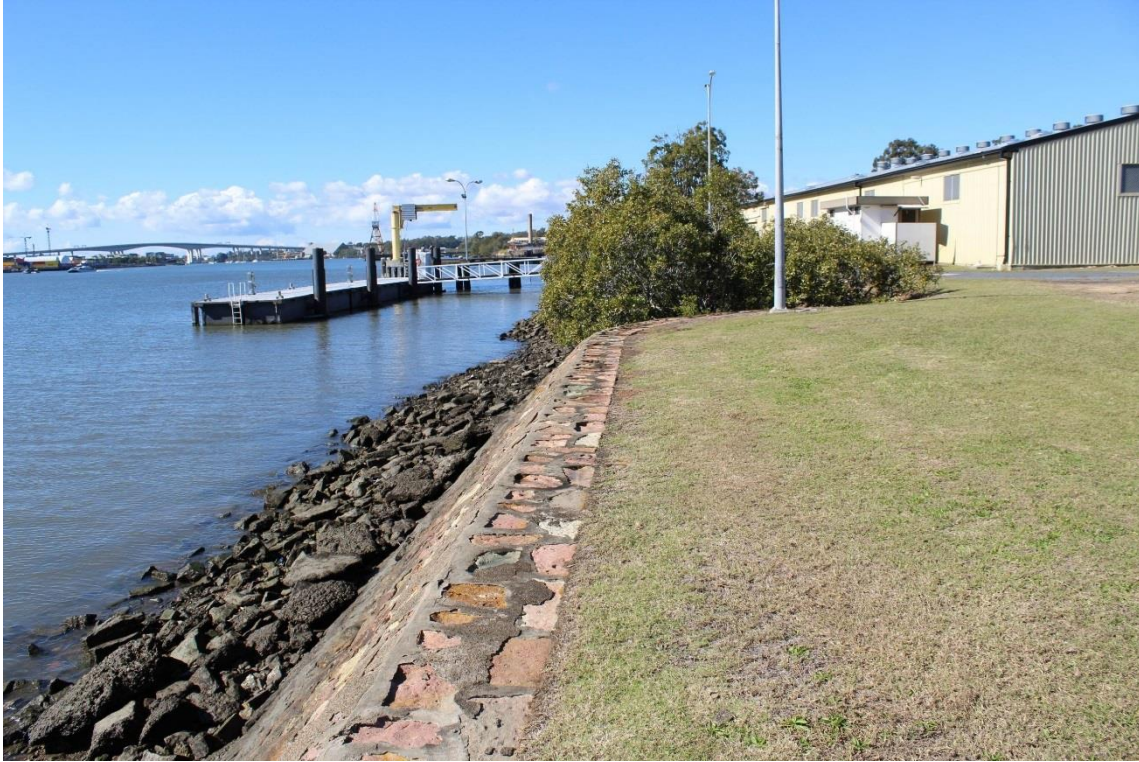
**Figure 35:** Section of sea wall that will have 2 water pipes inserted to assist storm water drainage from the site. (GML 2017)

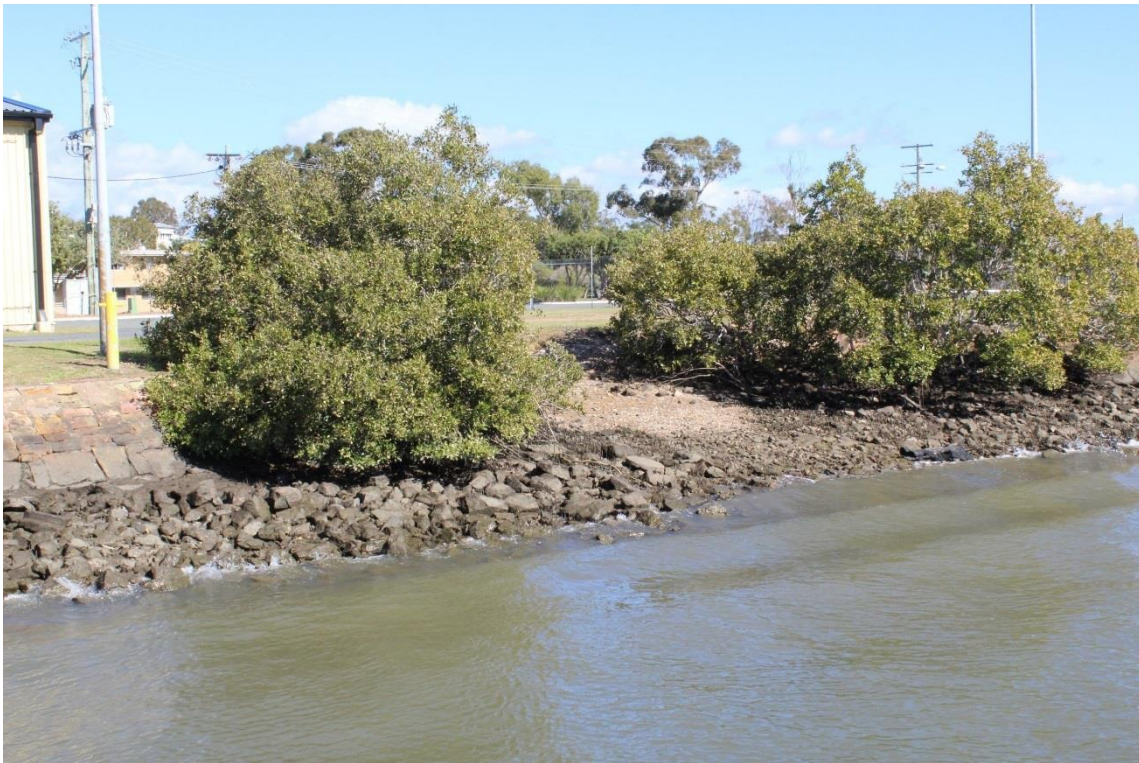
**Figure 36:** Current break in the sea wall where the proposed boat ramp will be constructed. (GML 2017)

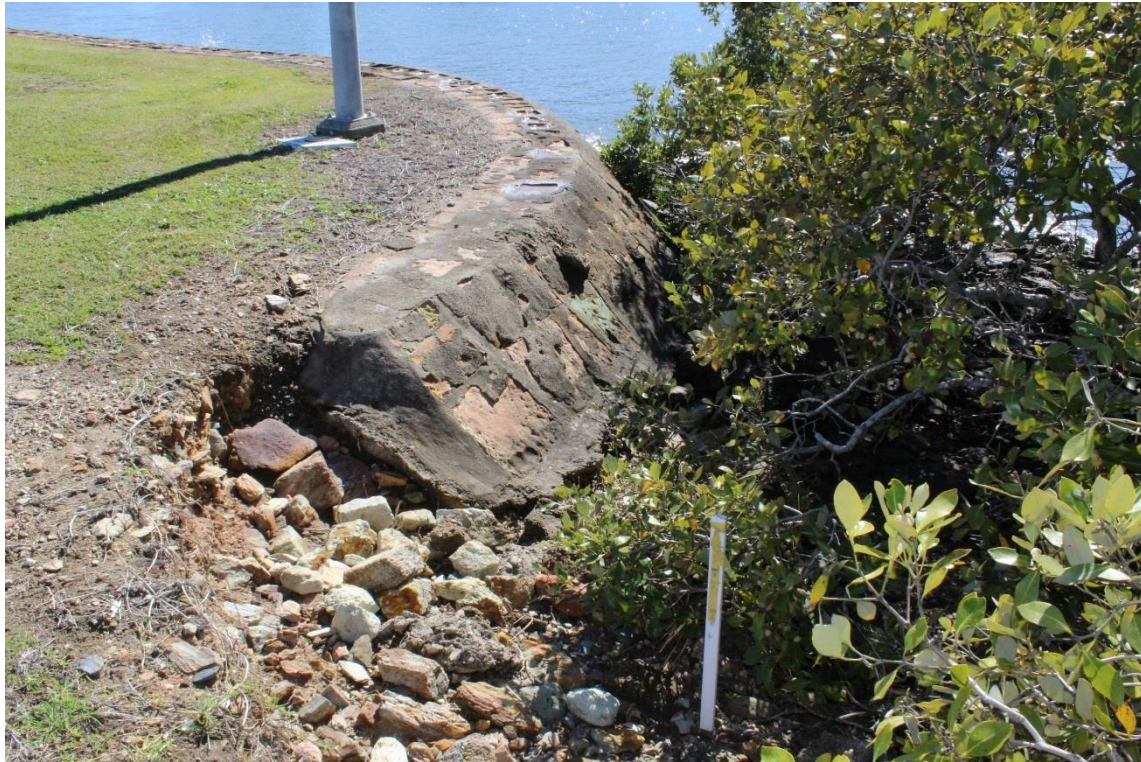
**Figure 37:** Detail of sea wall and gravelled break in the sea wall interface on the western side of the break. Minor works will be required to the sea wall to integrate the proposed boat ramp. (GML 2017)

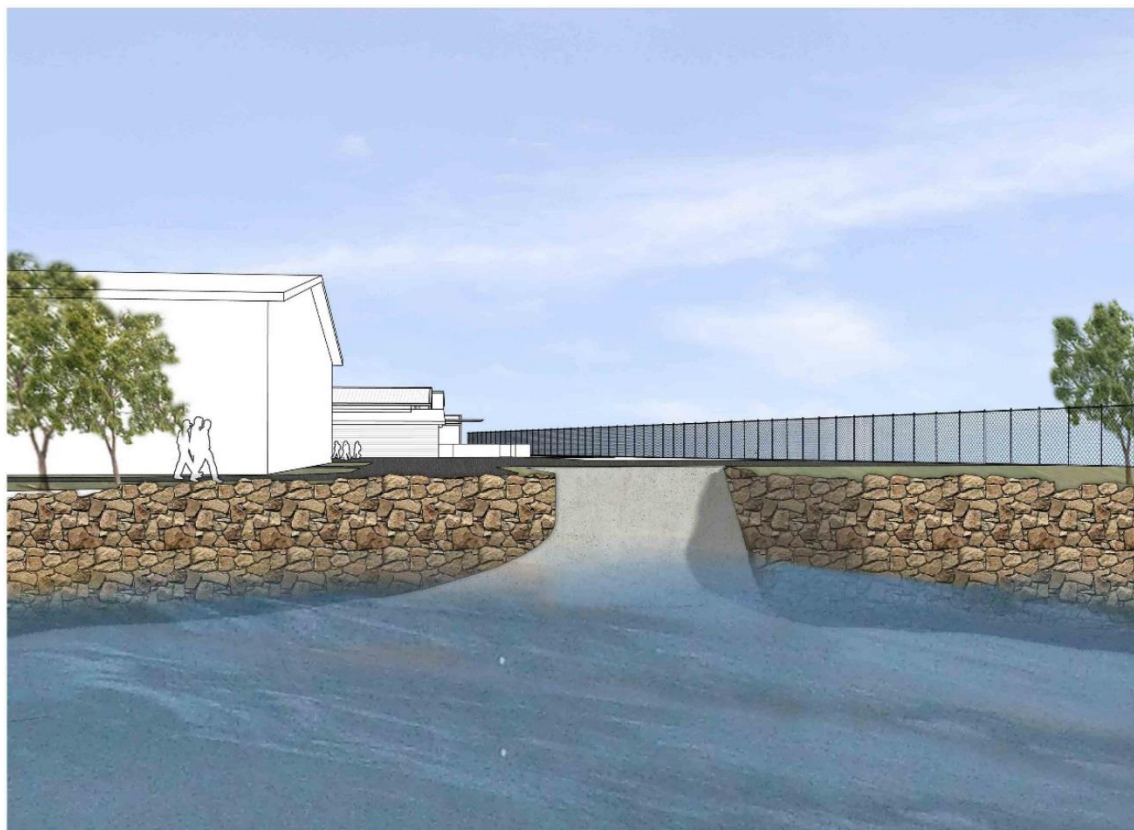
**Figure 38:** Concept drawing of the proposed boat ramp and the existing sea wall. (Source: Department of Defence 2017)

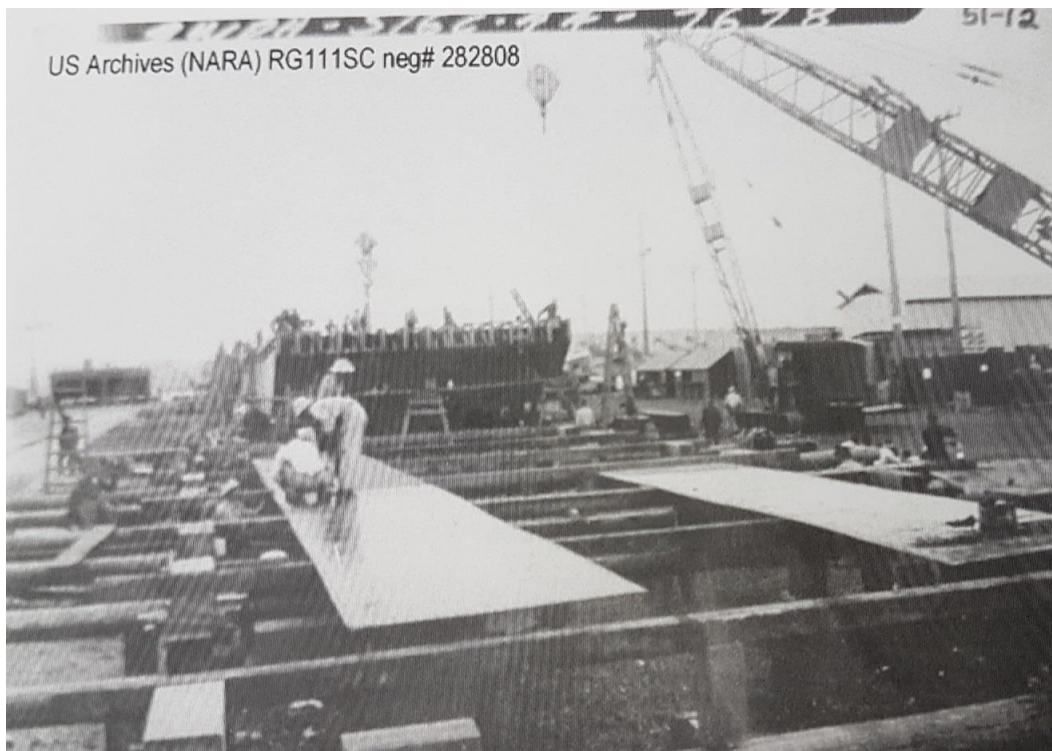
**Figure B.20:** Chinese workmen employed by the US Army lay the bottom plates of a kit form riveted barge at the Bulimba Ship Yards, Brisbane, 16 June 1944. The major parts of the barges, if not all materials, were factory cut to size and shipped from the US. These barges were crucial to the logistics of supply in the island campaigns of the Southwest Pacific. (Source: Marks & Dunn, undated, Brisbane WW2 v Now, No 7, copy held in the NLA)

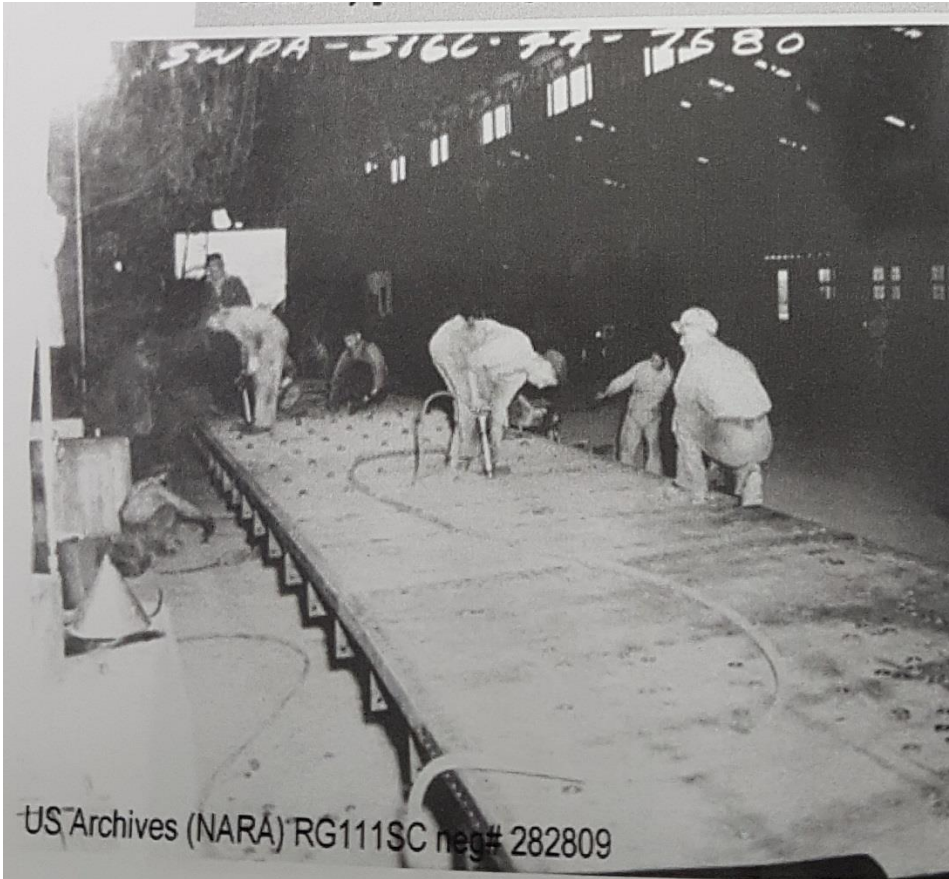
**Figure B.21:** Chinese workmen employed by the US Army prefabricate the sides for a kit form riveted barge 102 foot 4 inches at the Bulimba Ship Yards, Brisbane, 16 June 1944. Some work was indoors, but outside night lighting was used for shift work. (Source: Marks & Dunn, undated, Brisbane WW2 v Now, No 7, copy held in the NLA)

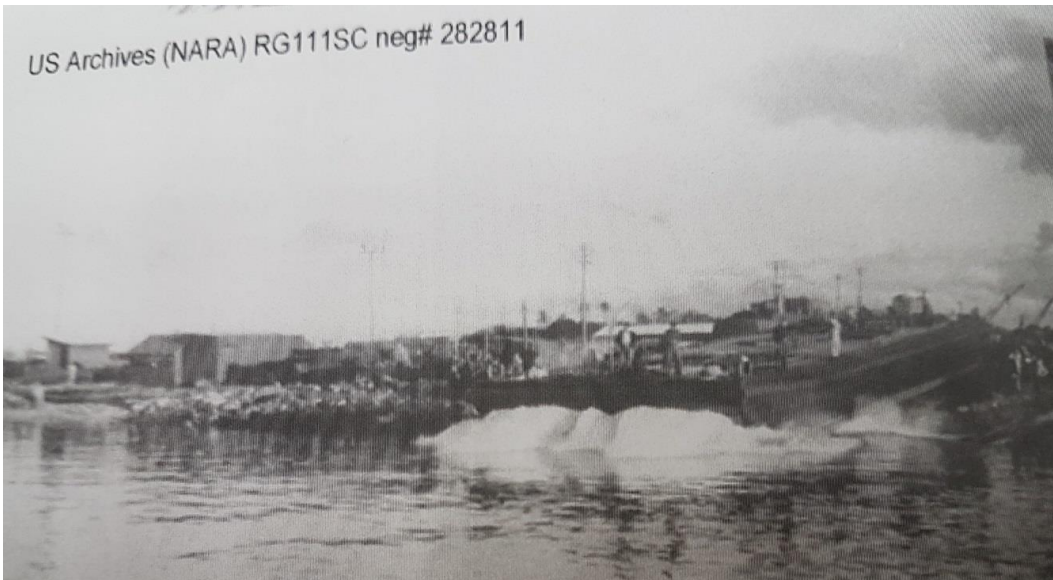
**Figure B.22:** Newly constructed barge, kit form riveted type, 102 feet 4 inches, slides off the ways at Bulimba Ship Yards, Brisbane, 16 June 1944. (Source: Marks & Dunn, undated, Brisbane WW2 v Now, No 7, copy held in the NLA)

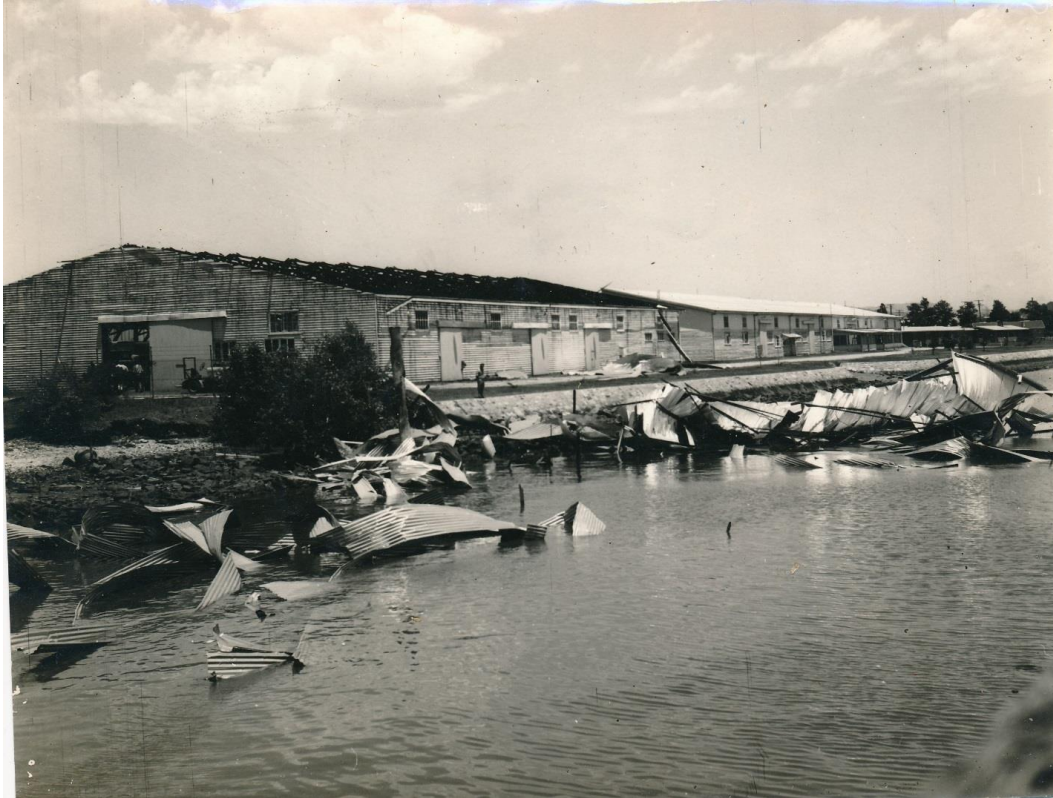
**Figure B.37:** Storm damage to A002 in 1973. Warehouse 5 adjacent to A002 can be seen in this image. (Source: Bulimba District Historical Society records)

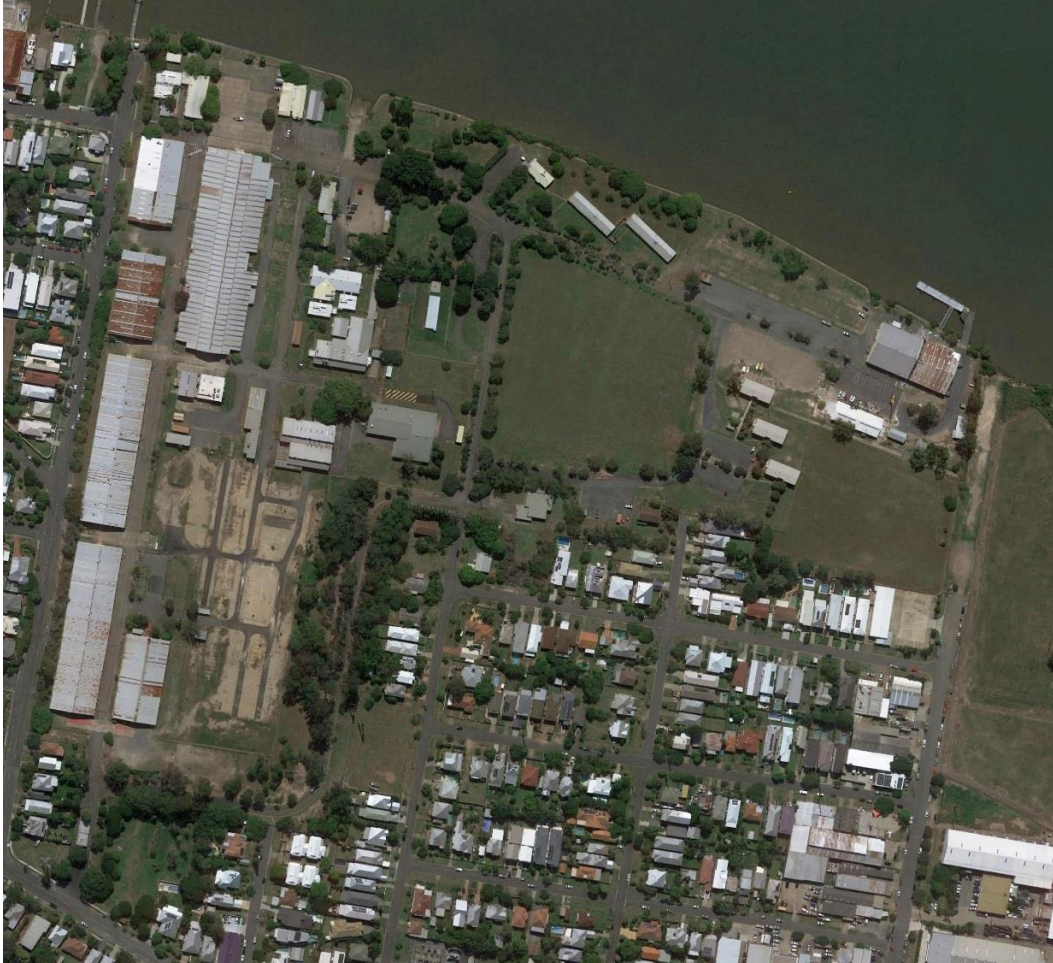
Figure B.47: 2015 aerial view of the site. The storm damage to the roof of A002 is evident in this image. (Source: Google Earth)
